AOS-W 6.5.0.0

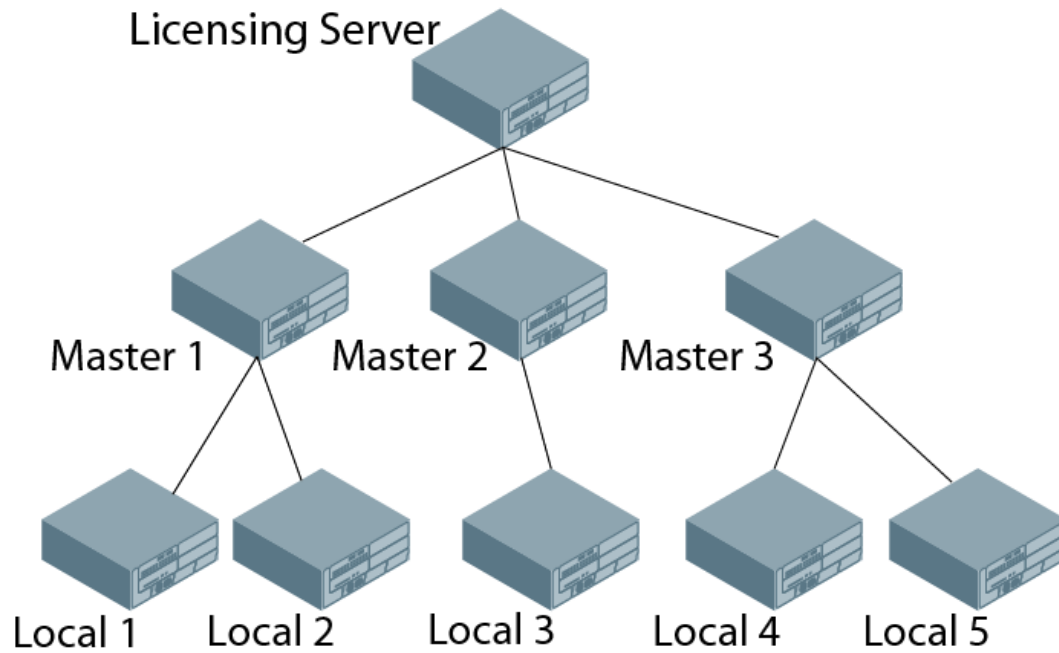
A centralized licensing server now supports multiple master/local domains—topologies where multiple masters have one or more attached local switches. This topology requires that all local switches are able to access the licensing server. Previous releases of AOS-W only supported topologies with local if all local switches using centralized licensing were associated to a single master switch, or to a redundant master switch pair.

Figure 1 Local Switches using Centralized Licensing in a Multi-Master Domain

All master switches should have the same advanced or enhanced security configuration. Mismatch in the security key will affect centralized licensing.
