Release Notes - Rev. B

OmniAccess Stellar AP

AWOS Release 4.0.2 - GA Release

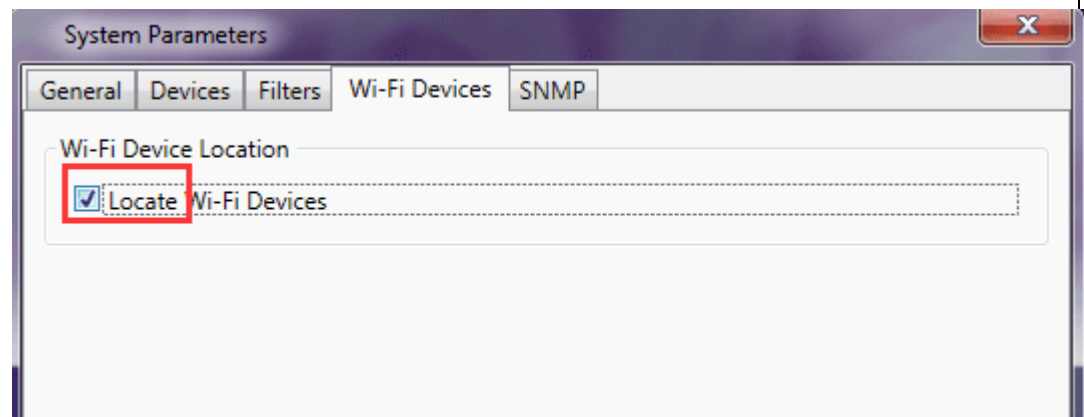
On AES Server -> System Parameters, select “Locate Wi-Fi Devices”:

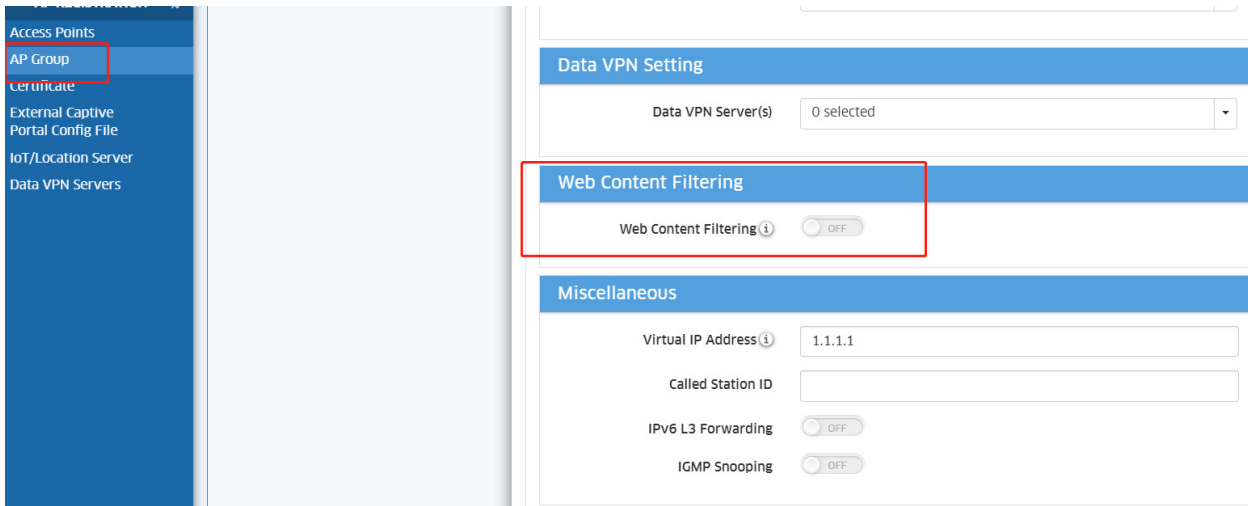
1. Group WCF configuration

The WCF function is the Web Content Filter function, which mainly filters the url to be accessed by client and adds release and deny rules so that it can only access the URL specified by the administrator.

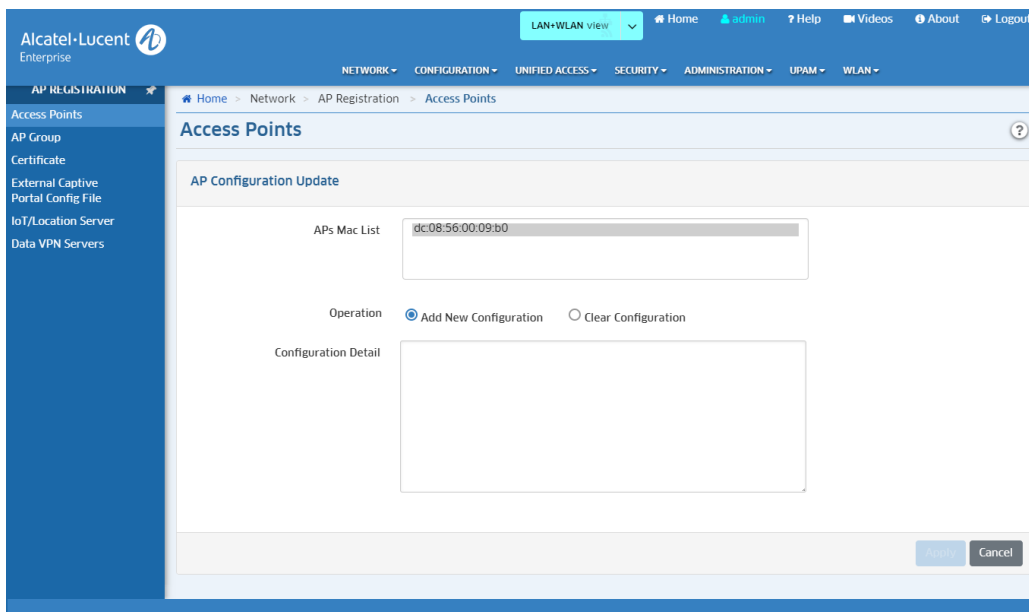
It will help the support team use the new OV version to temporarily resolve customer issues before the new AP is officially released.

Here are the configuration methods:

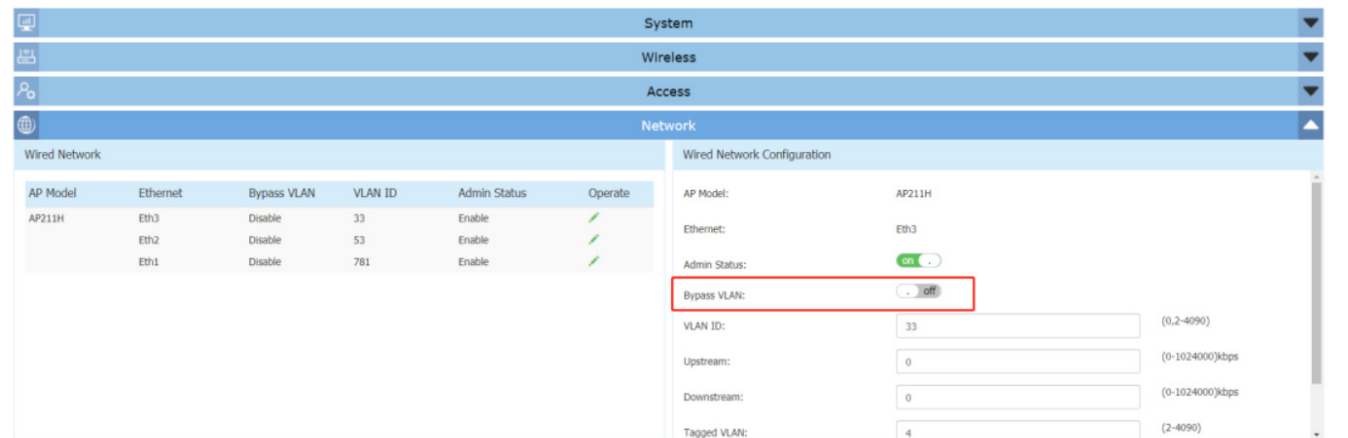
Support configuration through UI pages to control whether multicast messages are forwarded by CPU to meet different application scenarios.

1. For cluster mode, the configuration and status check methods are as follows:
