# Release Notes - Maintenance

## OmniAccess Stellar

AP1101, AP1201, AP1221, AP1222, AP1231, AP1232,  
AP1251, AP1201H

AWOS Release 3.0.5.1046

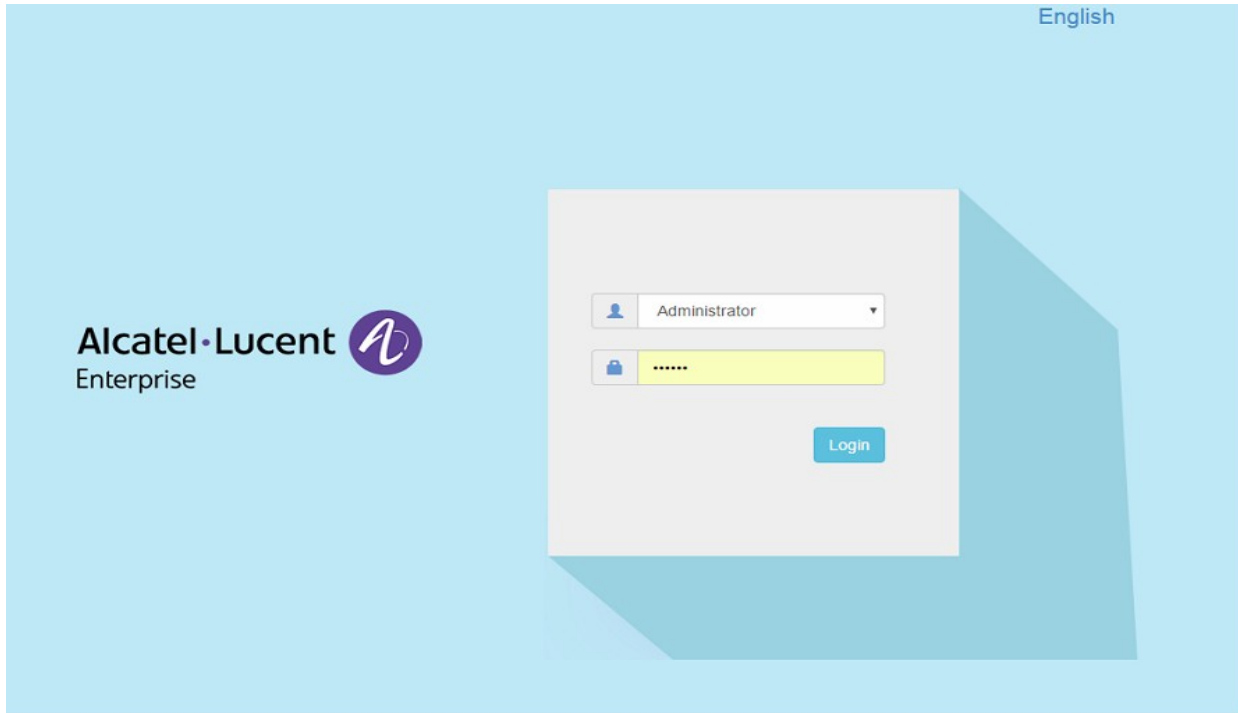
1. Login to AP using Administrator account with default password 'admin'.
