Release Notes

OmniAccess Stellar AP

AWOS Release 5.0.1 - MR1 Release

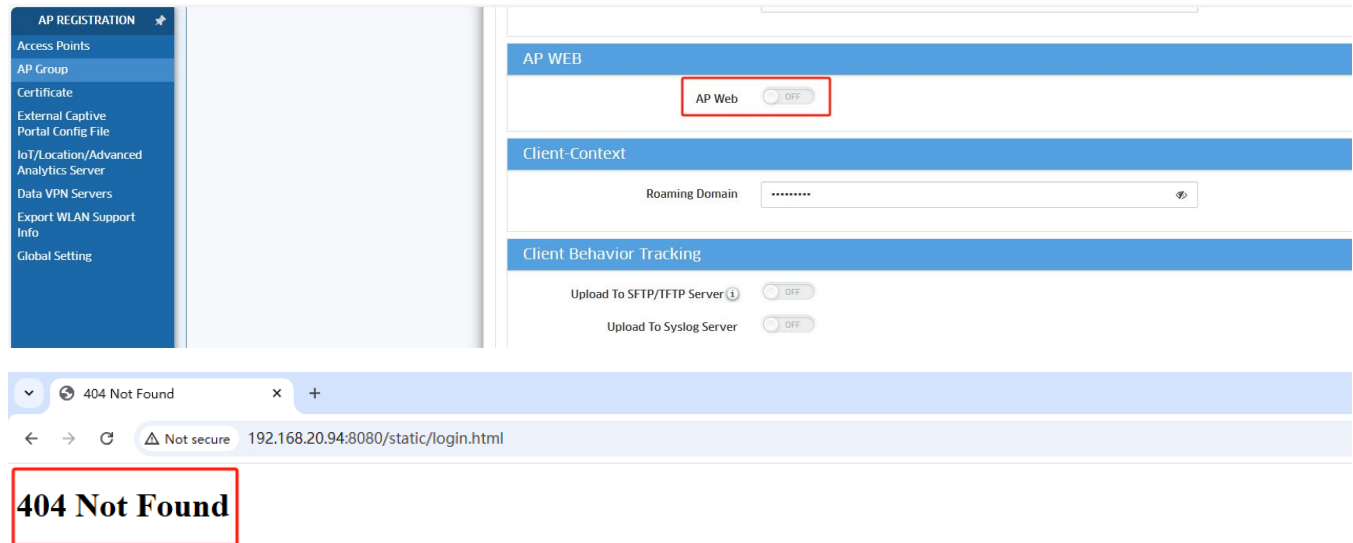
In the previous build, when Web access is disabled, no users can access the AP, but the Web Server is still running and user can see the Web Login page.

On AWOS 5.0.1 MR1, users cannot access Web Server of AP and will be returned 404 error when attempting to access Web Server.
