This document describes the new features and issues pertinent to the AOS-W 3.3.2.24 release.

What’s New in This Release

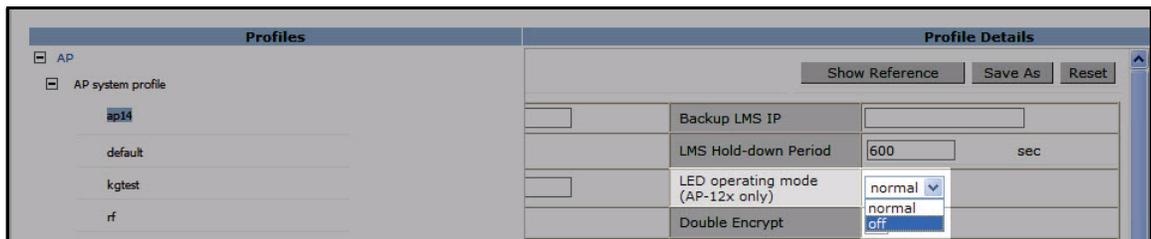
To disable the LEDs through the WebUI, navigate to **Configuration > Advanced Services > All Profiles > AP > AP System Profile**. Select the desired AP from the list. When an AP is selected, the **Profile Details** menu appears. Locate the **LED operating mode (AP-12x only)** parameter and select “off” from the drop down menu, as shown below.

LEDs can also be disabled through the CLI, while in configuration mode, using the following commands:

```
ap system-profile <profile-name>
led-mode {normal | off}
```
