AOS-W 6.4.1.0

Chapter Overview

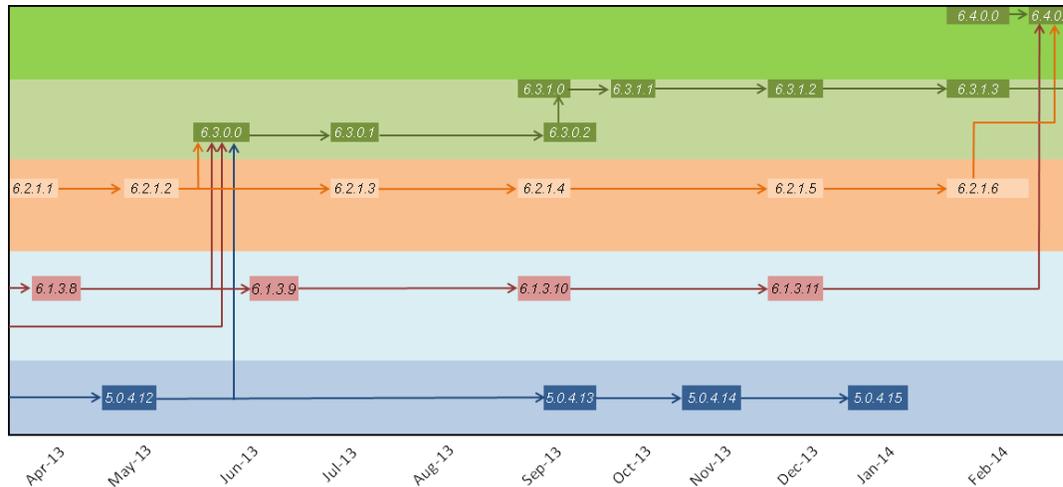
The following illustration shows the patch and maintenance releases that are included in their entirety in AOS-W 6.4.0.1:

Figure 1 AOS-W Releases and Code Stream Integration
