I have modified Intermediate Release

Omni Switch 9E, 6850, 6855 & 6400

Release 6.4.4.743.R01

The following is a list of issues that have been identified and corrected in AOS software release. This document is intended to be used as a pre-upgrade guide and does not replace the Release Notes which are created for every GA release of software.

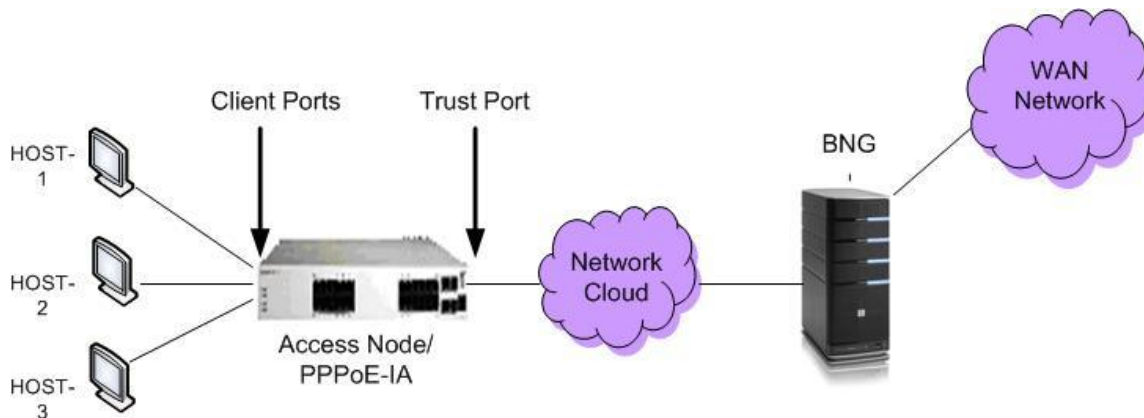
Termination Phase:

PADT

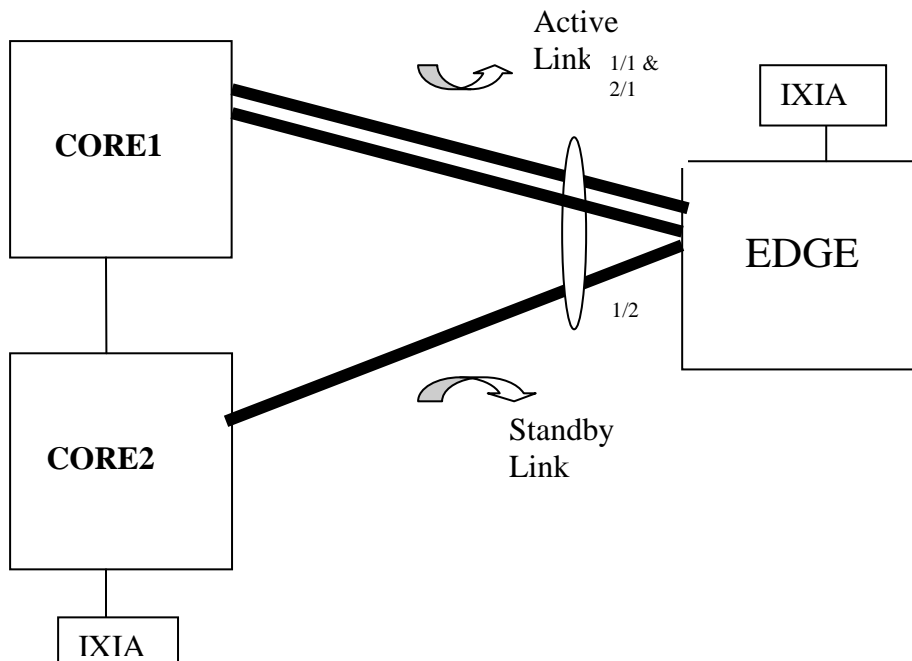
Topology :

On EDGE device create the LACP linkagg group of size 4 and set port 1/2 in STANDBY mode:

- > lacp linkagg 1 size 4 admin state enable
- > lacp linkagg 1 actor admin key 1
- > lacp agg 1/2 standby enable
- > lacp agg 1/1 actor admin key 1
- > lacp agg 1/2 actor admin key 1
- > lacp agg 2/1 actor admin key 1
