# Upgrading OmniSwitch 6850 Series Switches to 6.4.2.R01

This instruction sheet documents how to upgrade OmniSwitch 6850 Series Switches to 6.4.2.R01 firmware and software. The upgrade can be performed using the CLI, WebView, or SNMP. Alcatel-Lucent recommends using WebView to perform the upgrade. For upgrade instructions using the CLI, see [Upgrading with the CLI on page 13](#).

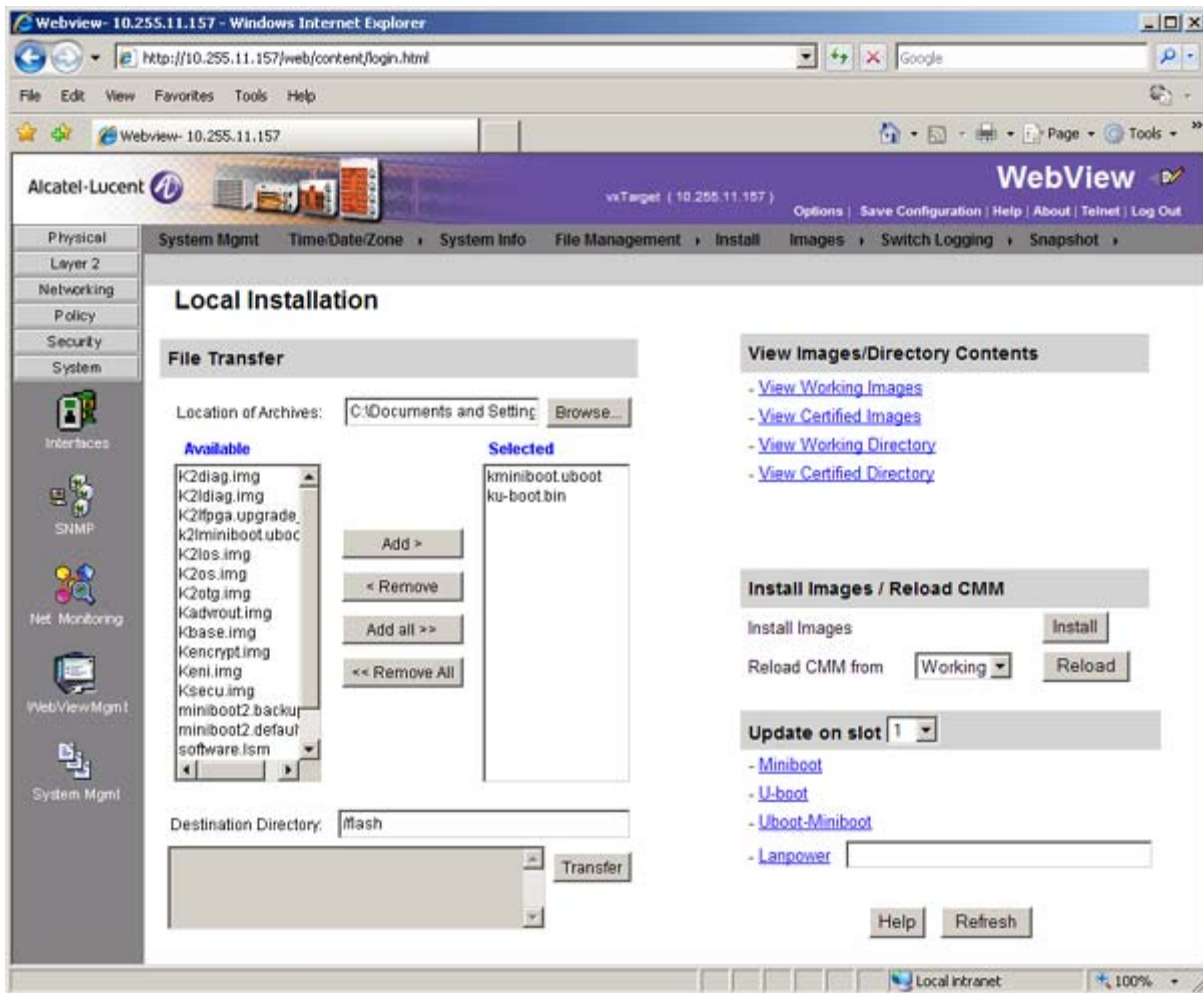
- Click on the **Remove All** button to move all of the files to the “Available” area, then select the **ku-boot.bin** file and the **kminiboot.uboot** file and click the **Add** button to move them to the “Selected” area as shown below.

- 6 Make sure the **Destination Directory** is **/flash**, then click the **Transfer** button. Wait until the process is complete (indicated in the area next to the **Transfer** button - “All files have been transferred successfully”).

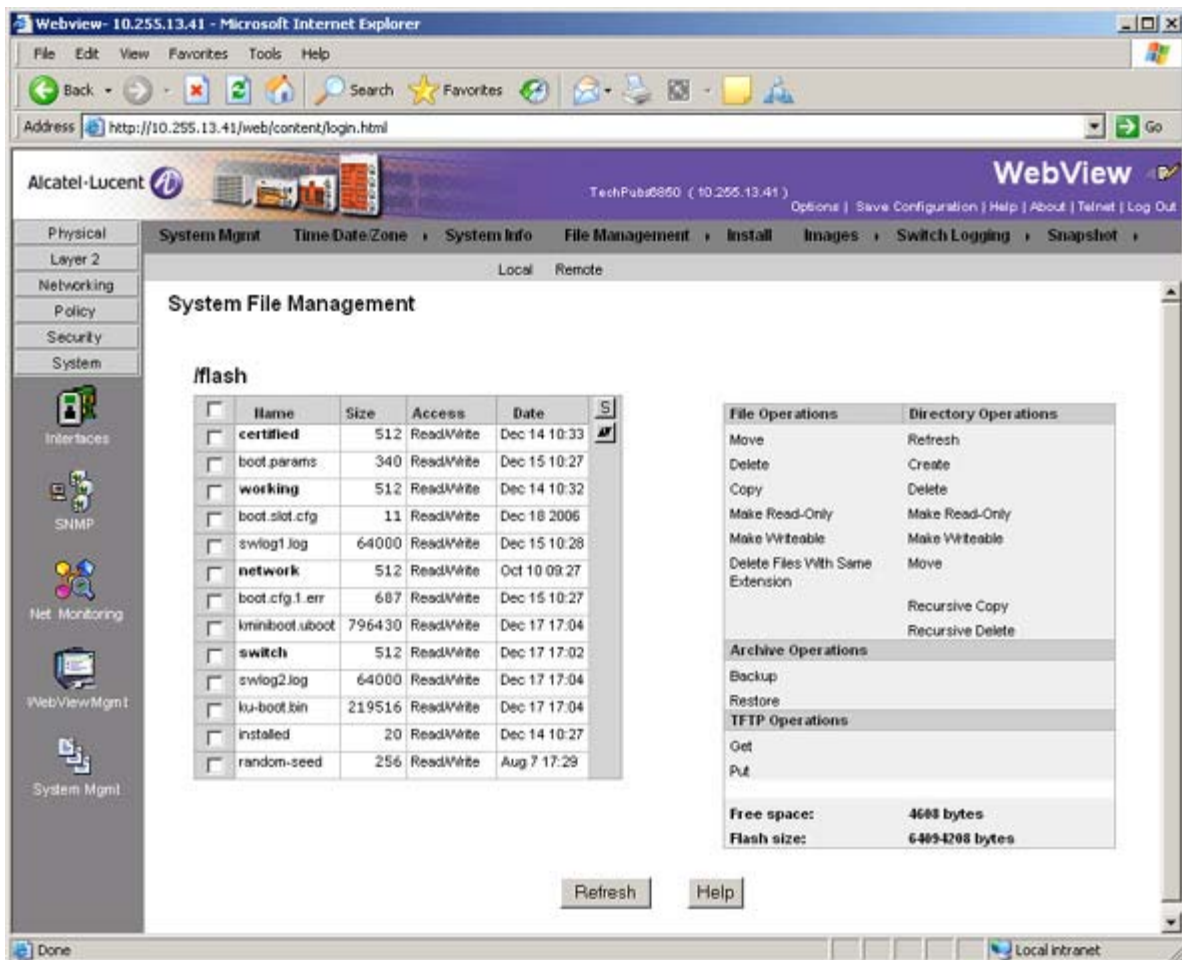
- 9 After verifying that the upgrade was successful (see [Verifying the Upgrade with WebView on page 10](#)), delete the **miniboot.uboot** and **ku-boot.bin** files from the Flash Directory by selecting **System > System Mgmt > File Management > Local**, as shown below.

- 10** Check the box next to the ku-boot.bin file, select **Delete** in the **File Operations** box, then click **OK** at the confirmation prompt. Repeat to delete the kminiboot.uboot file.
