Upgrading an OmniSwitch to 6.4.4.R01

Overview

These instructions documents how to upgrade the following OmniSwitch products to 6.4.4.R01 software and firmware. The upgrade can be performed using the CLI or WebView. Alcatel-Lucent recommends using WebView to perform the upgrade. Release 6.4.4.R01 is supported on the following switches. Click on the link to go to instructions for a specific switch.

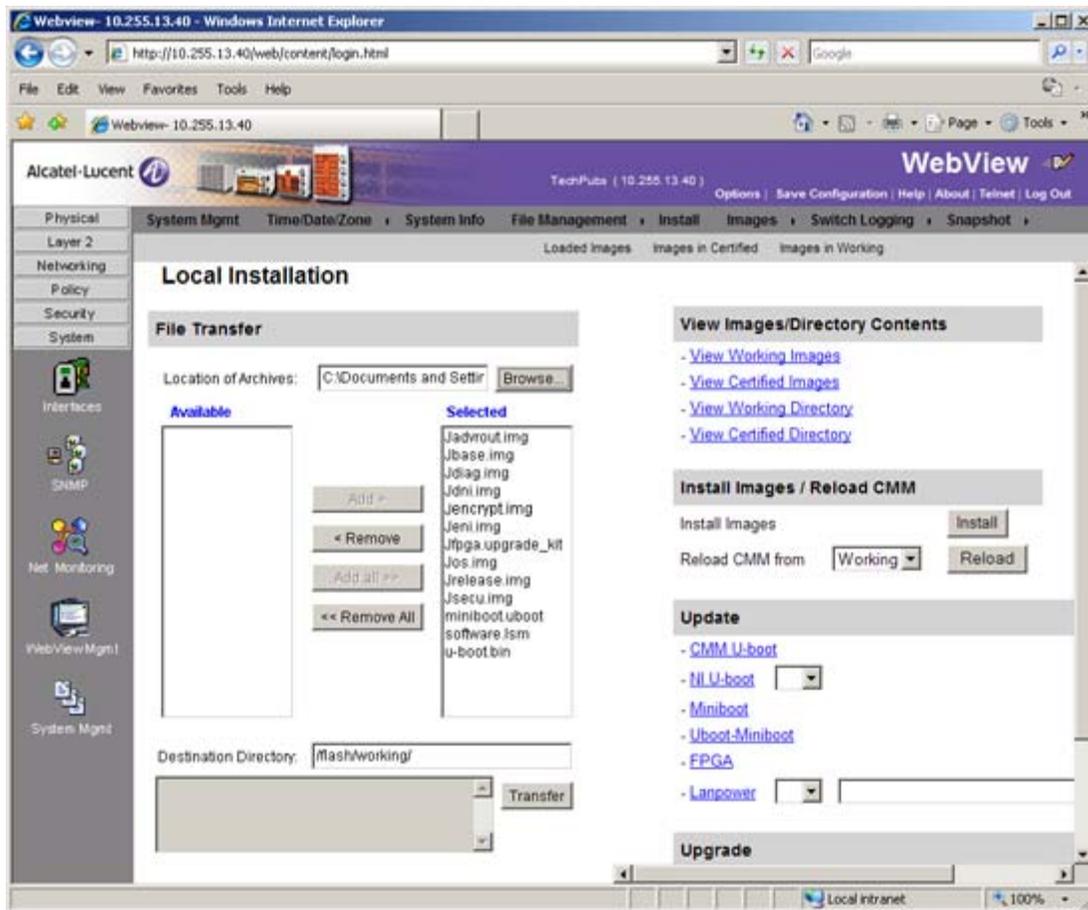
- 3 Select **System > System Mgmt > Install** to locate and FTP the 6.4.4.R01 Image Files that you downloaded in Step 1. Click on the **Browse** button to locate the files.
- 4 Select one of the files and click **Open**. All of the files will appear in the "Selected" area as shown below.

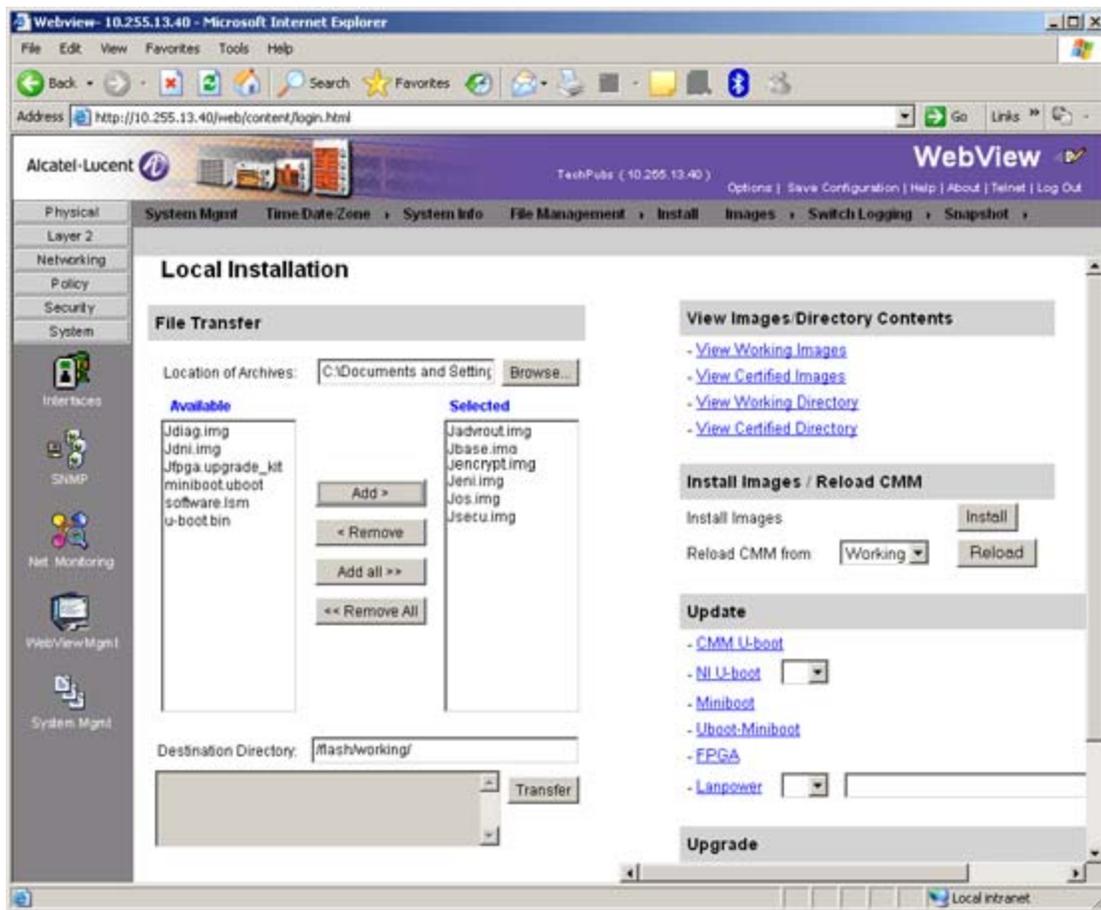
- 5 Click on the **Remove All** button to move all of the files to the “Available” area; then select the following Image Files and click the **Add** button to move them back to the “Selected” area as shown below: **Jadvrout.img**, **Jbase.img**, **Jencrypt.img**, **Jeni.img**, **Jos.img**, **Jsecu.img**.

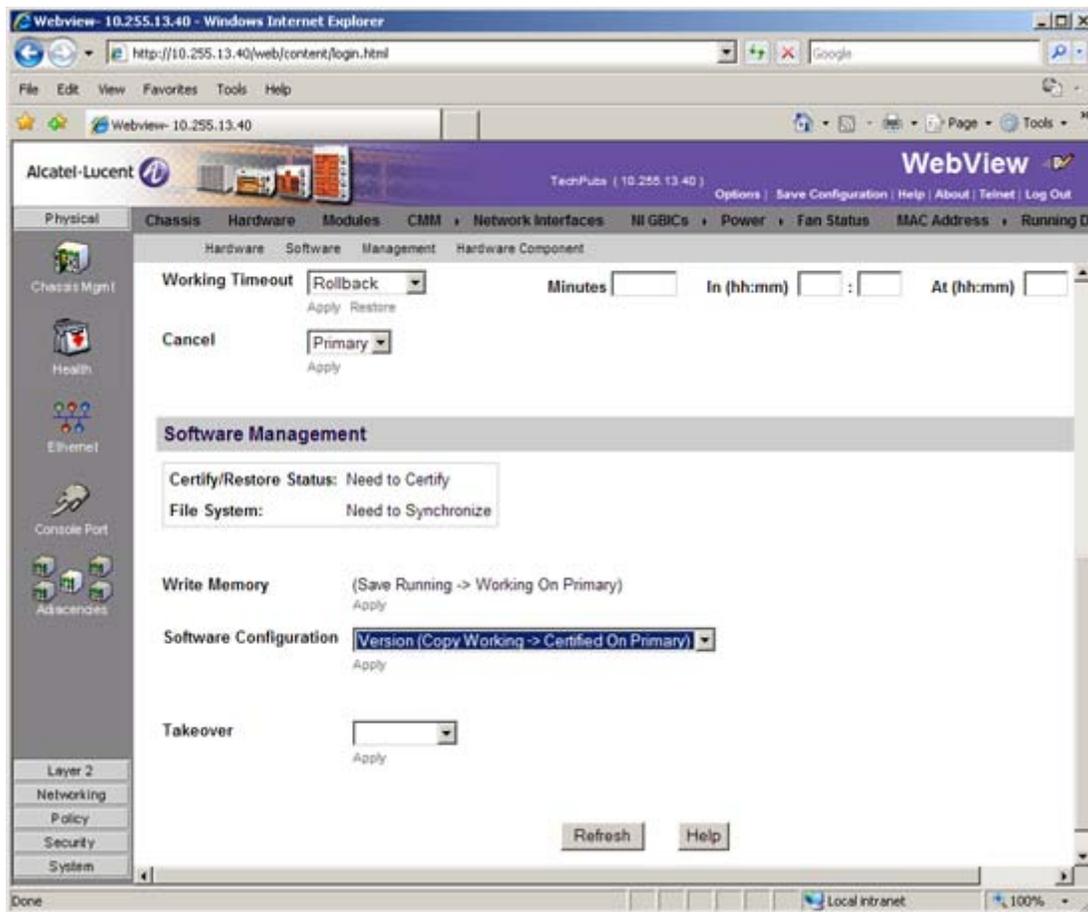
- 6 Transfer the files to the **flash/working** directory. Make sure the **Destination Directory** is **flash/working**, then click the **Transfer** button. Wait until the process is complete (indicated in the area next to the **Transfer** button - "All files have been transferred successfully").
- 7 Reload the switch from the Working Directory. In the "Install Images/Reload CMM" area, select **Working** in the **Reload CMM From** field, then click the **Reload** button. Click **OK** at the warning prompt. Wait until the process is complete.
- 8 After the CMM finishes rebooting, log into WebView.
- 9 Copy the files to the Certified Directory and sync the Primary and Secondary CMMs (if applicable). Select **Physical > Chassis Mgmt > CMM > Management** as shown below.

- 10** In the **Software Configuration** field, select **Copy Working -> Certified on Primary** for switches with a single CMM, or **Copy Working -> Certified & Synchronize with Secondary** for switches with a secondary CMM, then click **Apply**. The switch will copy the files from the Working to the Certified Directory and synchronize the CMMs (if applicable). Wait for the process to complete.

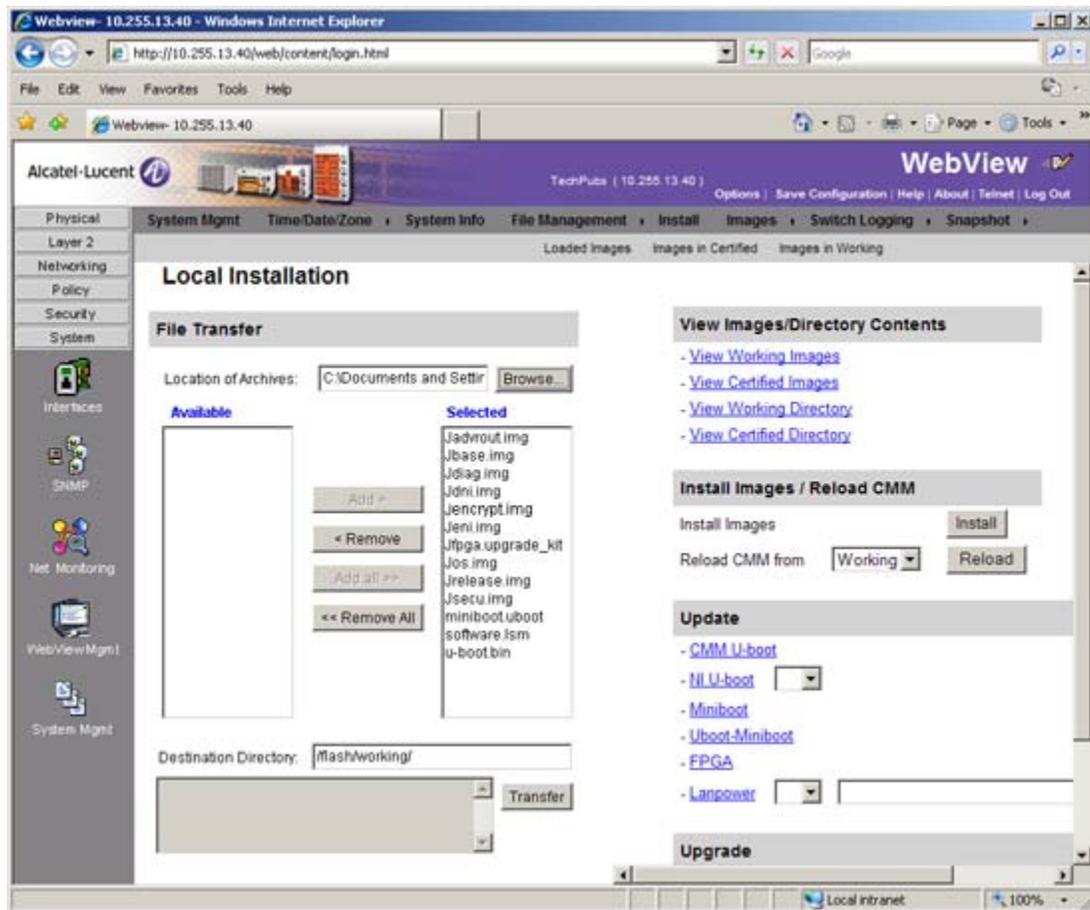
- 3 Select **System > System Mgmt > Install** to locate and FTP the 6.4.4.R01 Image Files that you downloaded in Step 1. Click on the **Browse** button to locate the files.
- 4 Select one of the files and click **Open**. All of the files will appear in the "Selected" area as shown below.

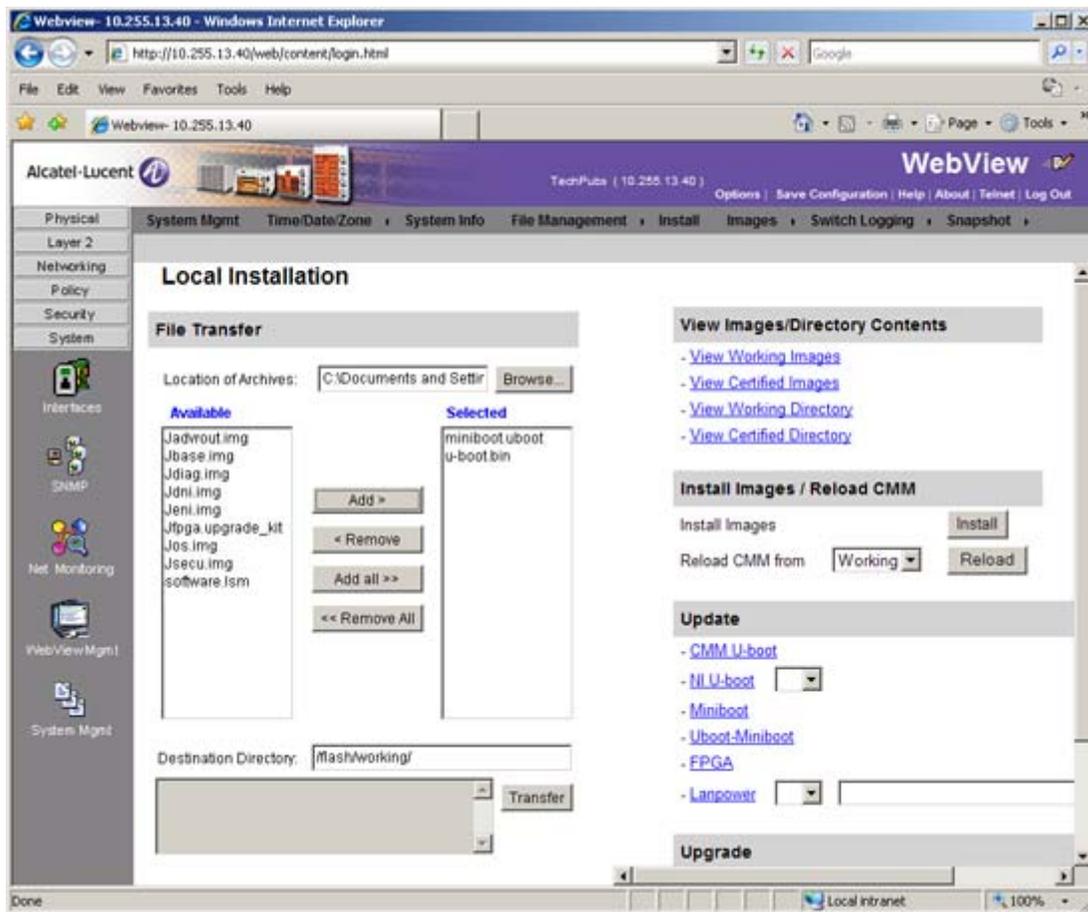
- 5 Click on the **Remove All** button to move all of the files to the "Available" area; then select both the **miniboot.uboot** and **u-boot.bin** files and click the **Add** button to move them to the "Selected" area as shown below.

- Transfer the files to the **/flash** Directory. Make sure the **Destination Directory** is **/flash**, then click the **Transfer** button. Wait until the process is complete (indicated in the area next to the **Transfer** button - "All files have been transferred successfully").

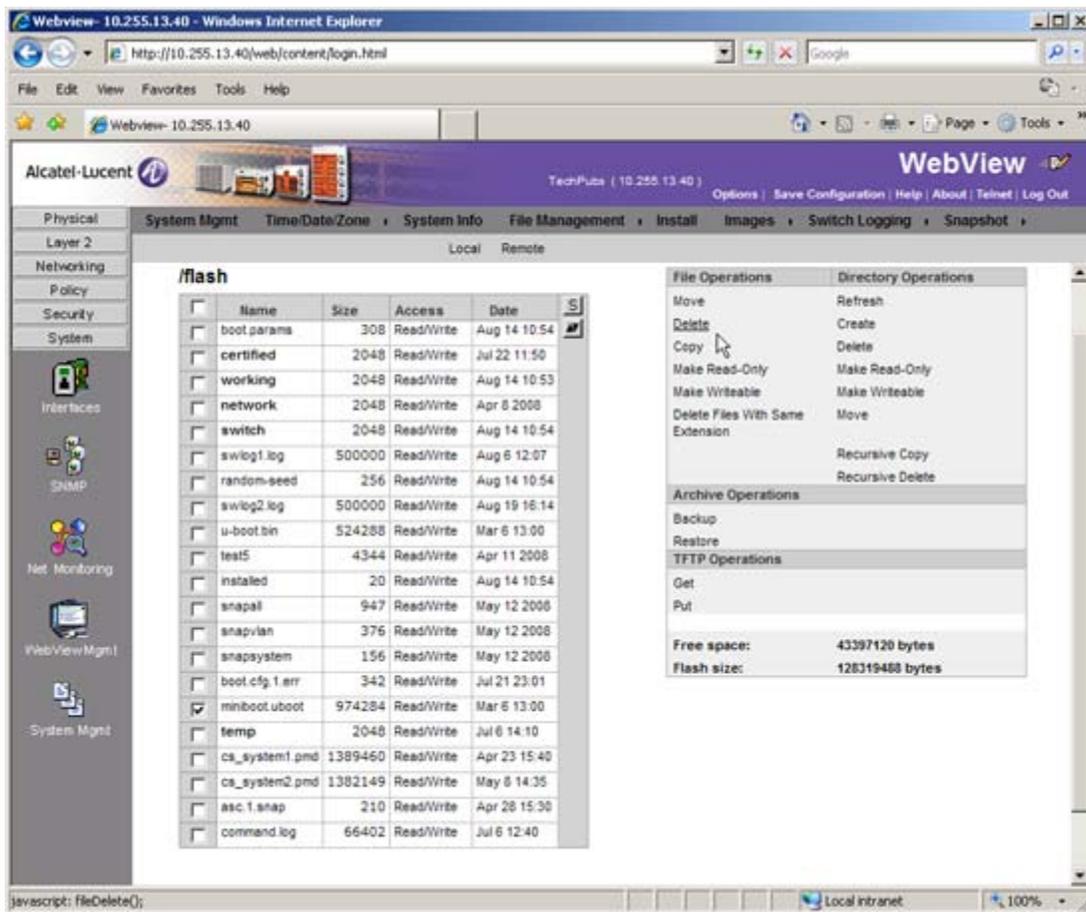
- Reload the switch from the Working Directory. In the "Install Images/Reload CMM" area, select **Working** from the **Reload CMM From** field, then click the **Reload** button. Click **OK** at the warning prompt. Wait until the process is complete.
- After verifying that the upgrade was successful, delete the **miniboot.uboot** and **uboot.bin** files from the Flash Directory by selecting **System > System Mgmt > File Management > Local**, as shown below.

- 10 Check the box next to the **miniboot.uboot** file, select **Delete** in the **File Operations** box, then click **OK** at the confirmation prompt. Repeat to delete the **u-boot.bin** file.

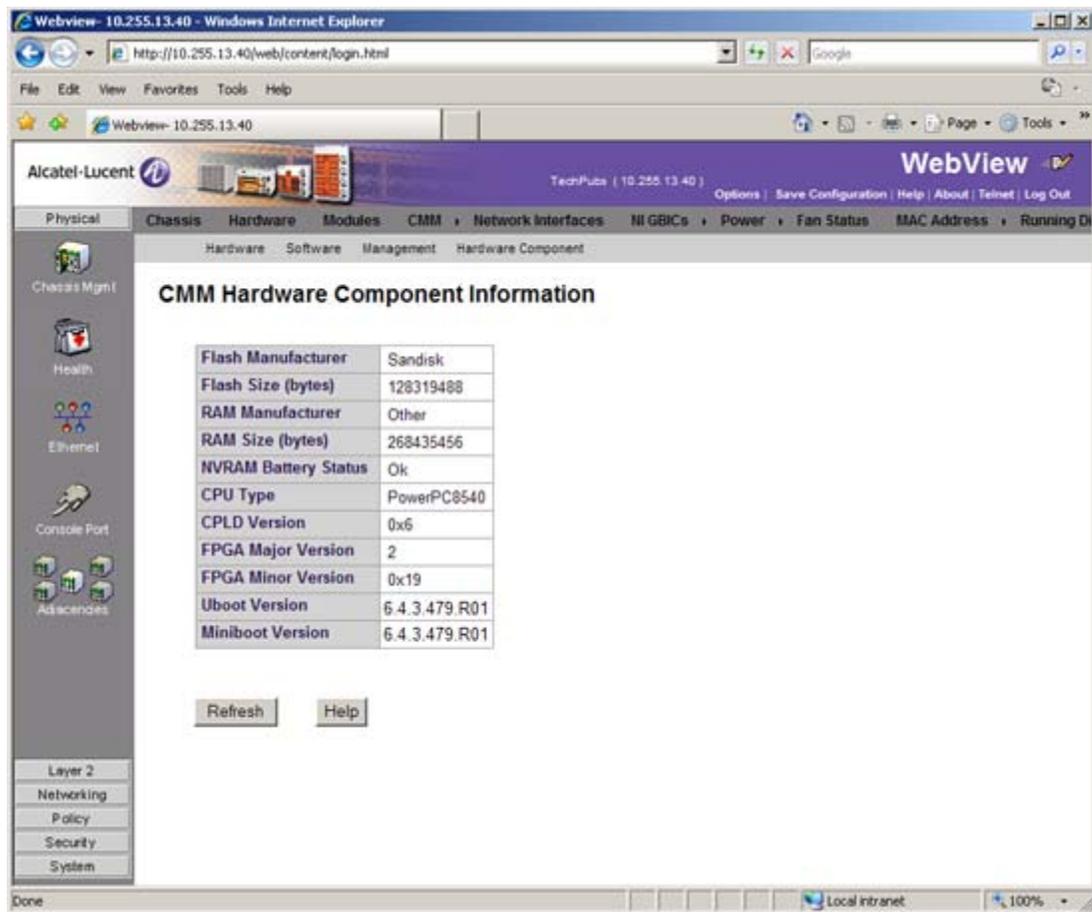
To verify that the U-Boot and Miniboot Files were successfully upgraded on the CMM, go to the **CMM Hardware Component Information** page by selecting **Physical > Chassis Mgmt > CMM > Hardware Component**, as shown below.

The screenshot displays the Alcatel-Lucent WebView interface in a Windows Internet Explorer browser. The browser's address bar shows the URL `http://10.255.13.40/web/content/login.html`. The page title is "Webview- 10.255.13.40". The interface features a navigation menu with tabs for Physical, Chassis, Hardware, Modules, CMM, Network Interfaces, NI GBICs, Power, Fan Status, MAC Address, and Running Diagnostics. The "CMM" tab is selected, and the page displays "CMM Hardware Component Information".

Flash Manufacturer	Sandisk
Flash Size (bytes)	128319488
RAM Manufacturer	Other
RAM Size (bytes)	268435456
NVRAM Battery Status	Ok
CPU Type	PowerPC8540
CPLD Version	0x6
FPGA Major Version	2
FPGA Minor Version	0x19
Uboot Version	6.4.3.479.R01
Miniboot Version	6.4.3.479.R01

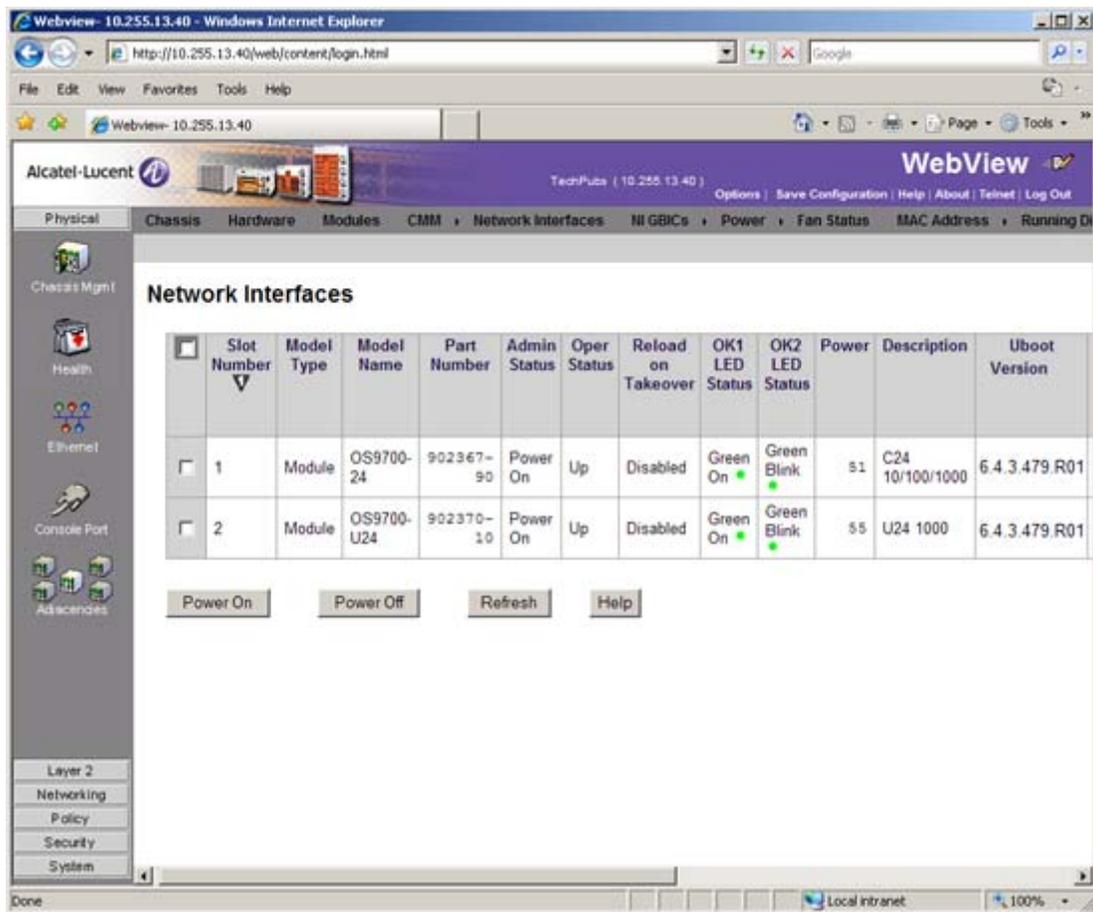
To verify that the U-Boot file was successfully upgraded on the switch's NIs, go to the **Network Interfaces** page by selecting **Physical > Chassis Mgmt > Network Interfaces**, as shown below.

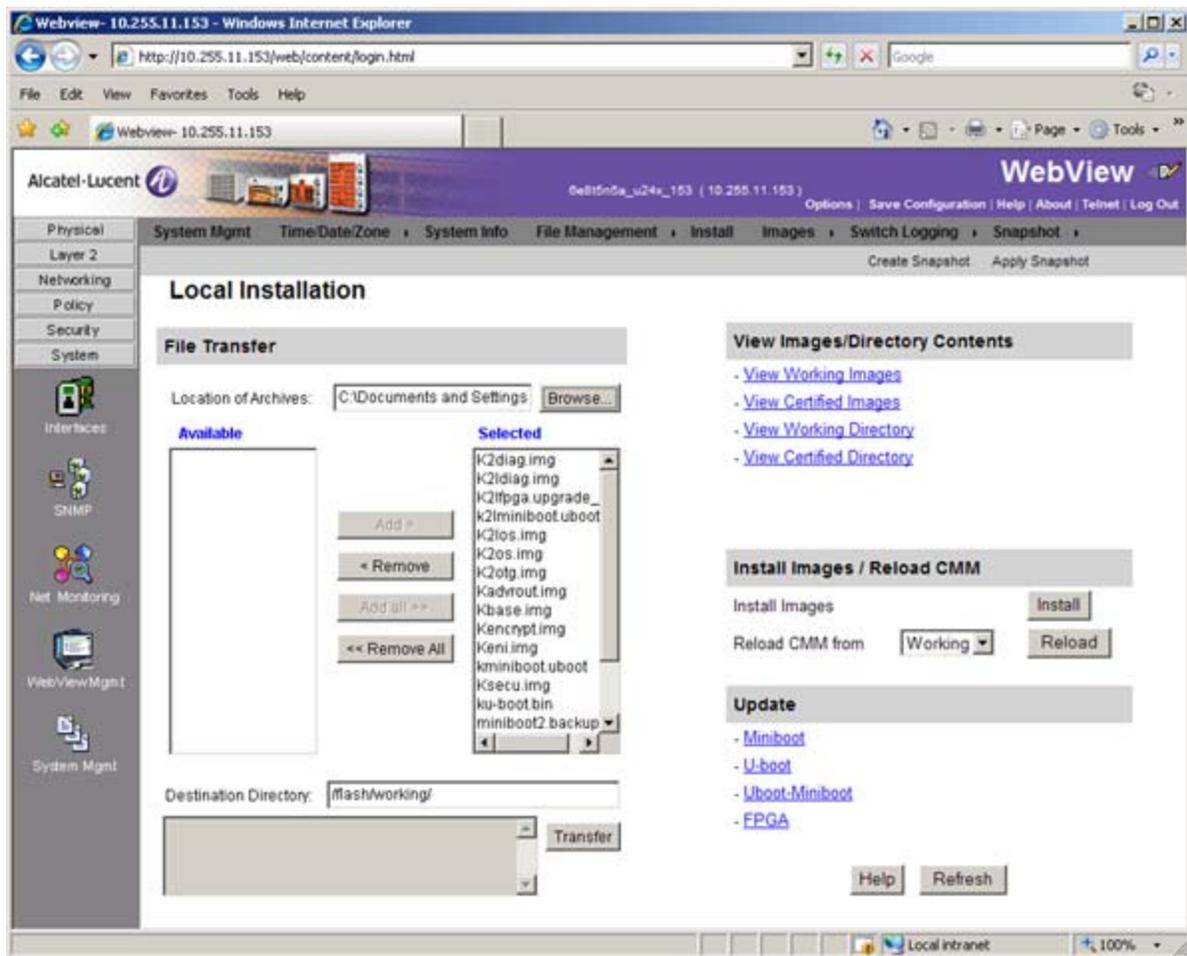
- 3 Select **System > System Mgmt > Install** to locate and FTP the 6.4.4.R01 image files that you downloaded in Step 1. Click on the **Browse** button to locate the files.
- 4 Select one of the files and click **Open**. All of the files will appear in the "Selected" area, as shown below.

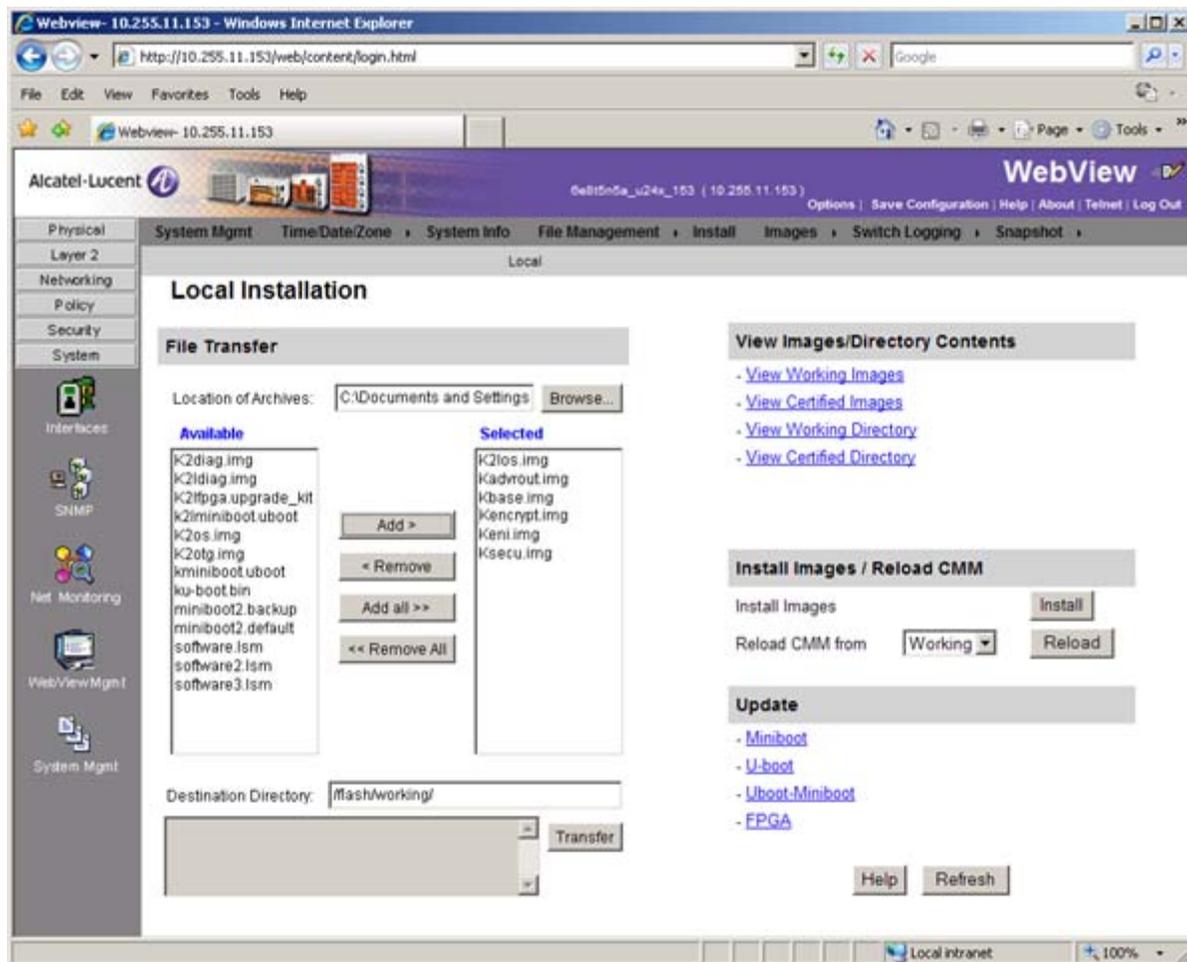
- 5 Click on the **Remove All** button to move all of the files to the “Available” area; then select the following image files and click the **Add** button to move them to the “Selected” area as shown below:
K2l2os.img, Kadvrout.img, Kbase.img, Kencrypt.img, Keni.img, Ksecu.img.

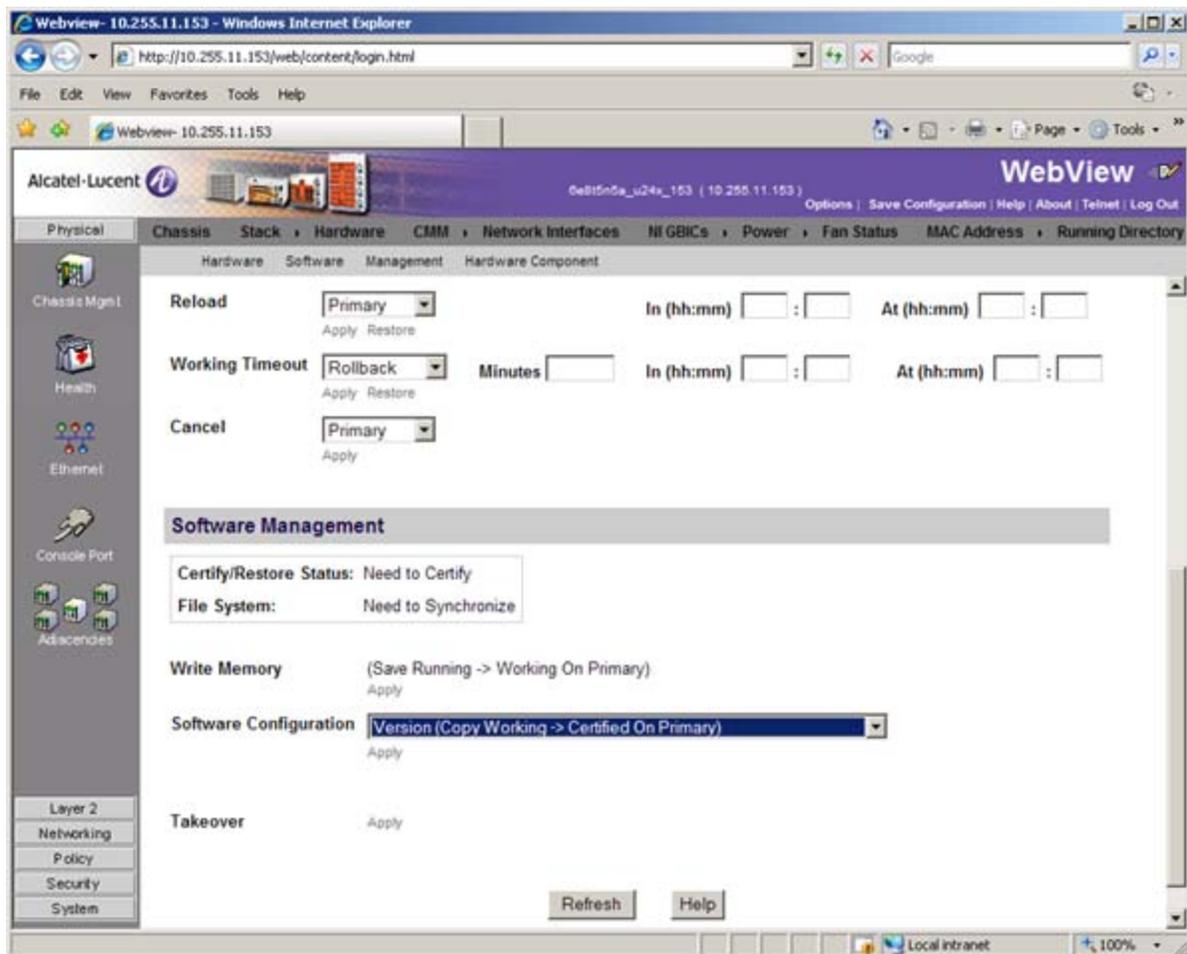
- 6 Transfer the files to the **flash/working** directory. Make sure the **Destination Directory** is **flash/working**, then click the **Transfer** button. Wait until the process is complete (indicated in the area next to the **Transfer** button - "All files have been transferred successfully").
- 7 Reload the switch from the Working Directory. In the "Install Images/Reload CMM" area, select **Working** in the **Reload CMM From** field, then click the **Reload** button. Click **OK** at the warning prompt. Wait until the process is complete.
- 8 After the CMM finishes rebooting, log into WebView.
- 9 Select **Physical > Chassis Mgmt > CMM > Management** as shown below.

- 10** In the **Software Management** field, select **Copy Working -> Certified on Primary** for standalone switches. For a stack, select **Copy Working -> Certified & Synchronize with Secondary** and click **Apply**. The switch will synchronize files from the working directory with all other stacks (if applicable). Wait for the synchronization process to complete on all switches before proceeding to the next step.

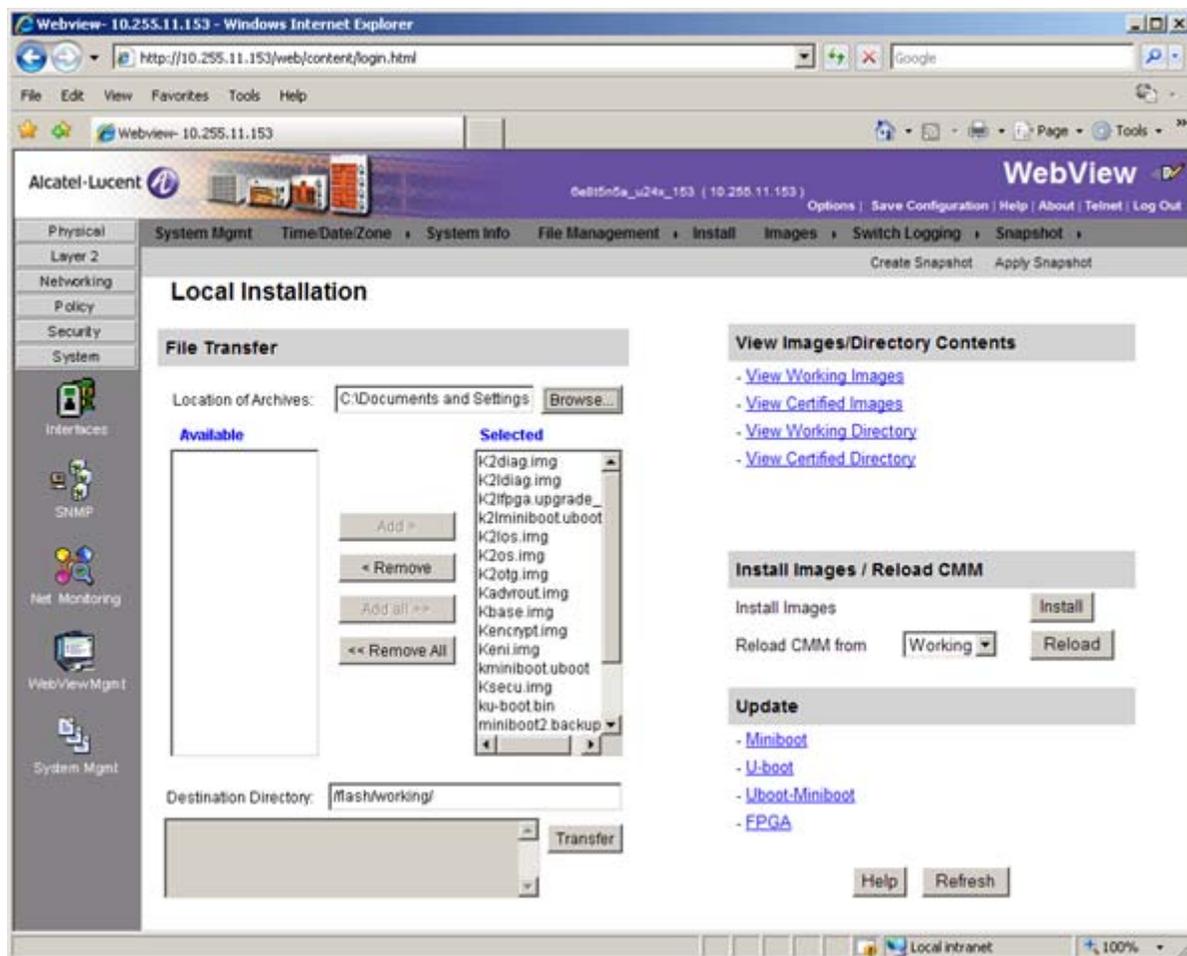
- 3 Select **System > System Mgmt > Install** to locate and FTP the 6.4.4.R01 image files that you downloaded in Step 1. Click on the **Browse** button to locate the files.
- 4 Select one of the files and click **Open**. All of the files will appear in the "Selected" area, as shown below.

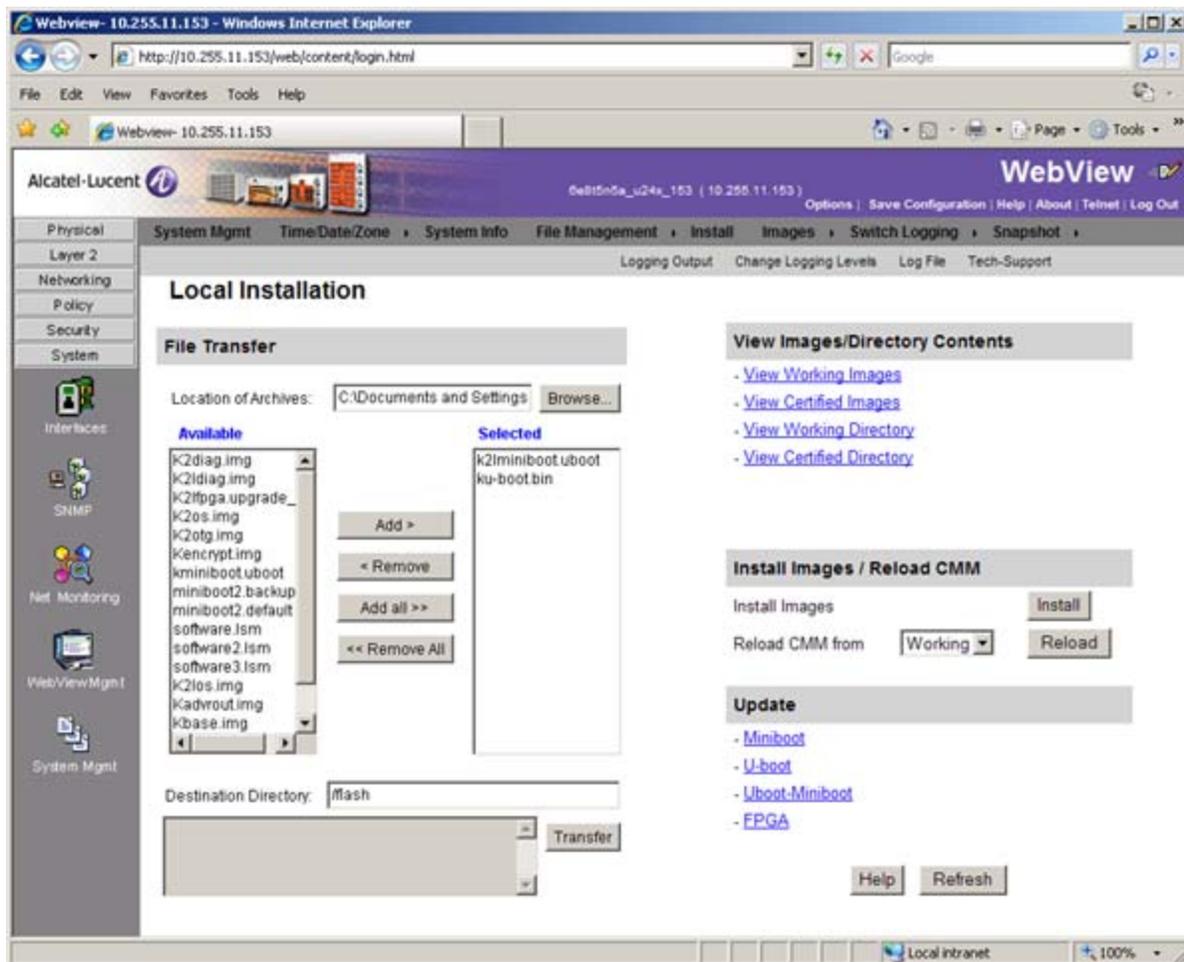
- 5 Click on the **Remove All** button to move all of the files to the "Available" area, then select the **ku-boot.bin** file and the **k2Iminiboot.uboot** file and click the **Add** button to move them to the "Selected" area as shown below.

- 6 Make sure the **Destination Directory** is /flash, then click the **Transfer** button. Wait until the process is complete (indicated in the area next to the **Transfer** button - “All files have been transferred successfully”).

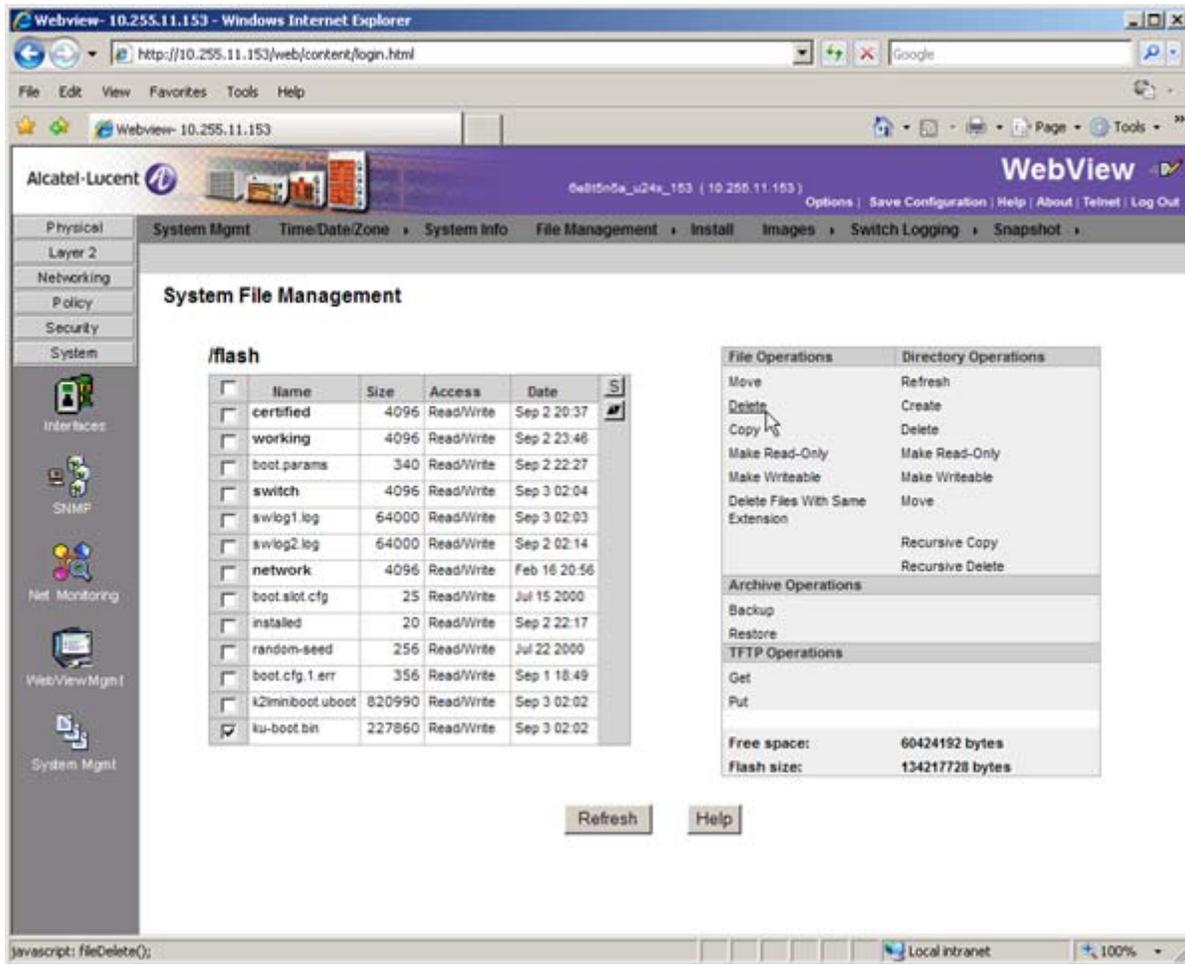
- 9 After verifying that the upgrade was successful, delete the **K2Iminiboot.uboot** and **ku-boot.bin** files from the Flash Directory by selecting **System > System Mgmt > File Management > Local**, as shown below.

- 10 Check the box next to the ku-boot.bin file, select **Delete** in the **File Operations** box, then click **OK** at the confirmation prompt. Repeat to delete the k2Iminiboot.uboot file.

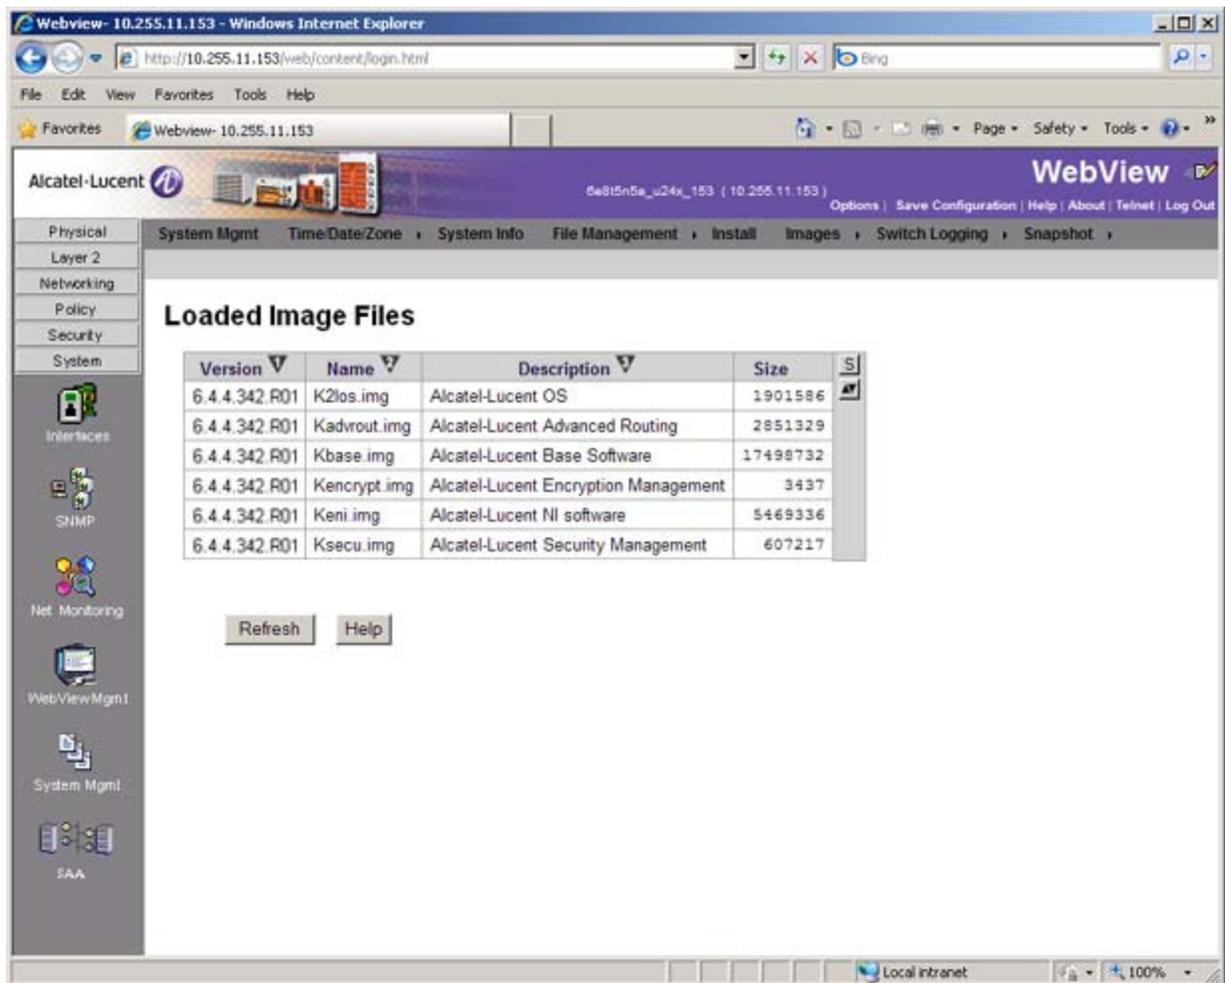
To verify that the software was successfully upgraded, go to the **Loaded Image Files** page by selecting **System > System Mgmt > Images > Loaded Images** as shown below.

In addition, you should also select **System > System Mgmt > Images > Images in Certified** and **System > System Mgmt > Images > Images in Working** to verify that Certified and Working directories were successfully upgraded.

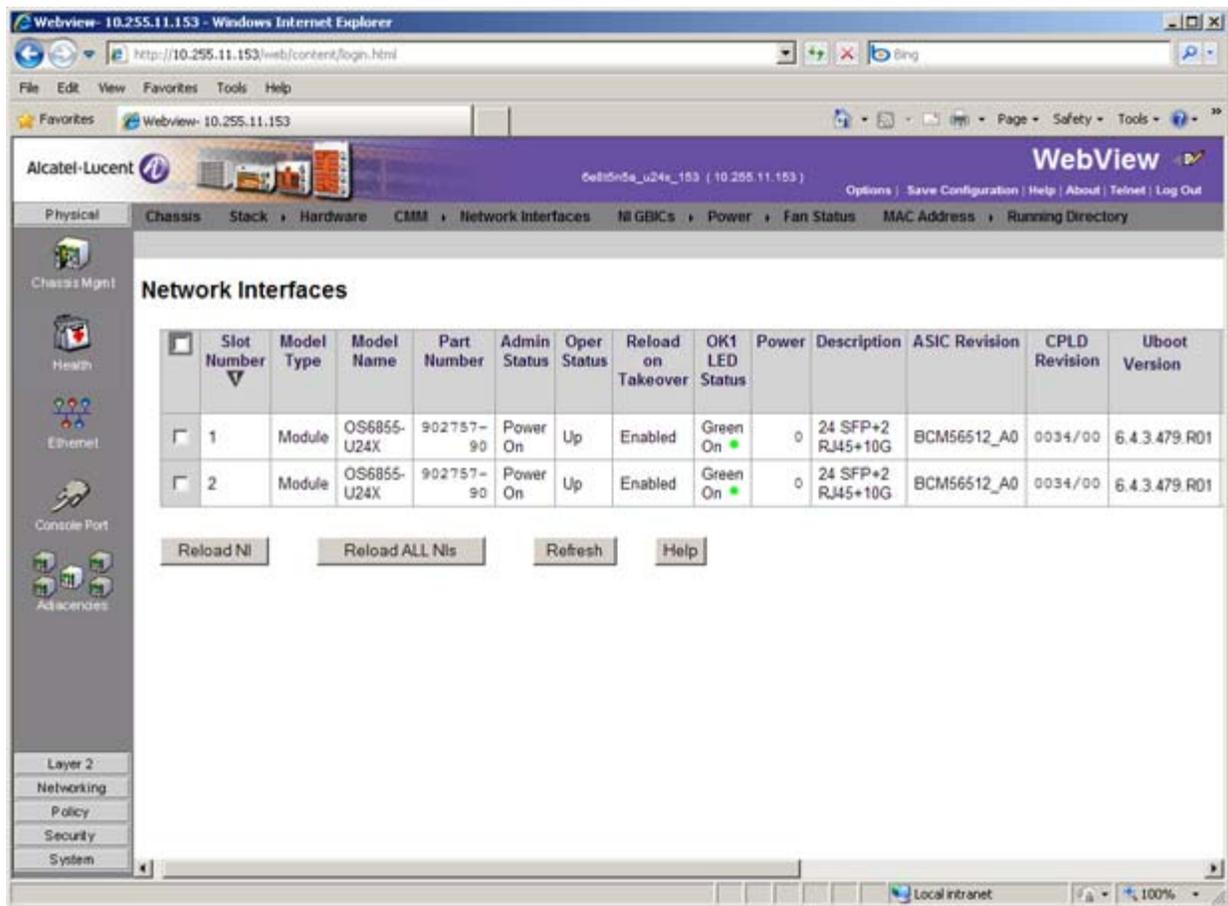
To verify that the U-Boot and Miniboot files were successfully upgraded, go to the **Network Interfaces** page by selecting **Physical > Chassis Mgmt > Network Interfaces**, as shown below. Scroll right to the **Uboot Version** and **Miniboot Version** columns for the switch(es). Information for each switch in a stack (if applicable) is displayed.

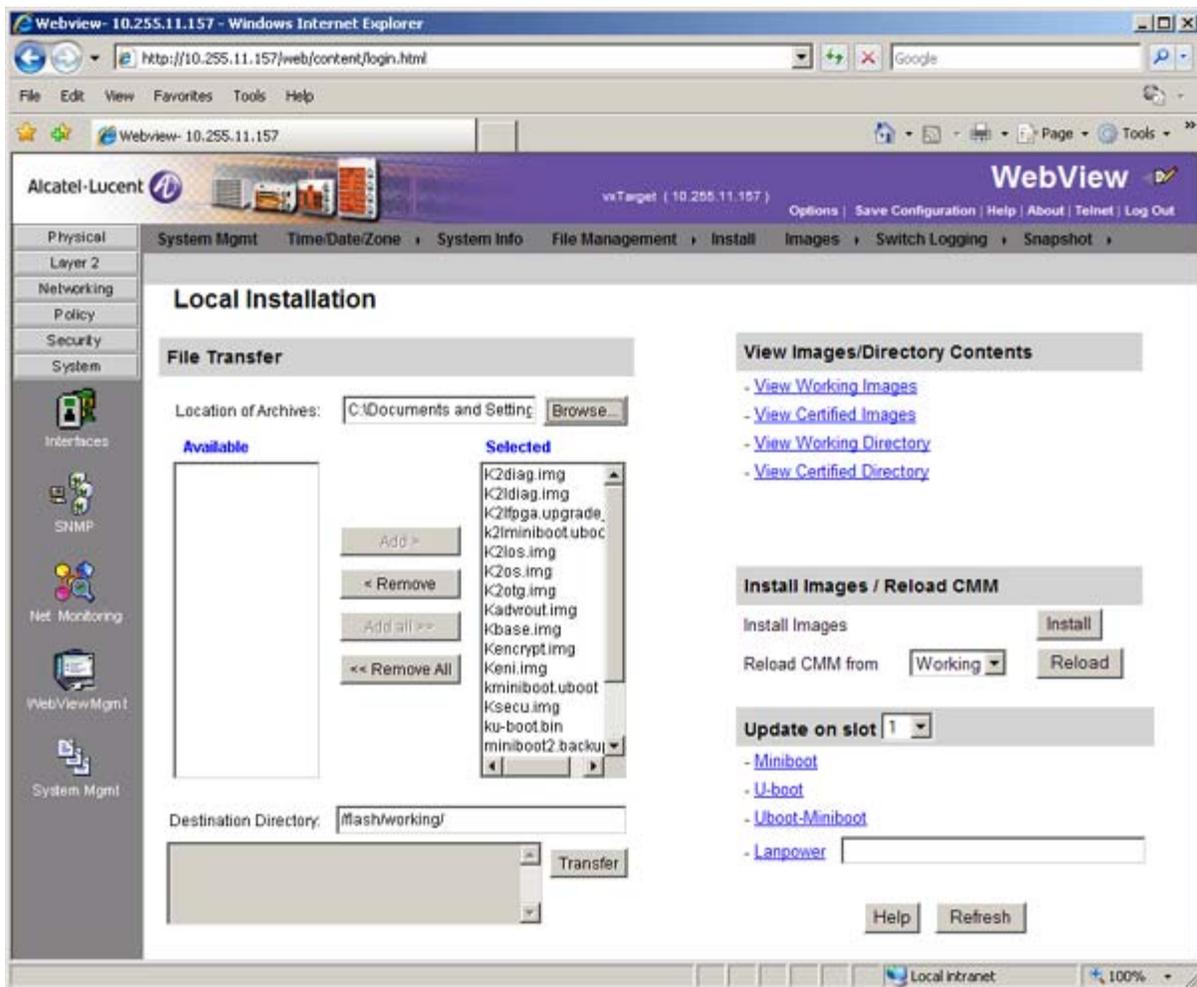
- 3 Select **System > System Mgmt > Install** to locate and FTP the 6.4.4.R01 image files that you downloaded in Step 1. Click on the **Browse** button to locate the files.
- 4 Select one of the files and click **Open**. All of the files will appear in the "Selected" area, as shown below.

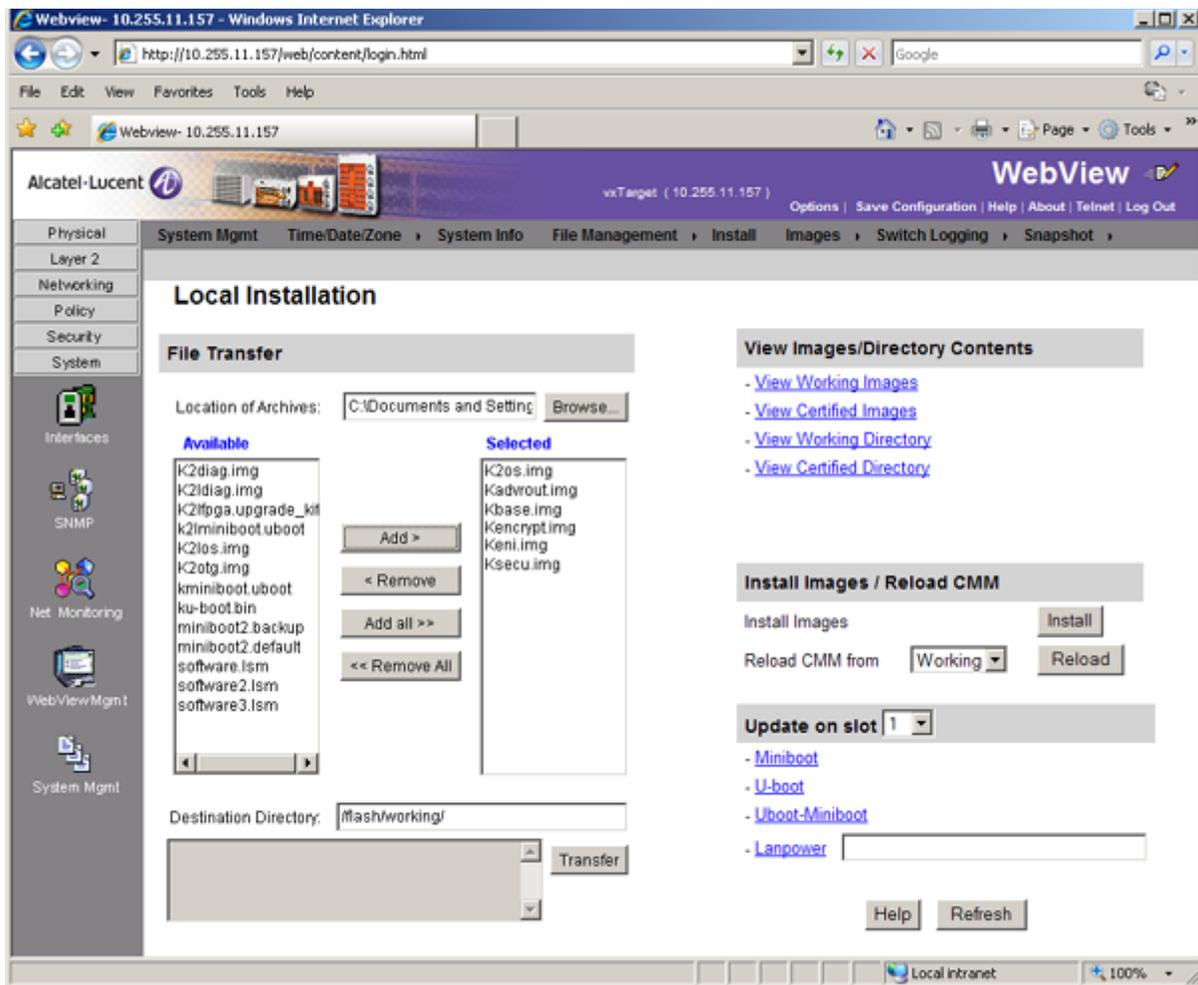
- 5 Click on the **Remove All** button to move all of the files to the “Available” area; then select the following image files and click the **Add** button to move them to the “Selected” area as shown below: **K2os.img**, **Kadvrout.img**, **Kbase.img**, **Kencrypt.img**, **Keni.img**, **Ksecu.img**.
