Upgrading an OmniSwitch to 6.4.4.R01

Overview

These instructions documents how to upgrade the following OmniSwitch products to 6.4.4.R01 software and firmware. The upgrade can be performed using the CLI or WebView. Alcatel-Lucent recommends using WebView to perform the upgrade. Release 6.4.4.R01 is supported on the following switches. Click on the link to go to instructions for a specific switch.

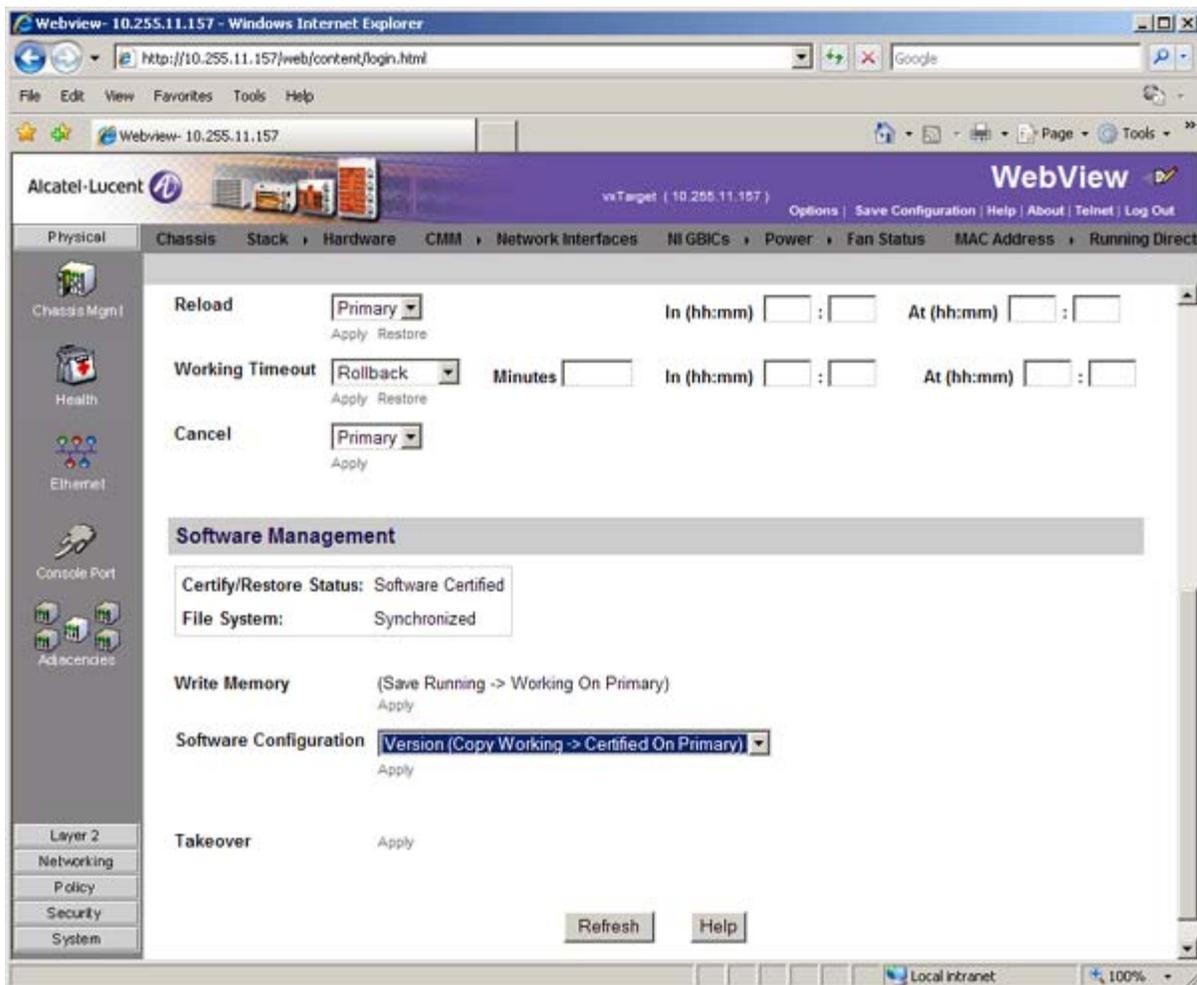
- 6 Transfer the files to the **flash/working** directory. Make sure the **Destination Directory** is **flash/working**, then click the **Transfer** button. Wait until the process is complete (indicated in the area next to the **Transfer** button - “All files have been transferred successfully”).
- 7 Reload the switch from the Working Directory. In the “Install Images/Reload CMM” area, select **Working** in the **Reload CMM From** field, then click the **Reload** button. Click **OK** at the warning prompt. Wait until the process is complete.
- 8 After the CMM finishes rebooting, log into WebView.
- 9 Select **Physical > Chassis Mgmt > CMM > Management** as shown below.

- 10** In the **Software Management** field, select **Copy Working -> Certified on Primary** for standalone switches. For a stack, select **Copy Working -> Certified & Synchronize with Secondary** and click **Apply**. The switch will synchronize files from the working directory with all other stacks (if applicable). Wait for the synchronization process to complete on all switches before proceeding to the next step.

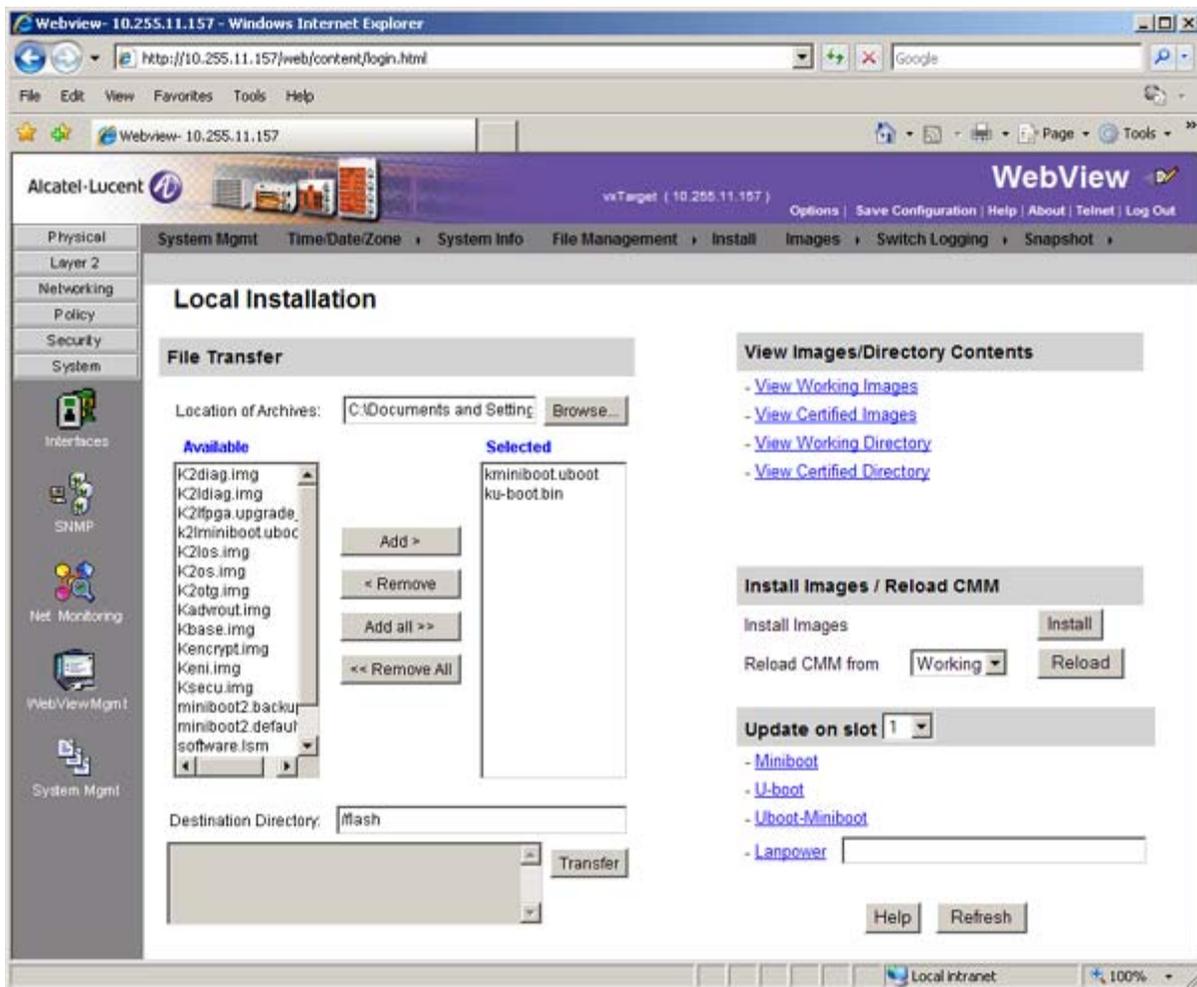
- 5 Click on the **Remove All** button to move all of the files to the “Available” area, then select the **ku-boot.bin** file and the **kminiboot.uboot** file and click the **Add** button to move them to the “Selected”

area as shown below.

- 6 Make sure the **Destination Directory** is **/flash**, then click the **Transfer** button. Wait until the process is complete (indicated in the area next to the **Transfer** button - “All files have been transferred successfully”).

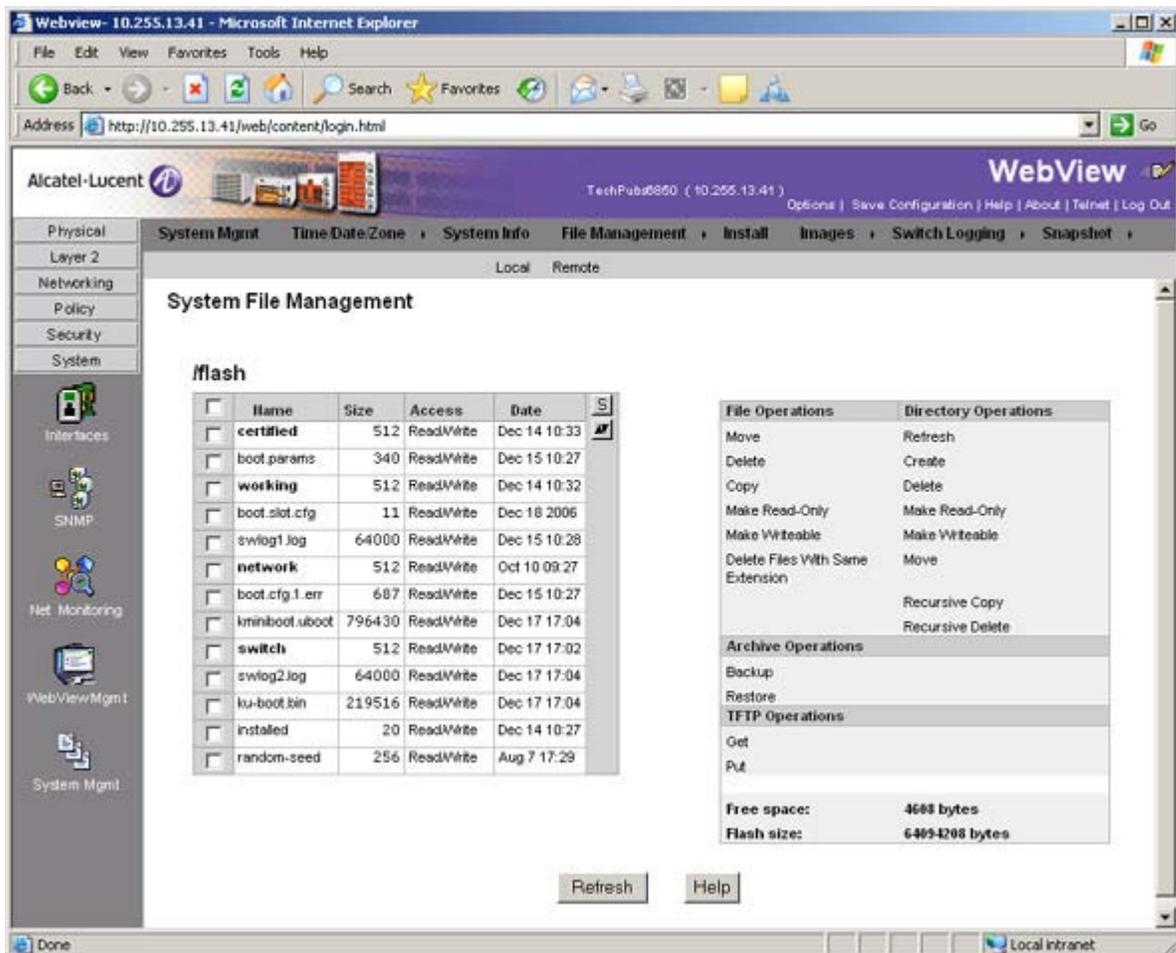
- 9 After verifying that the upgrade was successful, delete the **miniboot.uboot** and **ku-boot.bin** files from the Flash Directory by selecting **System > System Mgmt > File Management > Local**, as shown below.

- 10 Check the box next to the **ku-boot.bin** file, select **Delete** in the **File Operations** box, then click **OK** at the confirmation prompt. Repeat to delete the **kminiboot.uboot** file.

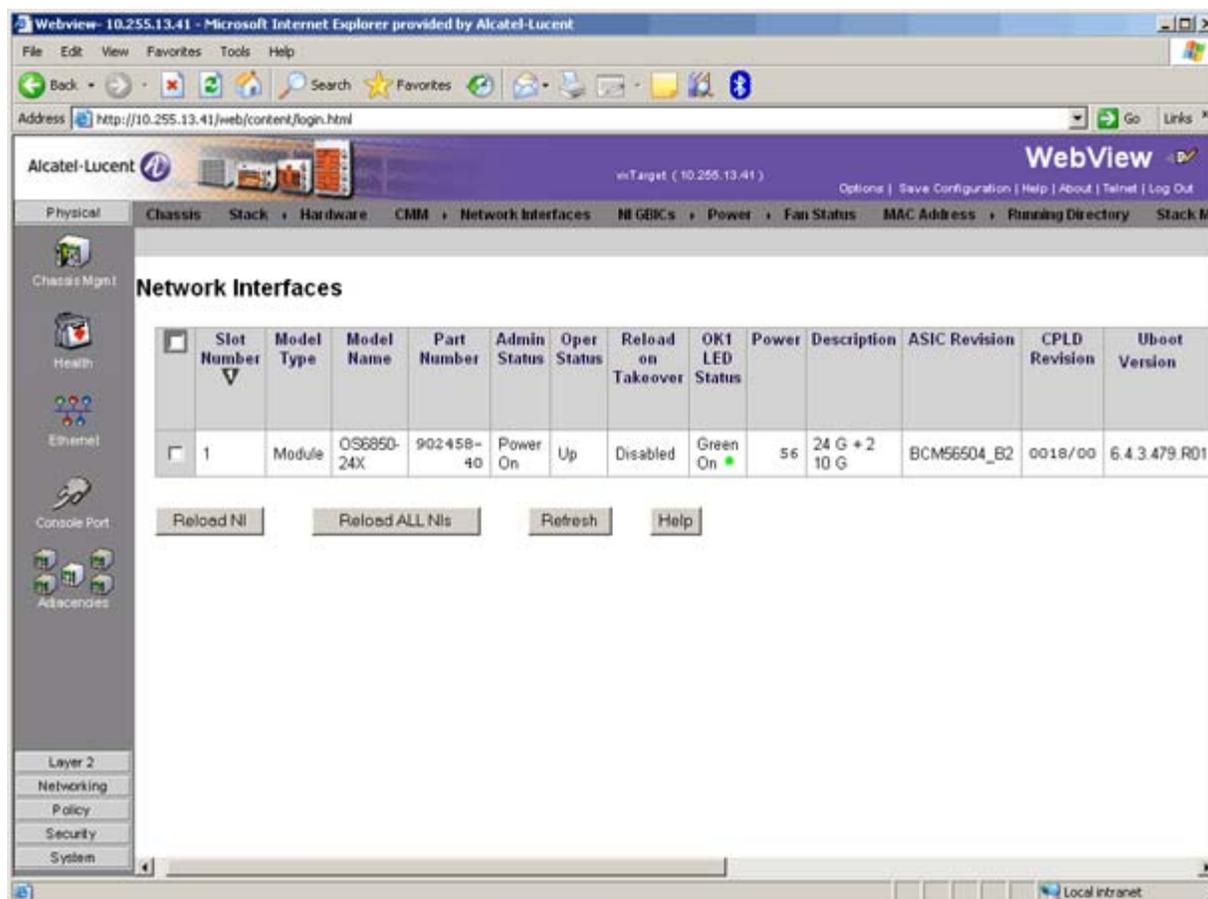
To verify that the U-Boot and Miniboot files were successfully upgraded, go to the **Network Interfaces** page by selecting **Physical > Chassis Mgmt > Network Interfaces**, as shown below. Scroll right to the **Uboot Version** and **Miniboot Version** columns for the switch(es). Information for each switch in a stack (if applicable) is displayed.

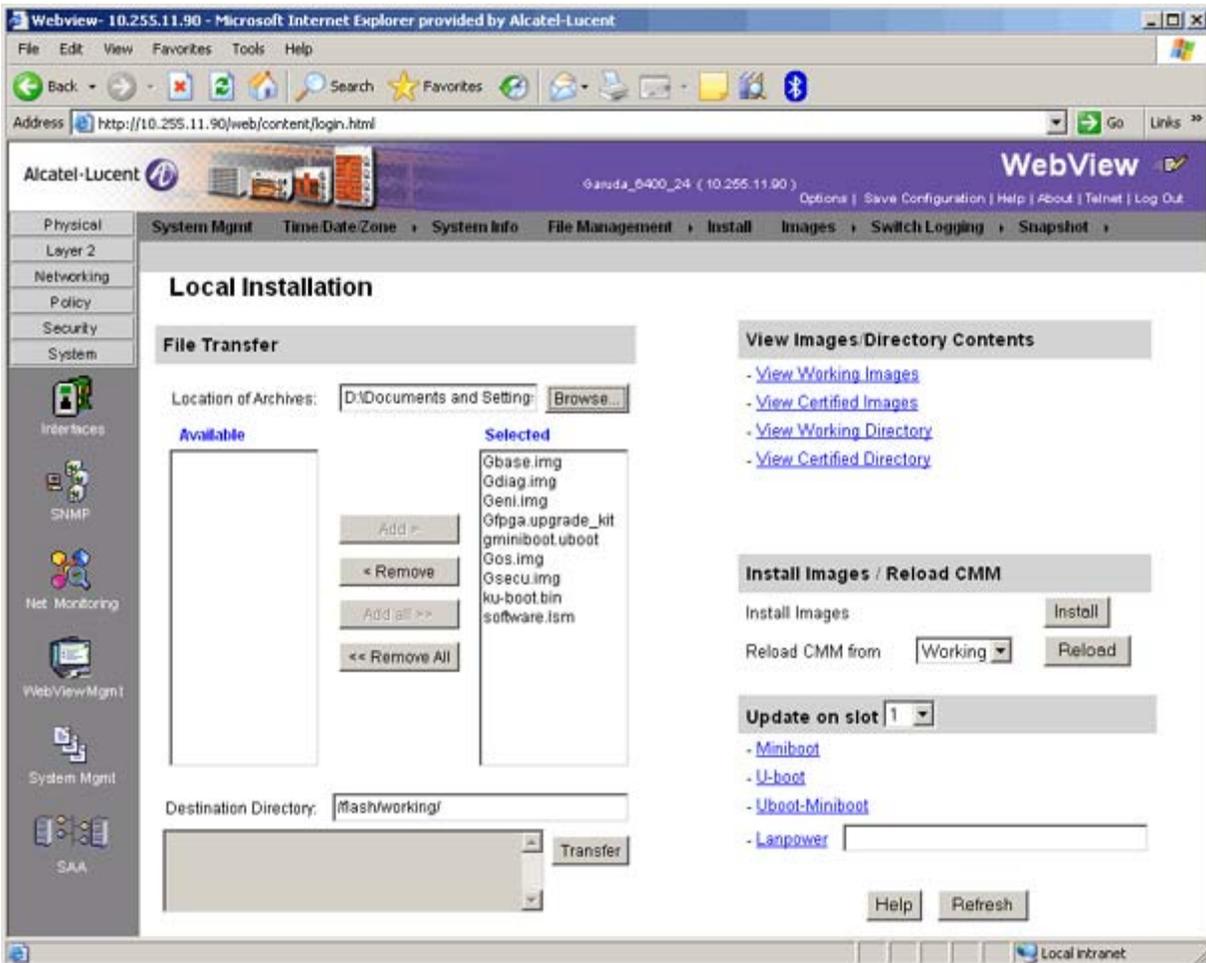
- 3 Select **System > System Mgmt > Install** to locate and FTP the 6.4.4.R01 image files that you downloaded in Step 1. Click on the **Browse** button to locate the files.
- 4 Select one of the files and click **Open**. All of the files will appear in the "Selected" area, as shown below.

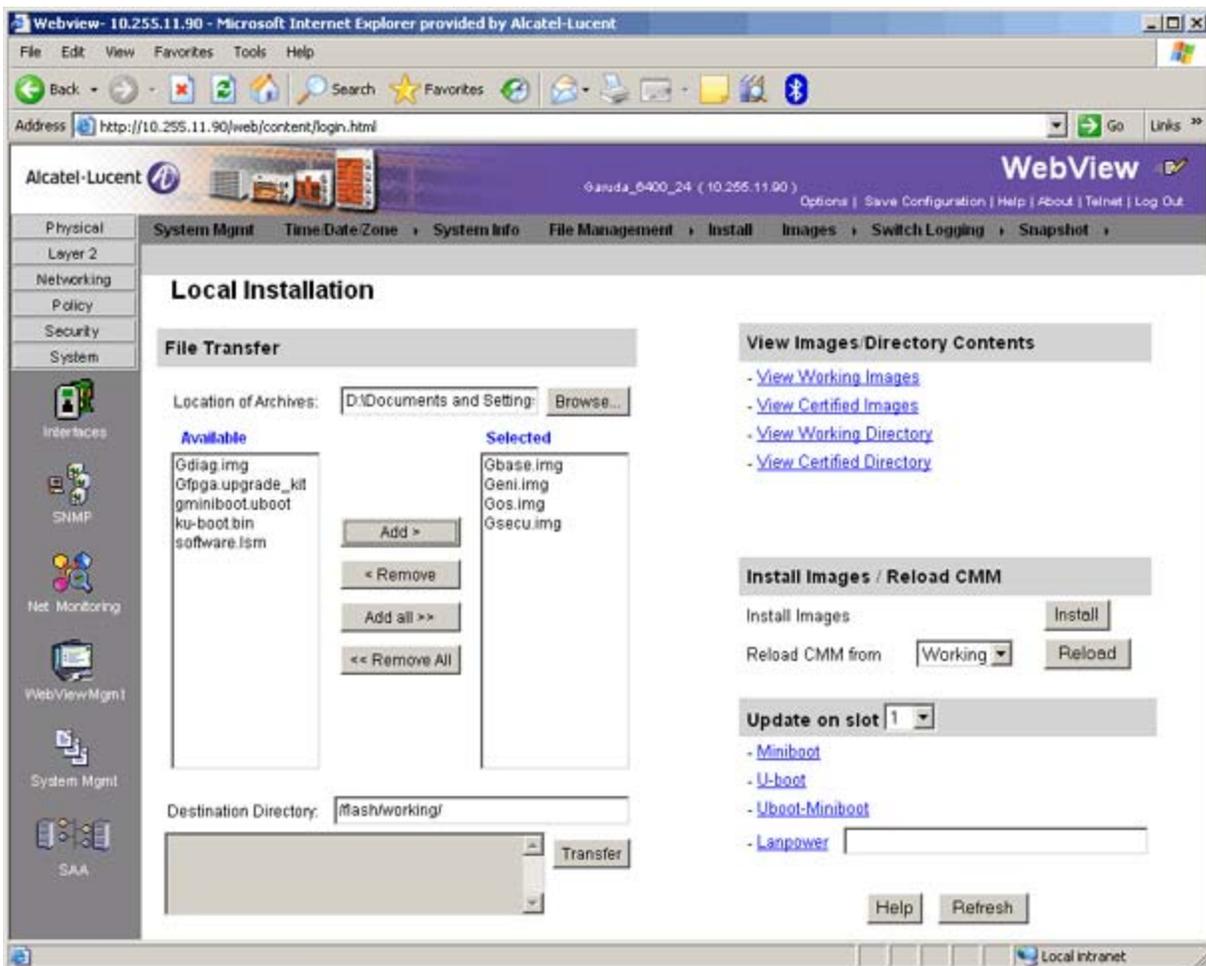
- 5 Click on the **Remove All** button to move all of the files to the “Available” area; then select the following image files and click the **Add** button to move them to the “Selected” area as shown below: **Gbase.img, Geni.img, Gos.img, Gsecu.img.**

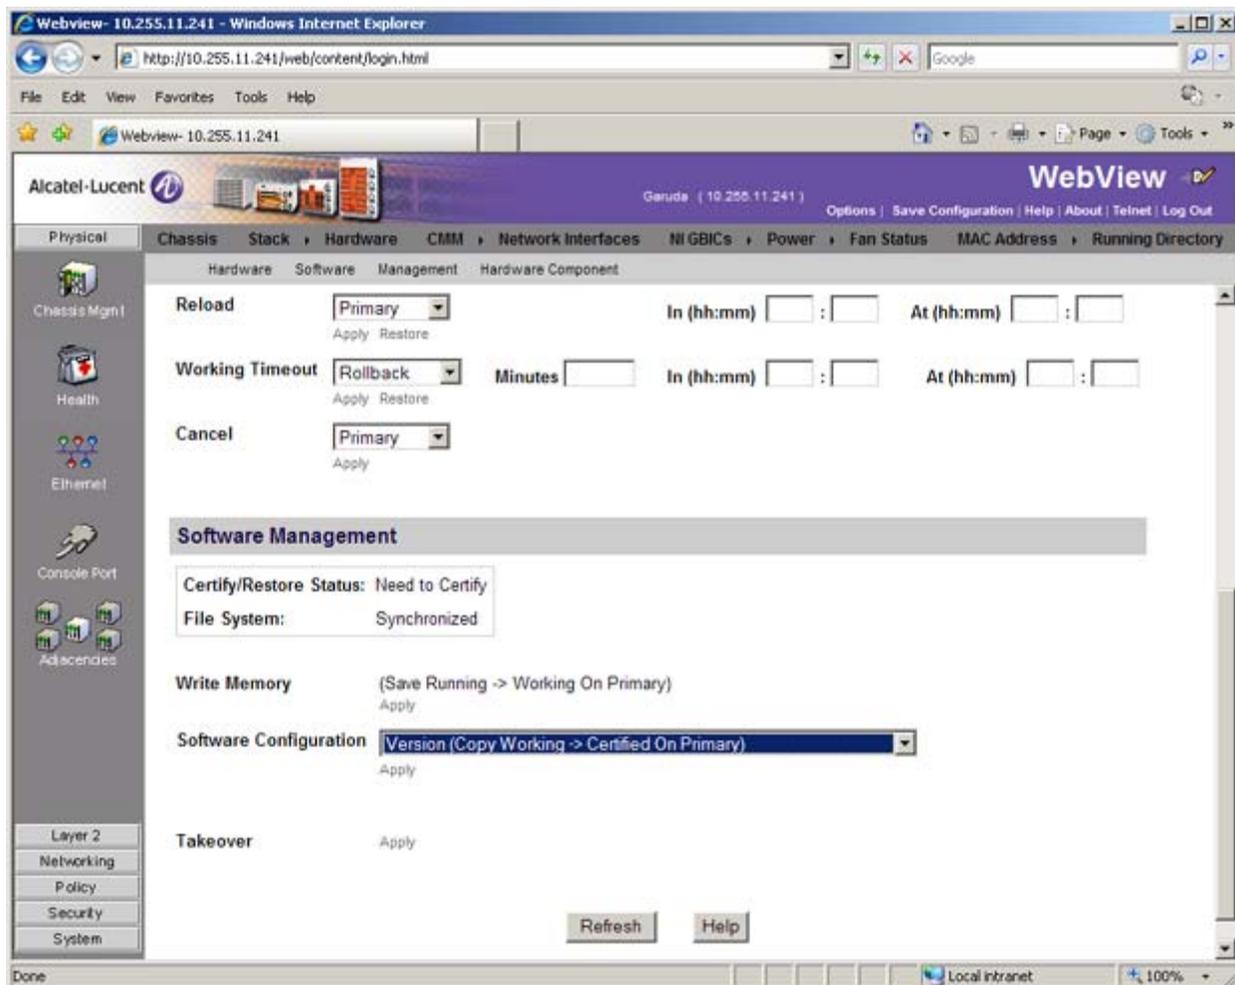
- 6 Transfer the files to the **flash/working** directory. Make sure the **Destination Directory** is **flash/working**, then click the **Transfer** button. Wait until the process is complete (indicated in the area next to the **Transfer** button - “All files have been transferred successfully”).
- 7 Reload the switch from the Working Directory. In the “Install Images/Reload CMM” area, select **Working** in the **Reload CMM From** field, then click the **Reload** button. Click **OK** at the warning prompt. Wait until the process is complete.
- 8 After the CMM finishes rebooting, log into WebView.
- 9 Select **Physical** > **Chassis Mgmt** > **CMM** > **Management** as shown below.

- 10** In the **Software Management** field, select **Copy Working -> Certified on Primary** for standalone switches. For a stack, select **Copy Working -> Certified & Synchronize with Secondary** and click **Apply**. The switch will synchronize files from the working directory with all other stacks (if applicable). Wait for the synchronization process to complete on all switches before proceeding to the next step.

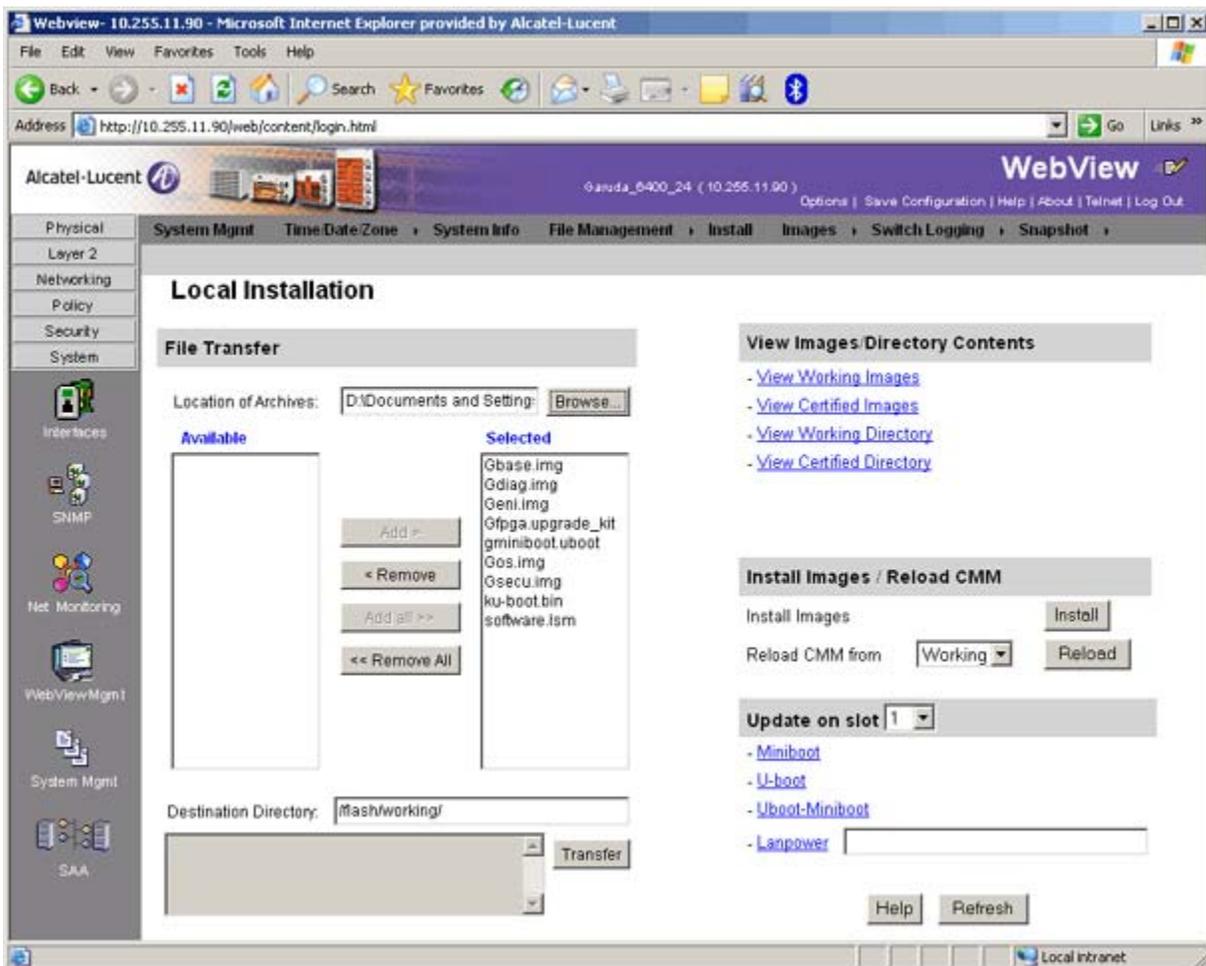
- 3 Select **System > System Mgmt > Install** to locate and FTP the 6.4.4.R01 image files that you downloaded in Step 1. Click on the **Browse** button to locate the files.
- 4 Select one of the files and click **Open**. All of the files will appear in the "Selected" area, as shown below.

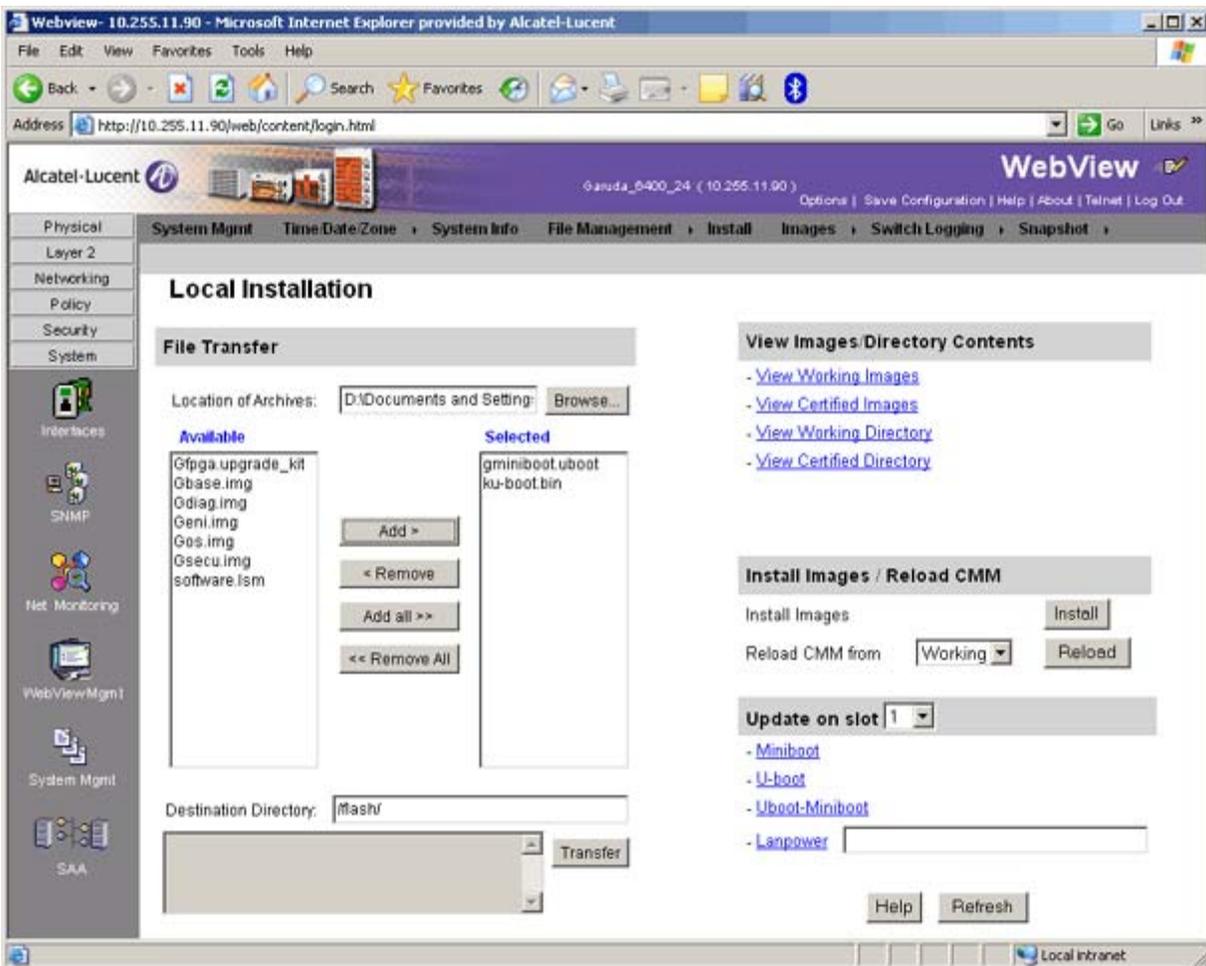
- 5 Click on the **Remove All** button to move all of the files to the "Available" area, then select the **gminiboot.uboot** file and the **ku-boot.bin** file and click the **Add** button to move them to the "Selected" area as shown below.

- 6 Make sure the **Destination Directory** is /flash, then click the **Transfer** button. Wait until the process is complete (indicated in the area next to the **Transfer** button - “All files have been transferred successfully”).

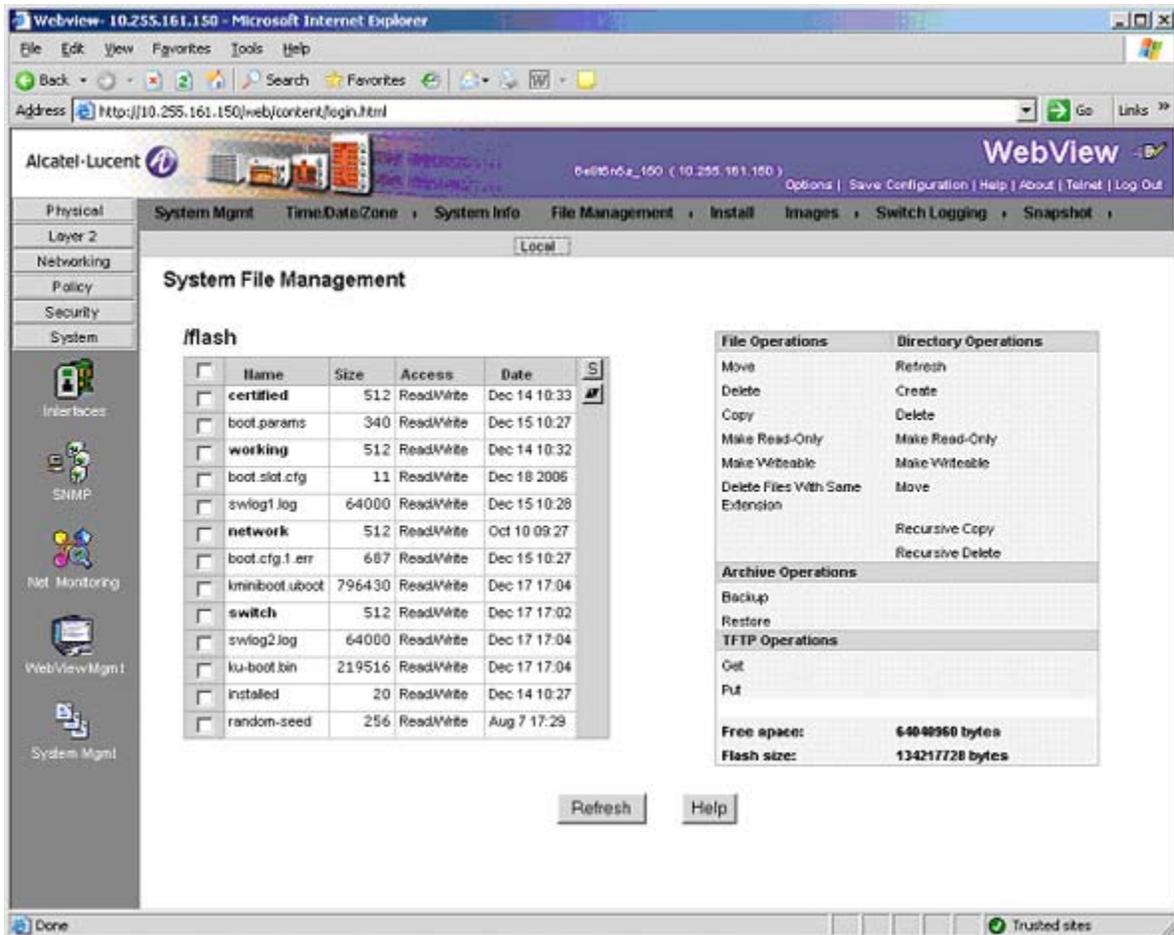
- After verifying that the upgrade was successful, delete the **miniboot.uboot** and **ku-boot.bin** files from the Flash Directory by selecting **System > System Mgmt > File Management > Local**, as shown below.

- Check the box next to the **ku-boot.bin** file, select **Delete** in the **File Operations** box, then click **OK** at the confirmation prompt. Repeat to delete the **kminiboot.uboot** file.
