Upgrading OmniSwitch 6855 Series Switches to 6.4.2.R01

This instruction sheet documents how to upgrade OmniSwitch 6855 Series Switches to 6.4.2.R01 firmware and software. The upgrade can be performed using the CLI, WebView, or SNMP. Alcatel-Lucent recommends using WebView to perform the upgrade. For upgrade instructions using the CLI, see [Upgrading with the CLI on page 13](#).

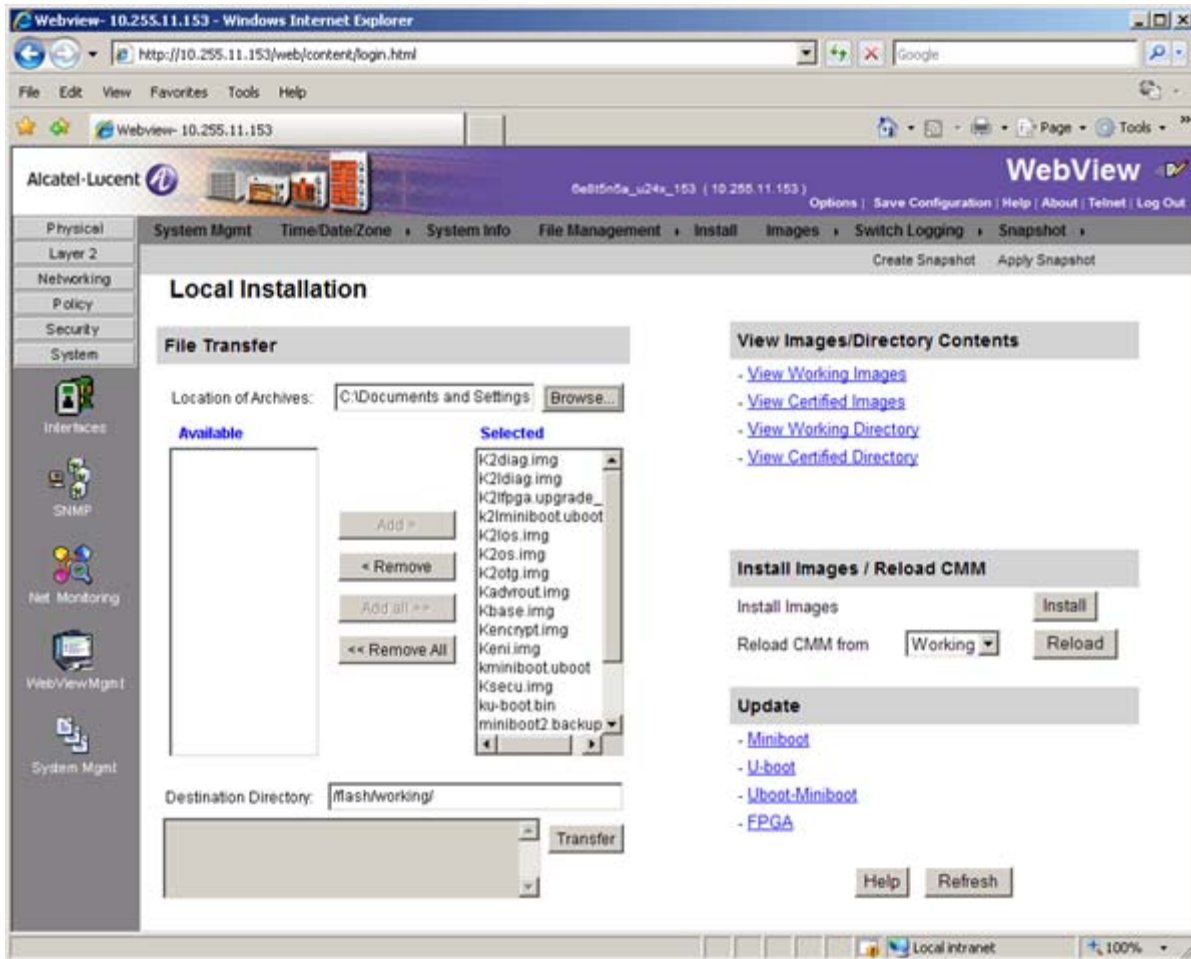
- 3 Select **System > System Mgmt > Install** to locate and FTP the 6.4.2.R01 image files that you downloaded in Step 1. Click on the **Browse** button to locate the files.
- 4 Select one of the files and click **Open**. All of the files will appear in the "Selected" area, as shown below.

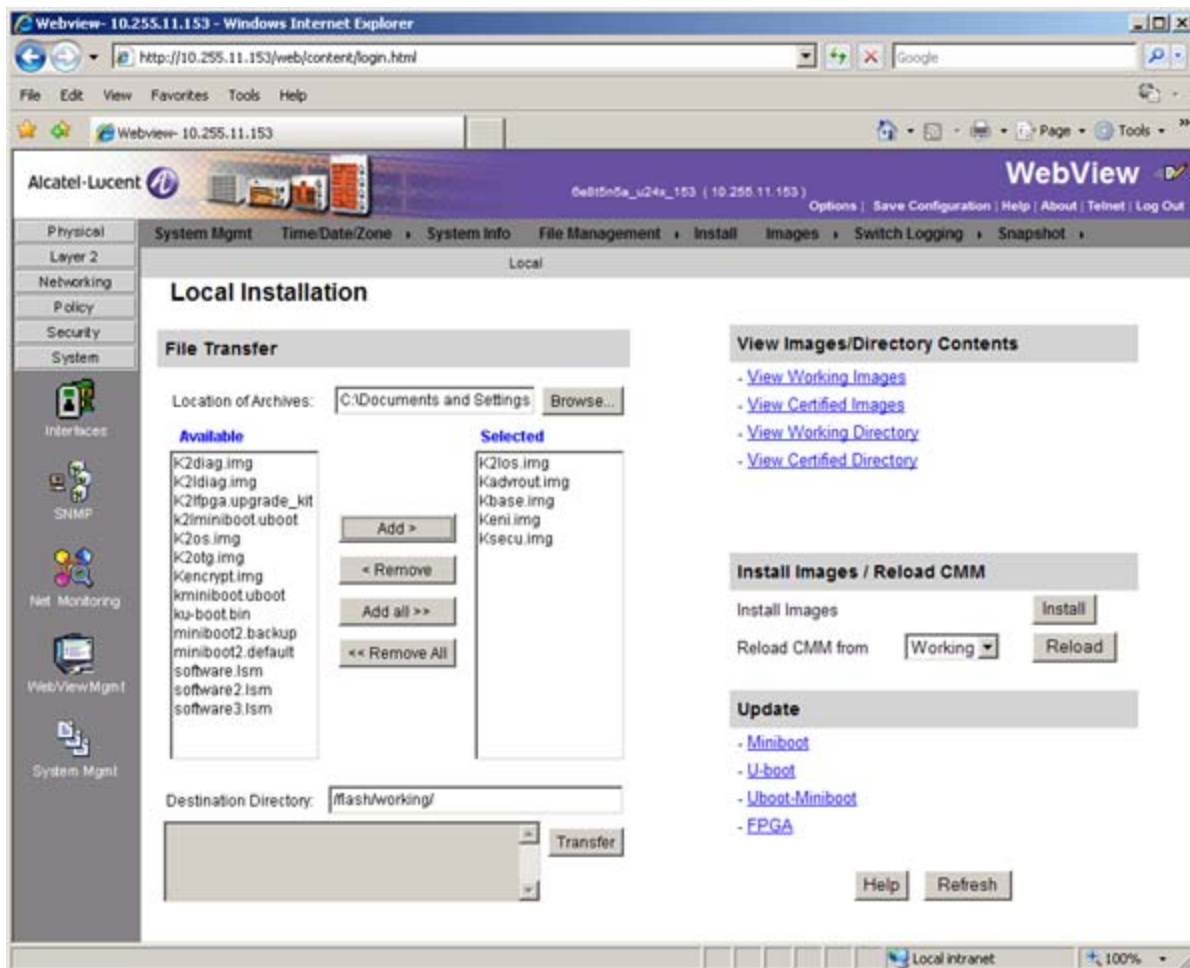
- 5 Click on the **Remove All** button to move all of the files to the “Available” area; then select the following image files and click the **Add** button to move them to the “Selected” area as shown below: **K2Ios.img, Kadvrout.img, Kbase.img, Keni.img, Ksecu.img.**

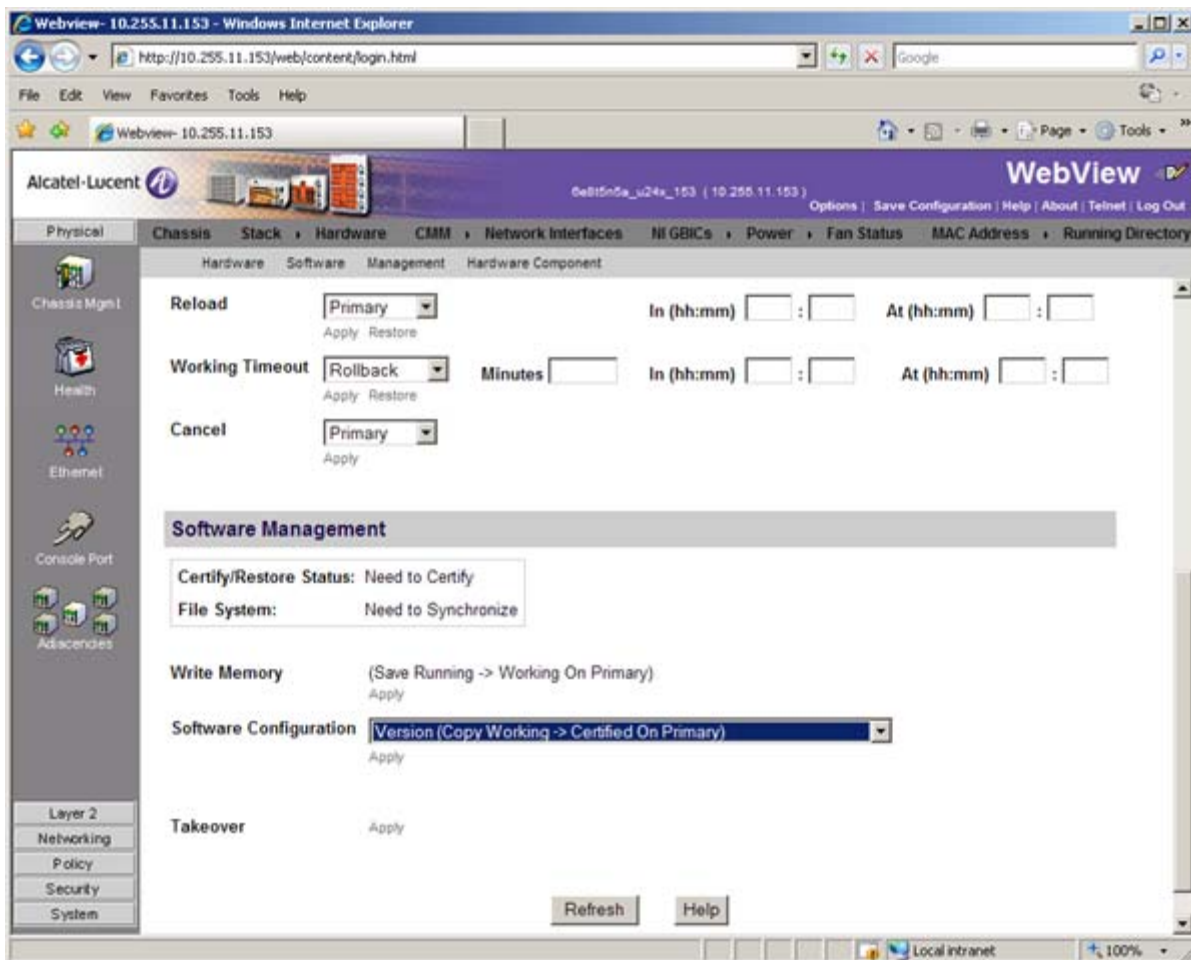
- 6 Transfer the files to the **flash/working** directory. Make sure the **Destination Directory** is **flash/working**, then click the **Transfer** button. Wait until the process is complete (indicated in the area next to the **Transfer** button - "All files have been transferred successfully").
- 7 Reload the switch from the Working Directory. In the "Install Images/Reload CMM" area, select **Working** in the **Reload CMM From** field, then click the **Reload** button. Click **OK** at the warning prompt. Wait until the process is complete.
- 8 After the CMM finishes rebooting, log into WebView.
- 9 Select **Physical > Chassis Mgmt > CMM > Management** as shown below.

- 10** In the **Software Management** field, select **Copy Working -> Certified on Primary** for standalone switches. For a stack, select **Copy Working -> Certified & Synchronize with Secondary** and click **Apply**.

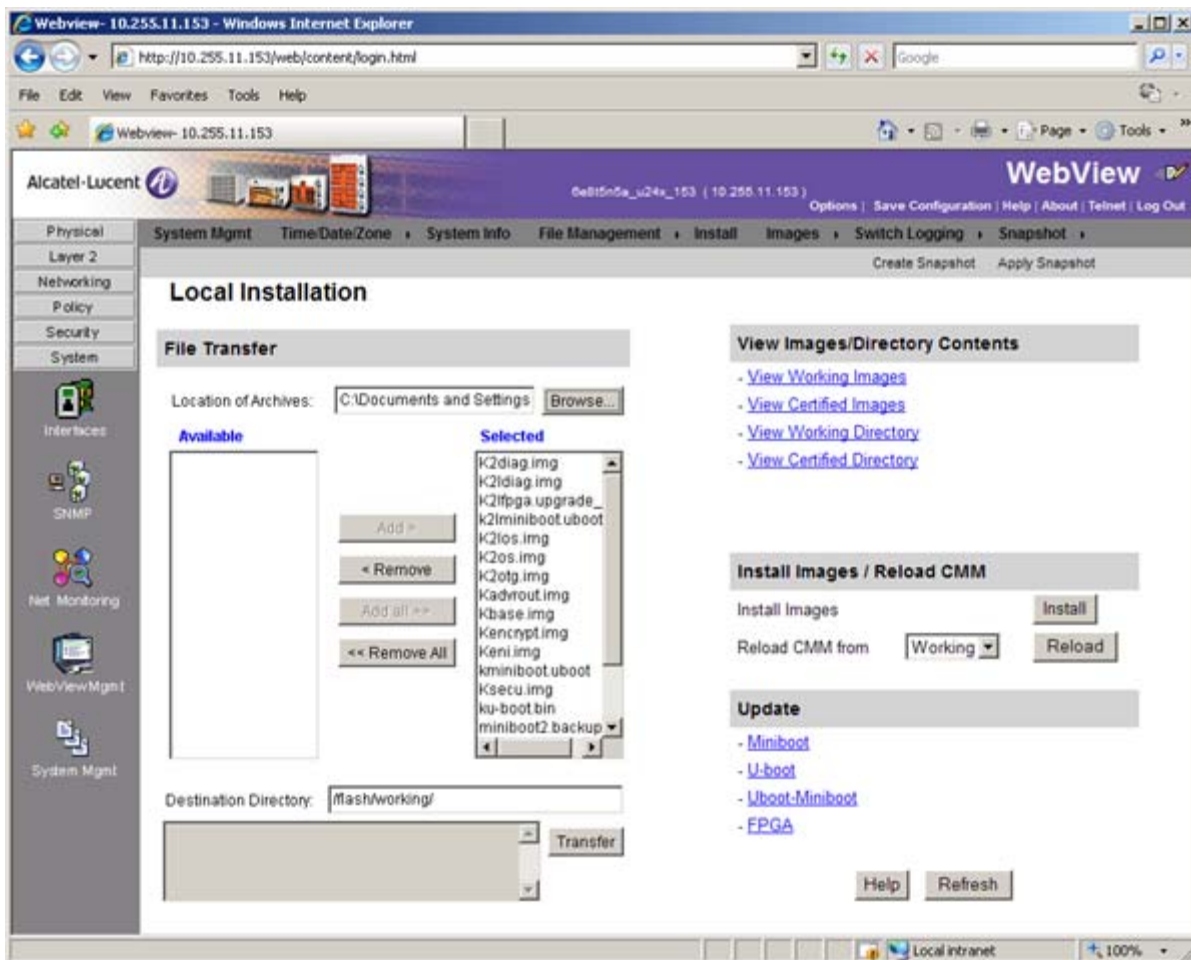
- 3 Select **System > System Mgmt > Install** to locate and FTP the 6.4.2.R01 image files that you downloaded in Step 1. Click on the **Browse** button to locate the files.
- 4 Select one of the files and click **Open**. All of the files will appear in the "Selected" area, as shown below.

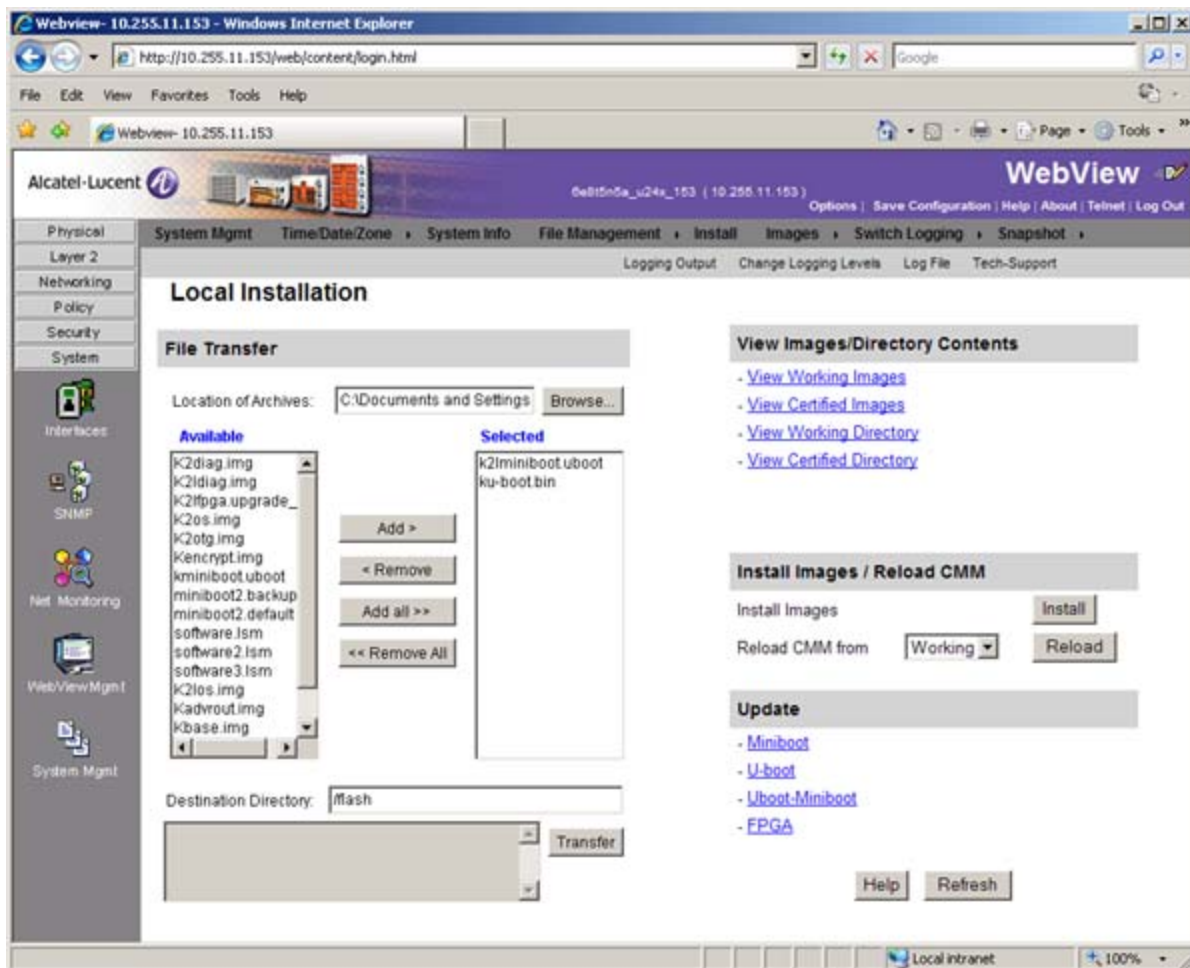
- 5 Click on the **Remove All** button to move all of the files to the “Available” area, then select the **ku-boot.bin** file and the **k2Iminiboot.uboot** file and click the **Add** button to move them to the “Selected” area as shown below.

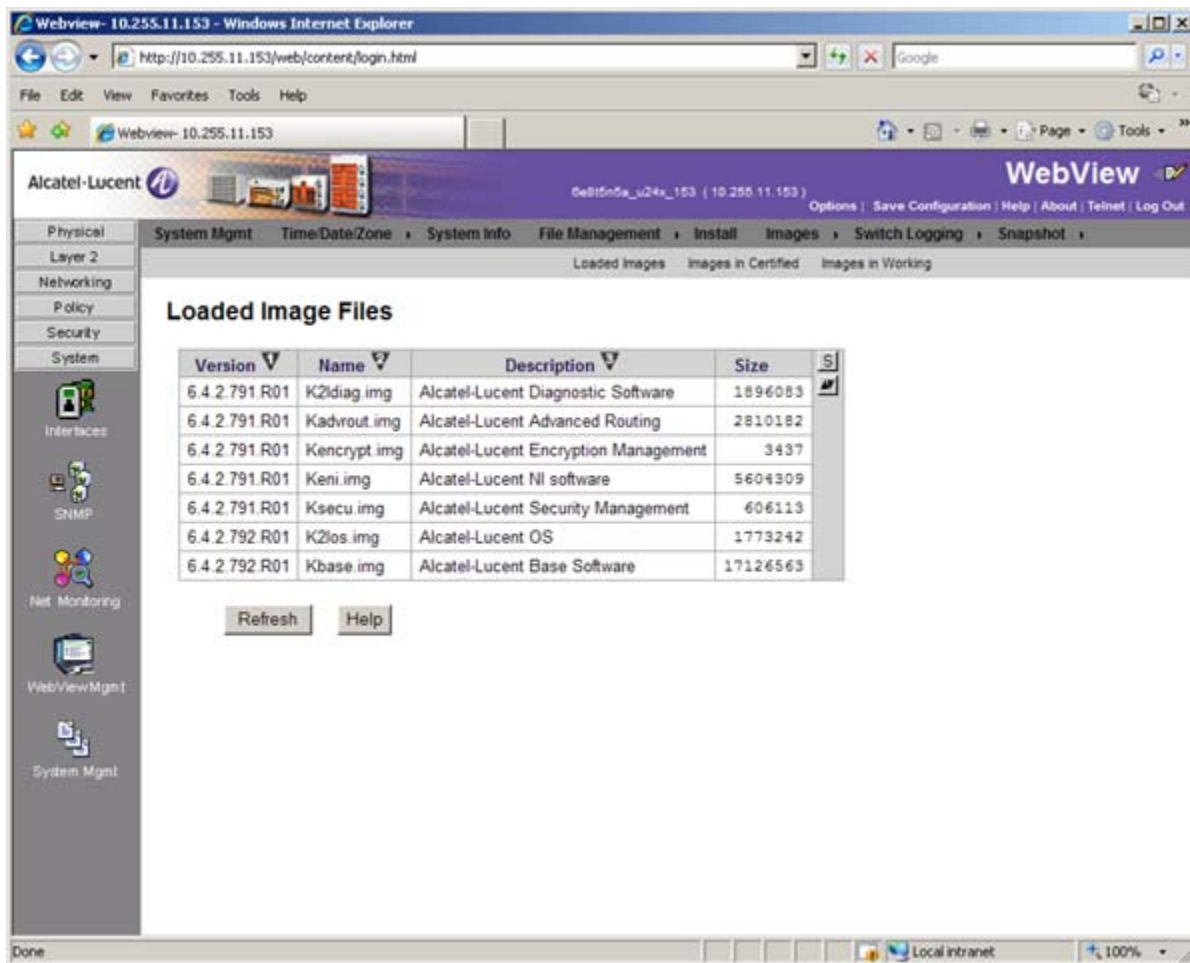
To verify that the software was successfully upgraded, go to the **Loaded Image Files** page by selecting **System > System Mgmt > Images > Loaded Images** as shown below.

The screenshot shows the Alcatel-Lucent WebView interface in a Windows Internet Explorer browser. The browser address bar shows the URL <http://10.255.11.153/web/content/login.html>. The page title is "Webview- 10.255.11.153". The main content area displays the "Loaded Image Files" page. The page has a navigation menu at the top with options like "System Mgmt", "Time/Date/Zone", "System Info", "File Management", "Install", "Images", "Switch Logging", and "Snapshot". Below the navigation menu, there are sub-menus for "Loaded Images", "Images in Certified", and "Images in Working". The main content area shows a table with the following data:

Version	Name	Description	Size
6.4.2.791.R01	K2ldiag.img	Alcatel-Lucent Diagnostic Software	1896083
6.4.2.791.R01	Kadvrout.img	Alcatel-Lucent Advanced Routing	2810182
6.4.2.791.R01	Kencrypt.img	Alcatel-Lucent Encryption Management	3437
6.4.2.791.R01	Keni.img	Alcatel-Lucent NI software	5604309
6.4.2.791.R01	Ksecu.img	Alcatel-Lucent Security Management	606113
6.4.2.792.R01	K2los.img	Alcatel-Lucent OS	1773242
6.4.2.792.R01	Kbase.img	Alcatel-Lucent Base Software	17126563

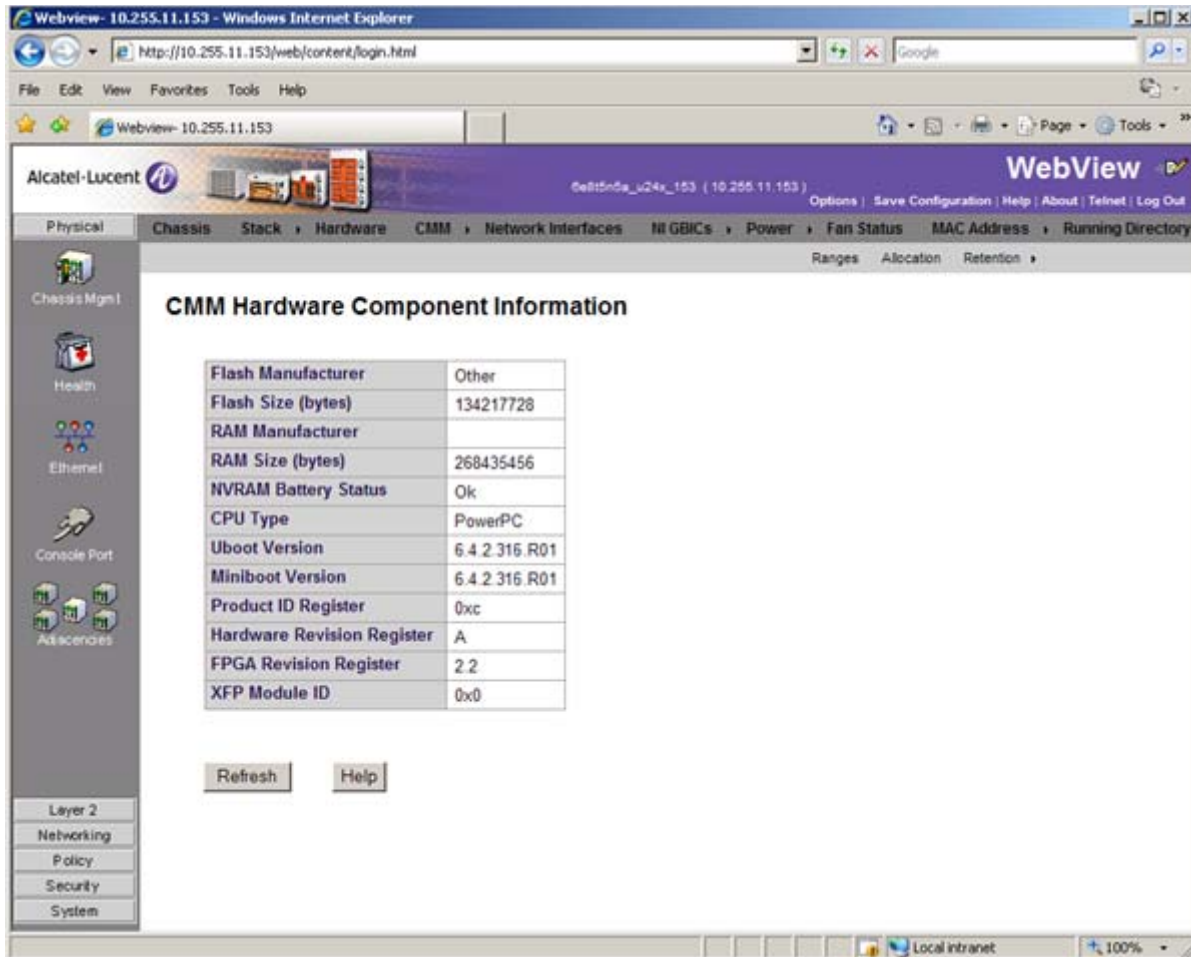
To verify that U-Boot and Miniboot files were successfully upgraded on the CMM, go to the **CMM Hardware Component Information** page by selecting **Physical > Chassis Mgmt > CMM > Hardware Component**, as shown below.

The screenshot shows the WebView interface for an Alcatel-Lucent switch. The browser address bar shows the URL `http://10.255.11.153/web/content/login.html`. The page title is "CMM Hardware Component Information". The table below contains the following data:

Flash Manufacturer	Other
Flash Size (bytes)	134217728
RAM Manufacturer	
RAM Size (bytes)	268435456
NVRAM Battery Status	Ok
CPU Type	PowerPC
Uboot Version	6.4.2.316.R01
Miniboot Version	6.4.2.316.R01
Product ID Register	0xc
Hardware Revision Register	A
FPGA Revision Register	2.2
XFP Module ID	0x0
