# Intermediate Release Notes

## OmniSwitch 9xxx, 6850, 6855 & 6400

### Release 6.4.2.968.R01

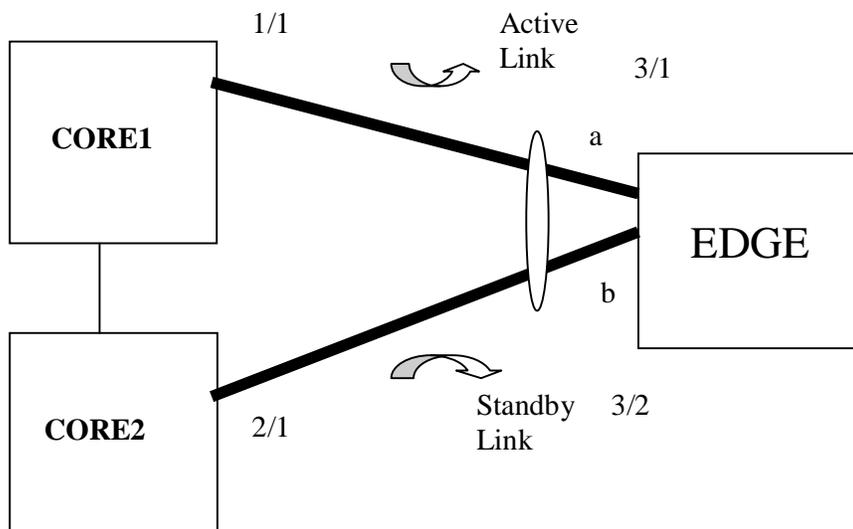
When the primary link fails the software will immediately bring up the secondary link to primary. When the old primary link returns it should remain in standby until the other link fails, and the failover is repeated. Pre-emption can be enabled on an aggregate basis, so that primary can move to attached state when the link recovers, after a period of time (pre-empt timer). By default pre-emption is disabled and the default pre-empt timer is 30 Sec. The timer value can range from 30 -300 Seconds

The typical setup is as follows:

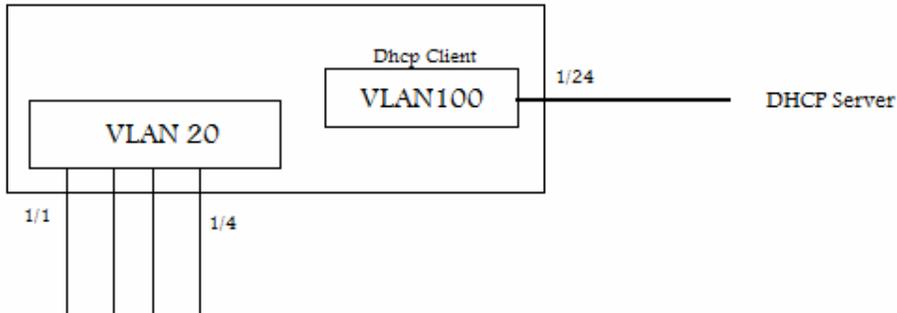
**Use Case Diagram:**

DHCP Client was designed in Omni Switch to function as DHCP client on any one configured VLAN & get an IP address from the DHCP server and create IP interface for that VLAN in the switch.
