# Upgrading OmniSwitch 9000 Series Switches to 6.4.2.R01

This instruction sheet documents how to upgrade OmniSwitch 9000 Series Switches to 6.4.2.R01 software and firmware. The upgrade can be performed using the CLI, WebView, or SNMP. Alcatel-Lucent recommends using WebView to perform the upgrade. For upgrade instructions using the CLI, see [Upgrading with the CLI on page 13](#).

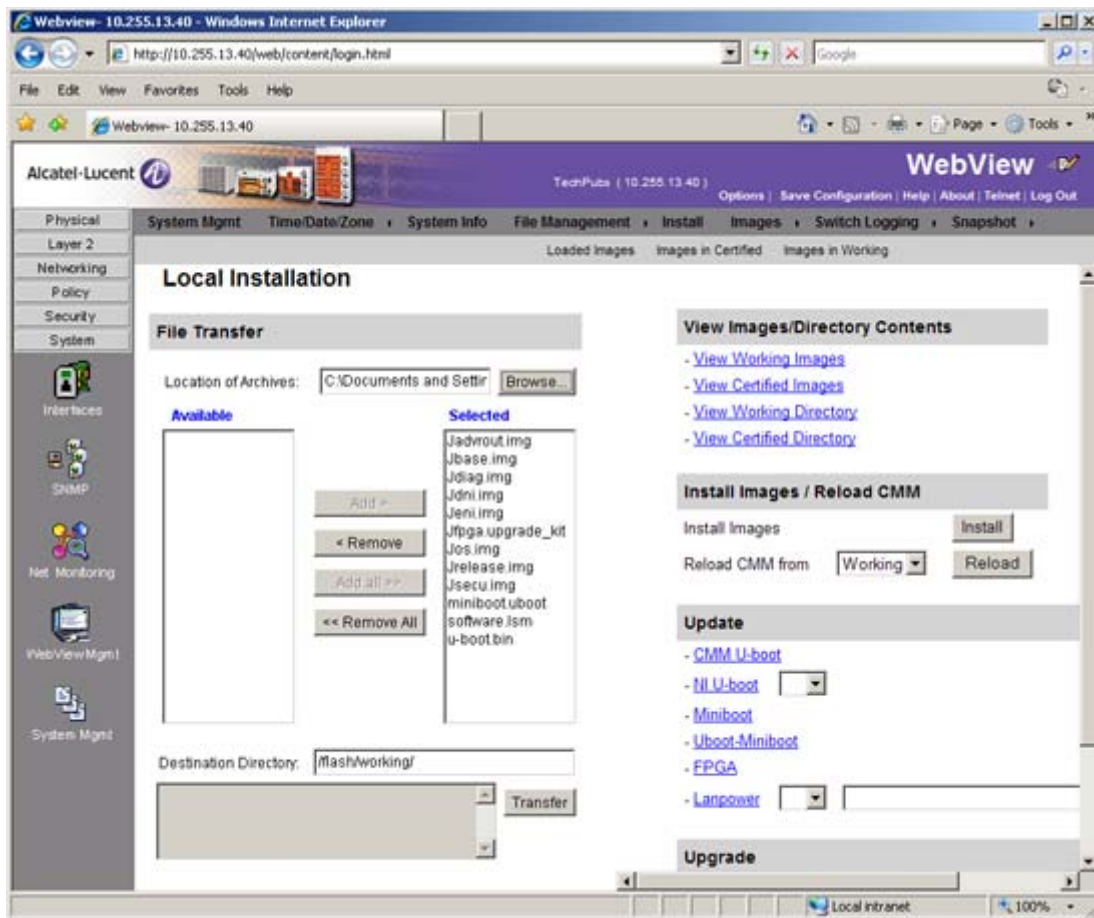
- 3 Select **System > System Mgmt > Install** to locate and FTP the 6.4.2.R01 image files that you downloaded in Step 1. Click on the **Browse** button to locate the files.
- 4 Select one of the files and click **Open**. All of the files will appear in the "Selected" area as shown below.

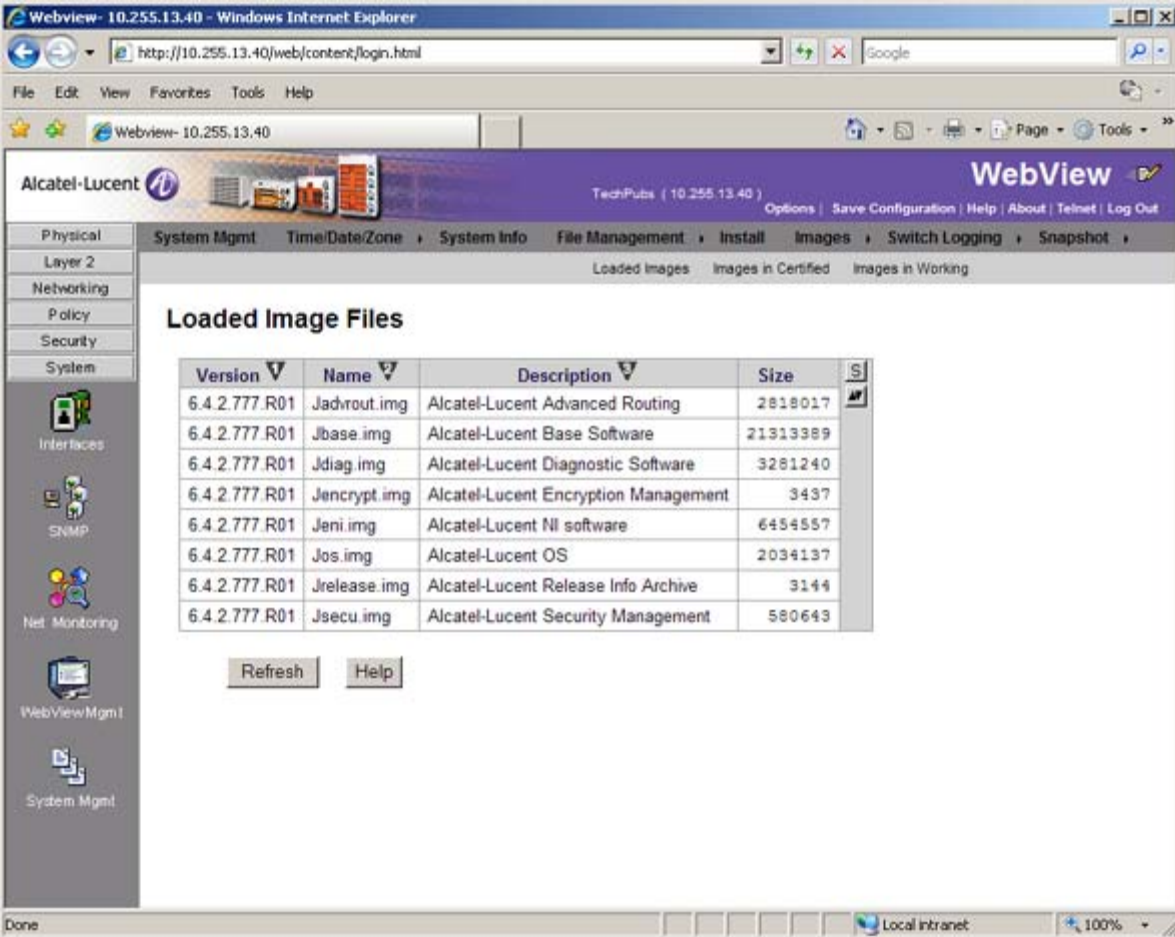
To verify that the software was successfully upgraded, go to the **Loaded Image Files** page by selecting **System > System Mgmt > Images > Loaded Images** as shown below.

The screenshot shows the Alcatel-Lucent WebView interface in a Windows Internet Explorer browser. The browser address bar shows the URL <http://10.255.13.40/web/content/login.html>. The page title is "Webview- 10.255.13.40 - Windows Internet Explorer". The main content area displays the "Loaded Image Files" page. The page has a navigation menu at the top with options like "System Mgmt", "Time/Date/Zone", "System Info", "File Management", "Install", "Images", "Switch Logging", and "Snapshot". The "Images" menu is expanded, showing "Loaded Images", "Images in Certified", and "Images in Working". The "Loaded Images" sub-menu is selected. The main content area shows a table of loaded image files.

Version	Name	Description	Size
6.4.2.777.R01	Jadvrout.img	Alcatel-Lucent Advanced Routing	2818017
6.4.2.777.R01	Jbase.img	Alcatel-Lucent Base Software	21313389
6.4.2.777.R01	Jdiag.img	Alcatel-Lucent Diagnostic Software	3281240
6.4.2.777.R01	Jencrypt.img	Alcatel-Lucent Encryption Management	3437
6.4.2.777.R01	Jeni.img	Alcatel-Lucent NI software	6454557
6.4.2.777.R01	Jos.img	Alcatel-Lucent OS	2034137
6.4.2.777.R01	Jrelease.img	Alcatel-Lucent Release Info Archive	3144
6.4.2.777.R01	Jsecu.img	Alcatel-Lucent Security Management	580643

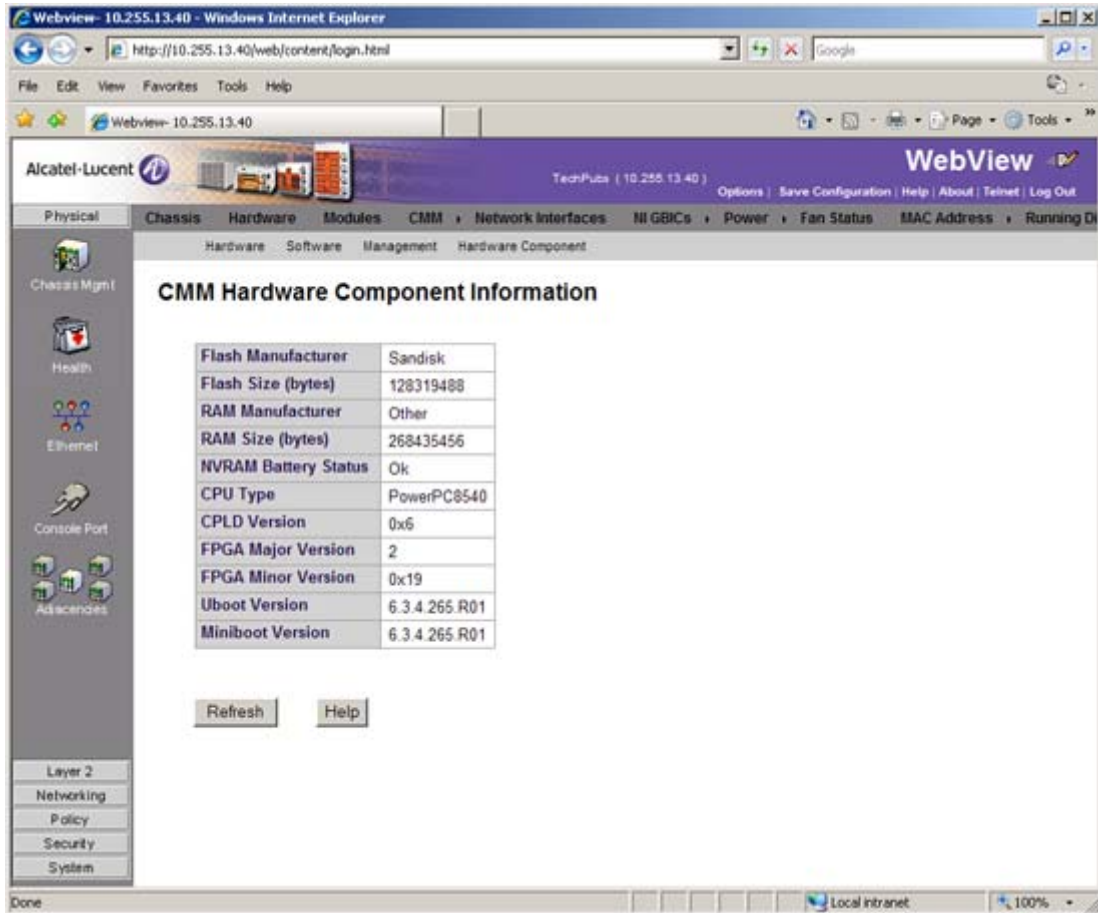
To verify that the U-Boot and Miniboot files were successfully upgraded on the CMM, go to the **CMM Hardware Component Information** page by selecting **Physical > Chassis Mgmt > CMM > Hardware Component**, as shown below.

The screenshot shows the Alcatel-Lucent WebView interface for a switch. The browser address bar shows the URL `http://10.255.13.40/web/content/login.html`. The page title is "CMM Hardware Component Information". The main content area displays a table with the following data:

Flash Manufacturer	Sandisk
Flash Size (bytes)	128319488
RAM Manufacturer	Other
RAM Size (bytes)	268435456
NVRAM Battery Status	Ok
CPU Type	PowerPC6540
CPLD Version	0x6
FPGA Major Version	2
FPGA Minor Version	0x19
Uboot Version	6.3.4.265.R01
Miniboot Version	6.3.4.265.R01
