Upgrading OmniSwitch 9000E Series Switches to 6.4.2.R01 or 6.4.2.S01

This instruction sheet documents how to upgrade OmniSwitch 9000E Series Switches to either 6.4.2.R01 or 6.4.2.S01 software and firmware. The upgrade can be performed using the CLI, WebView, or SNMP. Alcatel-Lucent recommends using WebView to perform the upgrade. For upgrade instructions using the CLI, see [Upgrading with the CLI on page 7](#). These instructions demonstrate the upgrade procedure for an 'R01' build, the steps for an 'S01' build are similar.

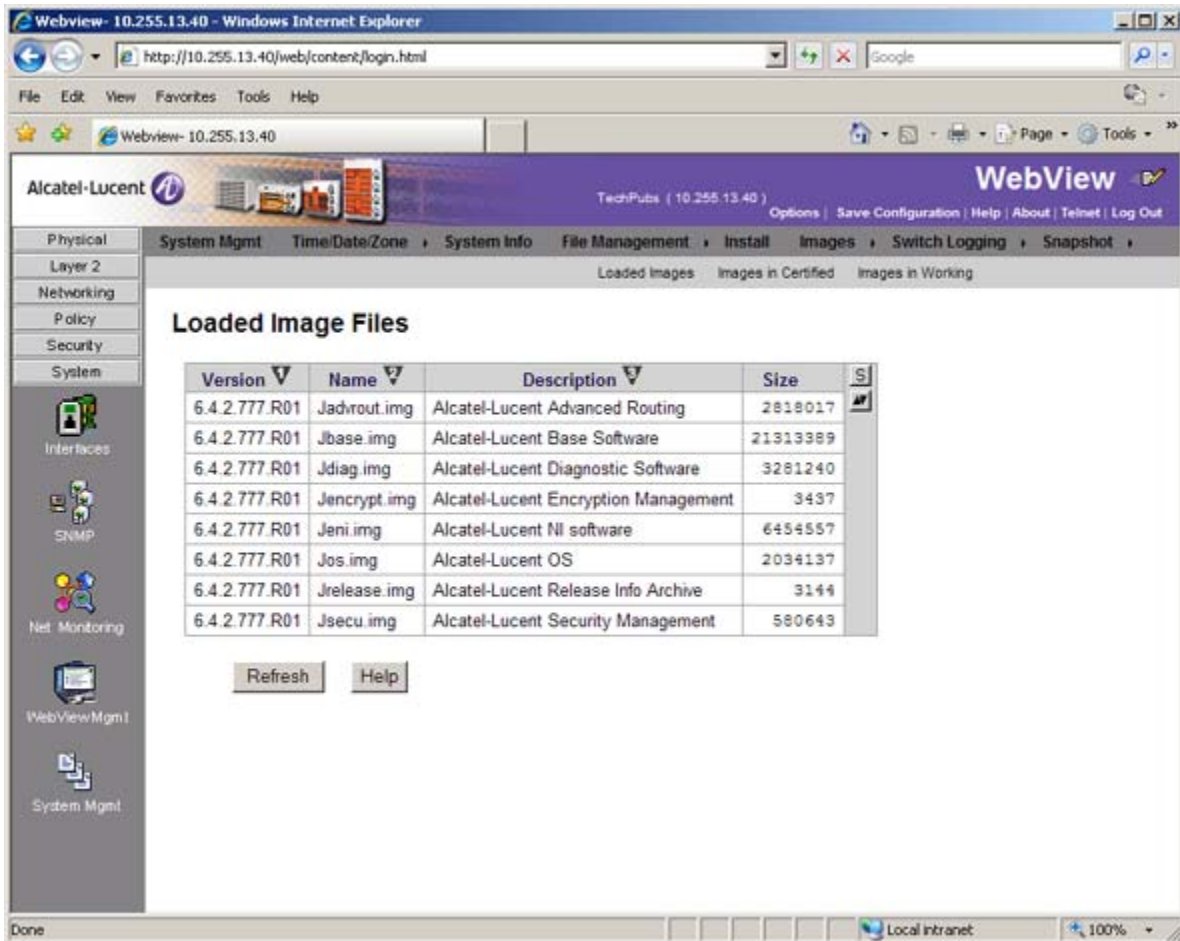
To verify that the software was successfully upgraded, go to the **Loaded Image Files** page by selecting **System > System Mgmt > Images > Loaded Images** as shown below.

The screenshot shows the Alcatel-Lucent WebView interface. The browser address bar shows `http://10.255.13.40/web/content/login.html`. The page title is "Webview- 10.255.13.40". The main navigation menu includes "System Mgmt", "Time/Date/Zone", "System Info", "File Management", "Install", "Images", "Switch Logging", and "Snapshot". The "Images" menu is expanded, showing "Loaded Images", "Images in Certified", and "Images in Working". The "Loaded Image Files" page displays a table with the following data:

Version	Name	Description	Size
6.4.2.777.R01	Jadvrout.img	Alcatel-Lucent Advanced Routing	2818017
6.4.2.777.R01	Jbase.img	Alcatel-Lucent Base Software	21313389
6.4.2.777.R01	Jdiag.img	Alcatel-Lucent Diagnostic Software	3281240
6.4.2.777.R01	Jencrypt.img	Alcatel-Lucent Encryption Management	3437
6.4.2.777.R01	Jeni.img	Alcatel-Lucent NI software	6454557
6.4.2.777.R01	Jos.img	Alcatel-Lucent OS	2034137
6.4.2.777.R01	Jrelease.img	Alcatel-Lucent Release Info Archive	3144
6.4.2.777.R01	Jsecu.img	Alcatel-Lucent Security Management	580643
