Release Notes - Maintenance

OmniSwitch 6860/6860E

Release 8.2.1.353.R01

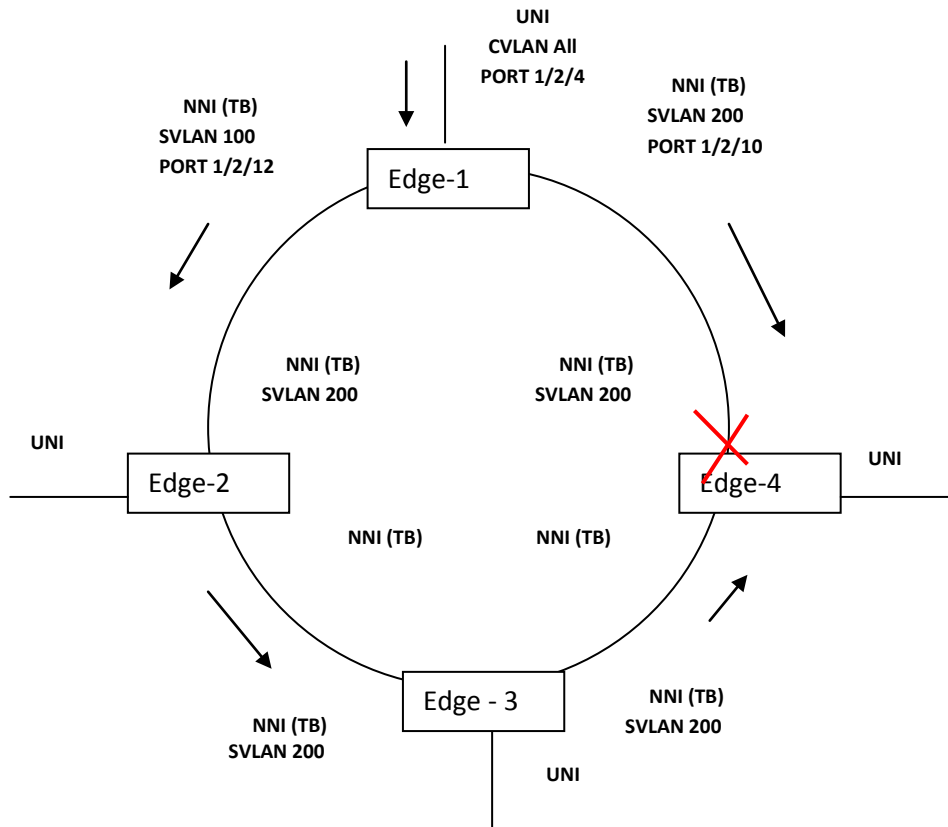
Transparent Bridging - Use Case 1 Diagram

In the above topology, VLANs 100 and 200 are configured on Edge-1 NNI ports. Only VLAN 200 is configured on all other edge switches NNI ports. On Edge-1 CVLAN 10 is mapped to SVLAN 100. Since transparent bridging is enabled on all the NNI ports of all the edge switches of this topology, though VLAN 100 is not configured on NNI ports of Edges 2, 3 and 4 explicitly, the traffic with VLAN 100 flows through the Edge-2, Edge-3 and Edge-4. Since transparent bridging is enabled only when STP mode is 'FLAT', one of the links in the ring goes to blocking state preventing loops.
