# Release Notes - Rev. B

## OmniSwitch 9900

### Release 8.4.1.R01

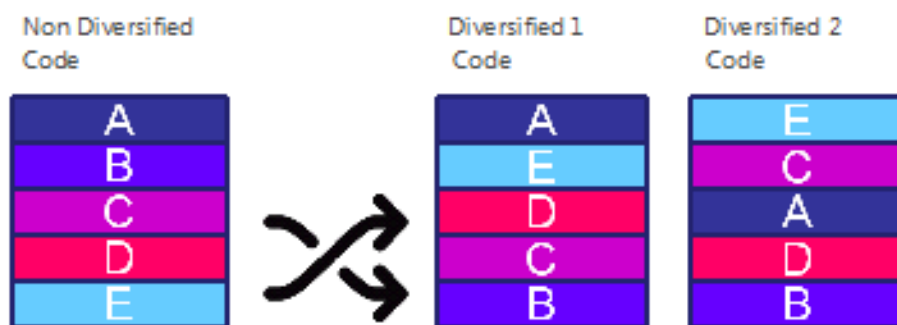
Software diversification randomizes the executable program so that various instances of the same software, while functionally identical, are arranged differently. The CodeGuardian solution rearranges internal software while maintaining the same functionality and performance and modifies the deliverable application to limit or prevent/impede software exploitation. There will be up to 3 different diversified versions per GA release of code.
