# Release Notes - Maintenance

OmniAccess AP1101, AP1221,  
AP1222, AP1251  
AWOS Release 3.0.0.61

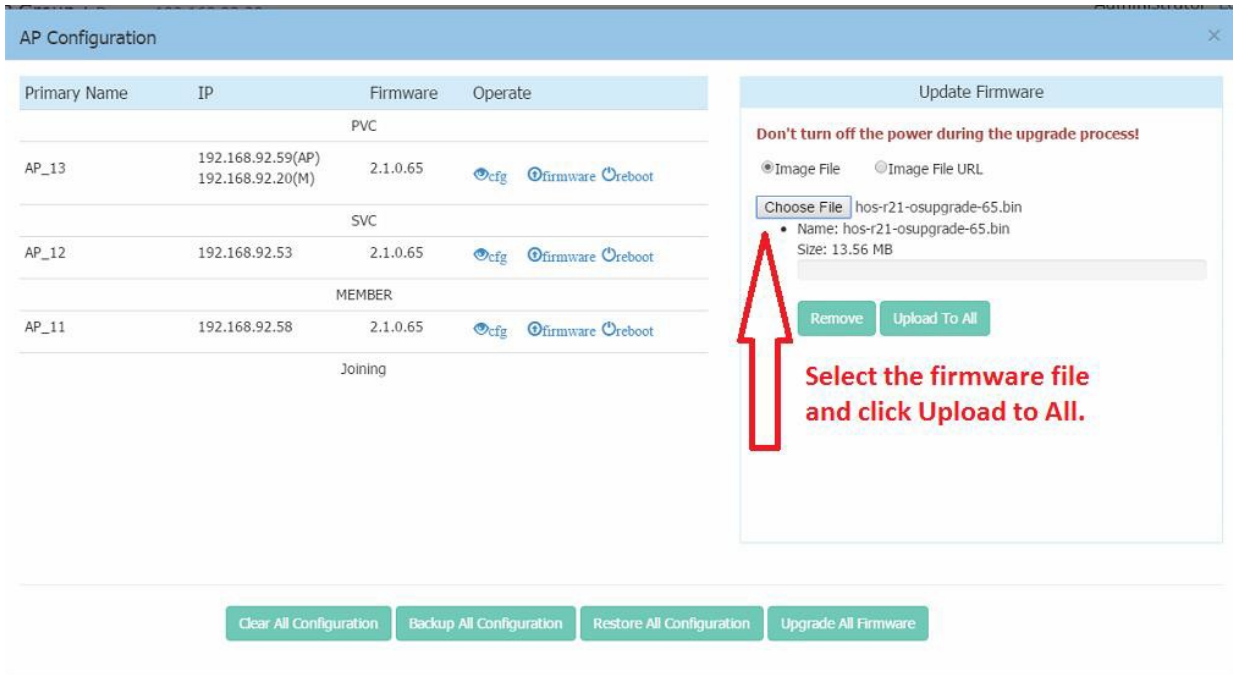
4. Select the firmware file and click **Upload To All**, this will upgrade the firmware and reboot the AP.

The screenshot shows the 'AP Configuration' window with a table of APs and an 'Update Firmware' dialog box. The table lists APs grouped by type: PVC, SVC, MEMBER, and Joining. The 'Update Firmware' dialog box has a warning 'Don't turn off the power during the upgrade process!' and options for 'Image File' and 'Image File URL'. A 'Choose File' button is highlighted with a red arrow, and a text box below it says 'Select the firmware file and click Upload to All.' The dialog also shows a file named 'hos-r21-osupgrade-65.bin' with a size of 13.56 MB and 'Remove' and 'Upload To All' buttons. At the bottom of the window are buttons for 'Clear All Configuration', 'Backup All Configuration', 'Restore All Configuration', and 'Upgrade All Firmware'.
