Release Notes - Maintenance

OmniAccess Stellar

AP1101, AP1221, AP1222, AP1231, AP1232, AP1251

AWOS Release 3.0.2.38

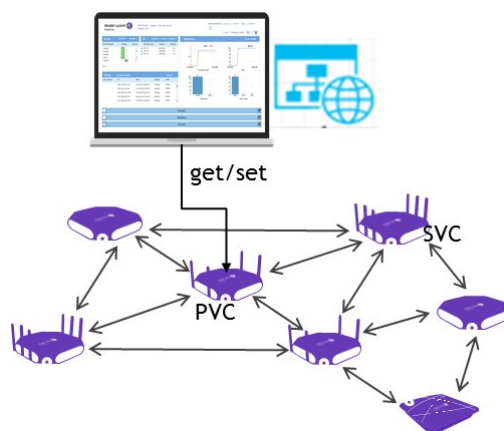
The AP configuration model is shown in the following diagram. The management website gets and sets configuration only through PVC, and PVC is responsible for forwarding those commands to the other Access Points in the group, therefore, PVC can connect with other Access Points in any situation whether the Management website is accessed across the NAT or not.

The AP Group can be remotely managed by mapping the company external network and the PVC IP or the Group Management IP (hereinafter referred to as GMIP).

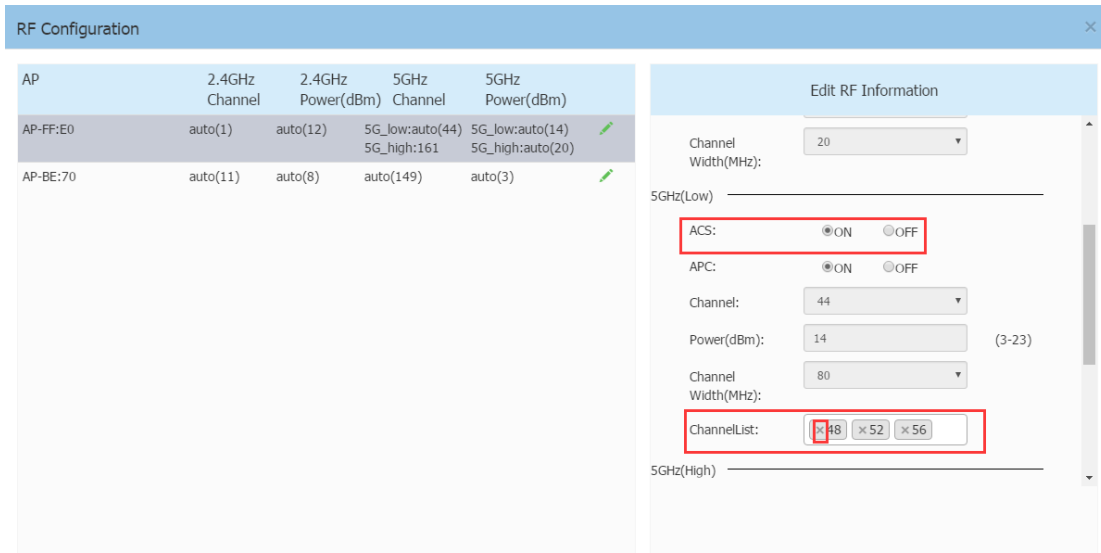
1. Log in to the AP page, then click “Wireless--RF Configuration” to enter the page of RF Configuration.
2. Select the AP you want to edit, then config the channel list in the right panel.
3. First open the ACS automatic channel list selection button, and then add the channel value in the Channel List. If you want to delete a channel, click “x”. If the channel list is empty, the AP makes auto selection in the all channels.

- 2.4 GHz doesn't support auto channel-list selection.

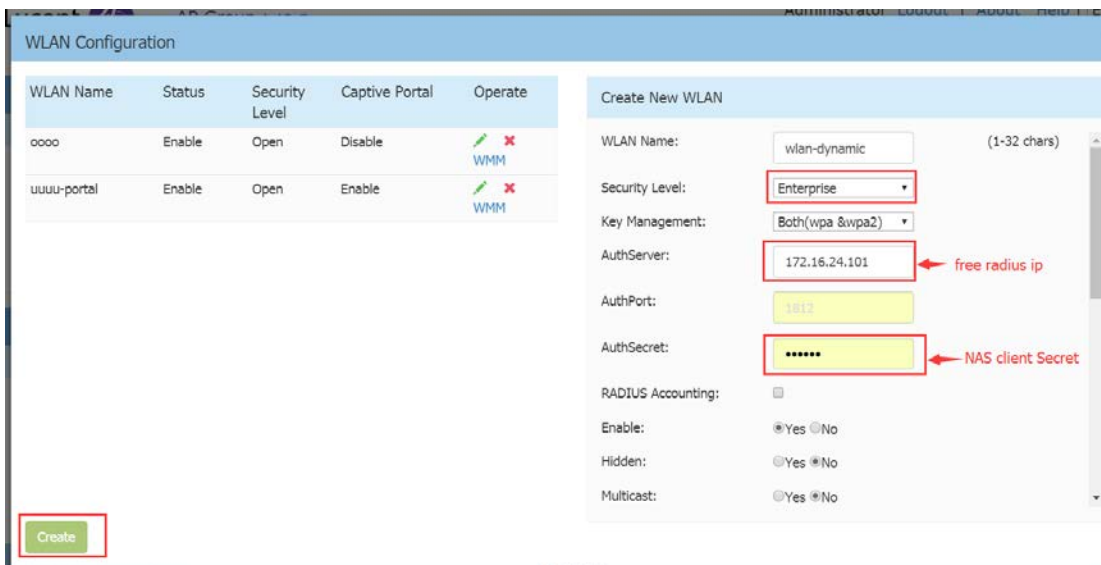
With Radius authentication, OmniAccess Stellar now supports the attribute "Tunnel-Private-Group-Id" which facilitates user based dynamic VLAN assignment.

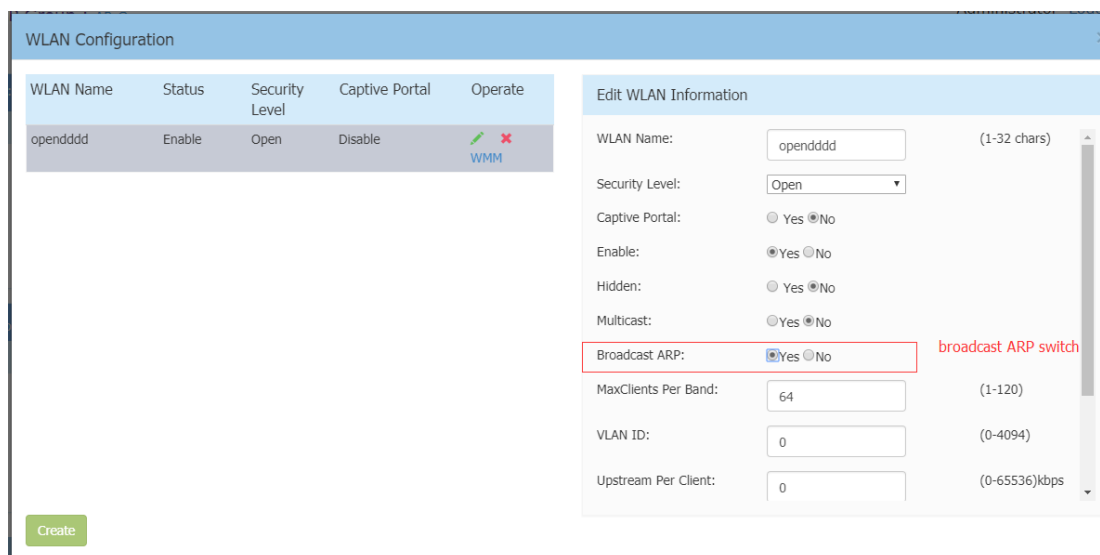
Broadcast/Multicast Optimization can be configured as below:

The screenshot displays the 'WLAN Configuration' window. On the left, a table lists WLAN configurations. On the right, the 'Edit WLAN Information' form is shown with various settings. The 'Broadcast ARP' option is highlighted with a red box and labeled 'broadcast ARP switch'.

The Stellar AP will act as an "ARP Proxy". If the ARP-request packet requests a client's MAC address and the AP knows the client's MAC and IP address, the AP will respond to the ARP-request but not forward the ARP-request (broadcast) to all broadcast domains. This reduces ARP broadcast packet forwarding and significantly improves

network performance. Note that Stellar APs do not act as ARP proxy for Gratuitous ARP packets. When the station gets an IP from DHCP or IP release/ renew, the station will send Gratuitous ARP packets. AP will not respond to such special ARP packets and broadcast them normally.

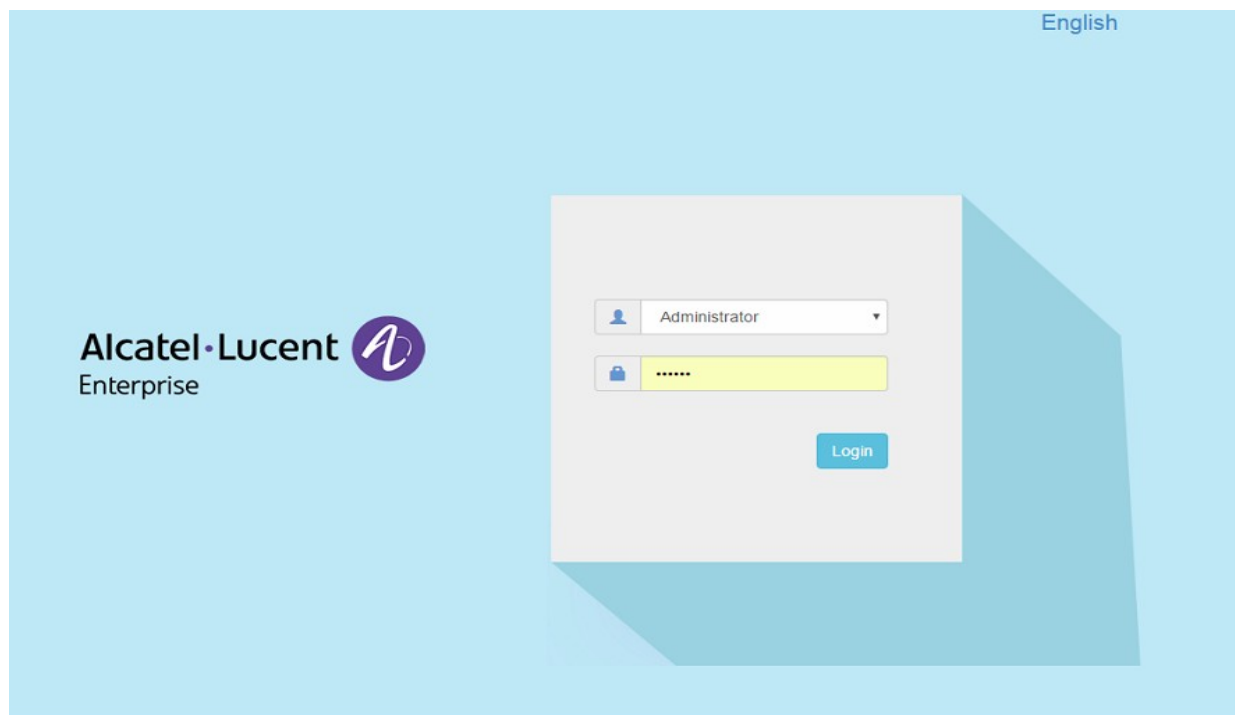
1. Login to AP using Administrator account with default password 'admin'.
