Release Notes - Rev. B

OmniAccess Stellar AP

AWOS Release 3.0.7 - GA Release

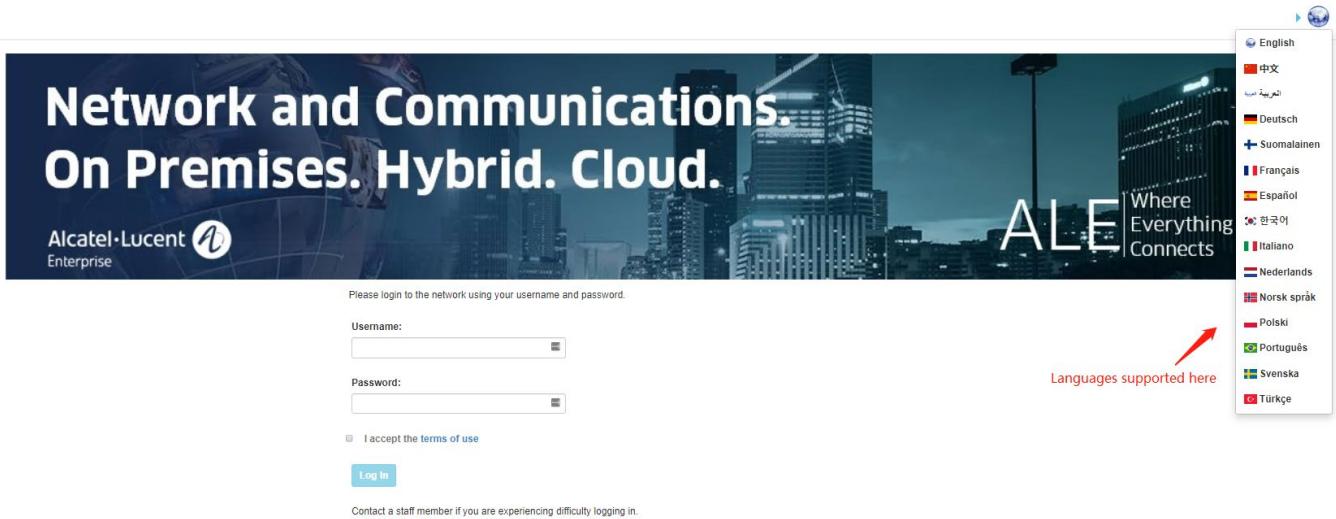
Multi Language Guest Captive Portal

In 3.0.7 Scope, we support up to 15 languages of Guest Captive Portal in Express mode as screenshot below:

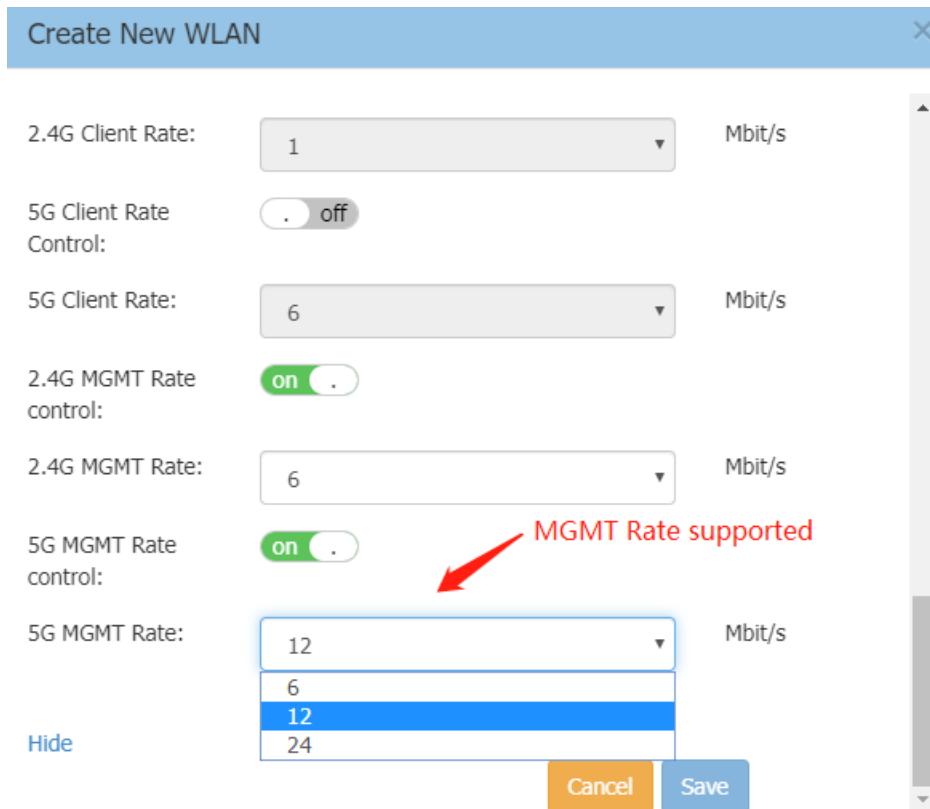
PERWIFI-49: For 5GHz band add support for 12, 24Mbps as part of minimum management rate control

The minimum management on 5Ghz band is supported in AWOS 3.0.7 as below, the default management rate is 12Mbps.

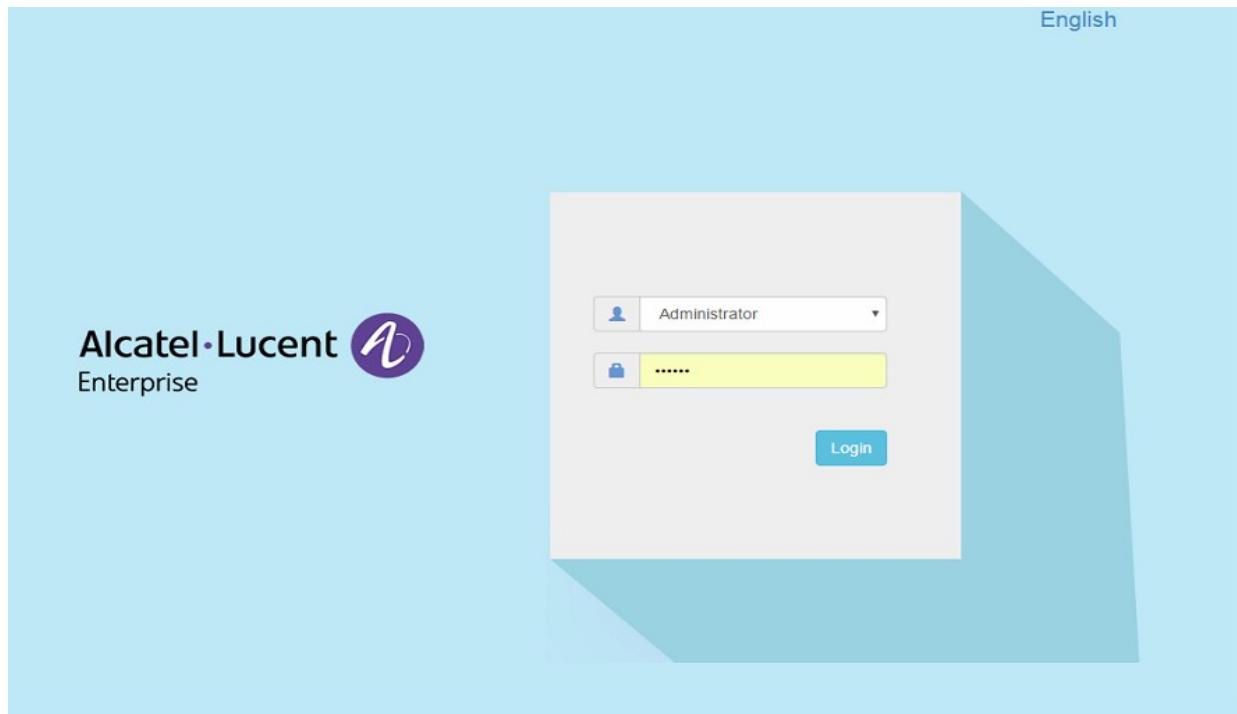
General Software Upgrade Instructions (WiFi Express)

1. Login to AP using Administrator account with default password ‘admin’.
