# Release Notes - Rev. B

OmniAccess Stellar AP

AWOS Release 4.0.4 - MR1 Release

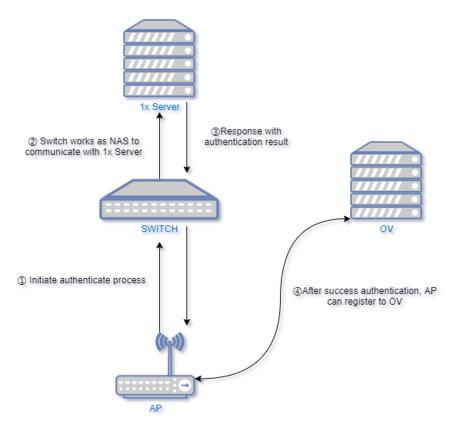
This function provides a method for allowing only APs authenticated over 802.1x for trusting WLAN clients on OmniSwitch, chart blow describes the main workflow of this function.

Configurations needs to be done on both AP/AP Group (thru OV management) and Switch side, for details please refer to OmniVista user guide.

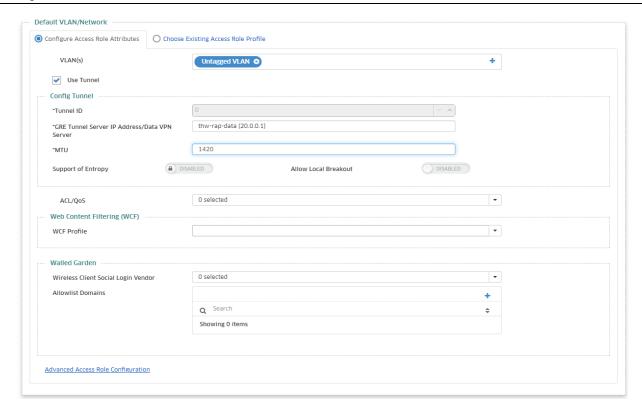
1. MTU of data VPN is configurable on OVE/OVC SSID Settings:

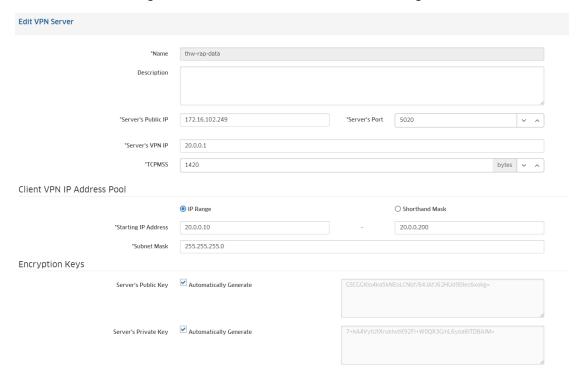
2. TCPMSS of data VPN is configurable on OVE/OVC Data VPN Servers settings:

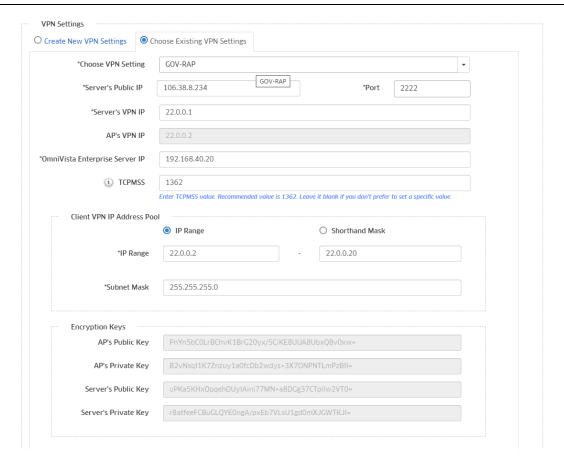
3. TCPMSS of management VPN is configurable on GOV Device Catalog(freemium tenant):

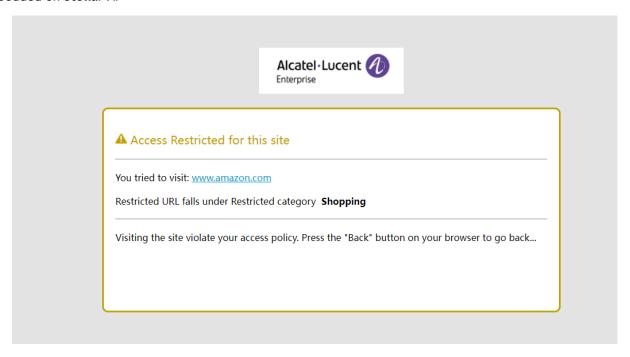
In this release, when a page is blocked by WCF, End user is notified when redirected to Restricted Web Page embedded on Stellar AP

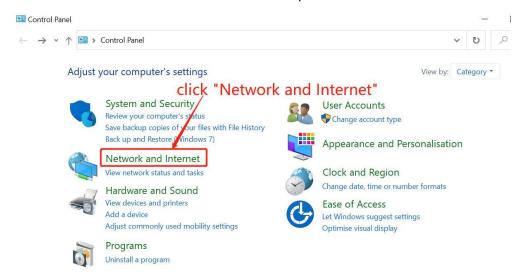
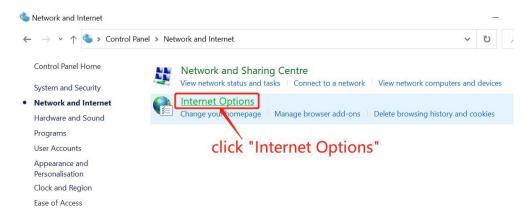
- 1. Configure http/https proxy on the wireless client (Windows OS for example).
- 1.1 Open "Control Panel"> "Network and Internet"> "Internet Options"

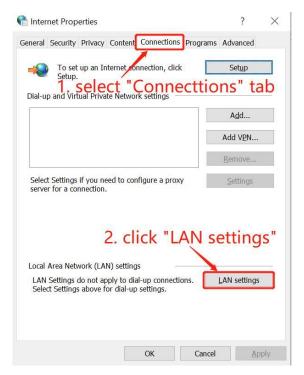
1.2 The "Internet Properties" window pops up, select the "Connections" tab, and click "LAN Settings"

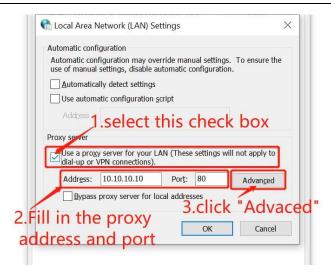
1.3 The "Local Area Network (LAN) Settings" window pops up, check "Use a proxy server for your LAN", fill in the proxy server address and port, and click the "Advanced" button

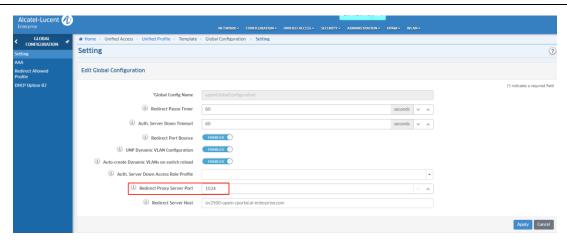
- 2. Set the proxy port on the AP.
- 2.1 Log in to the OV management page and go to Home > Unified Access > Unified Profile > Template > Global Configuration > Setting  $\circ$

Modify or create Global Configuration and fill in the proxy port used by the client in "Redirect Proxy Server Port".

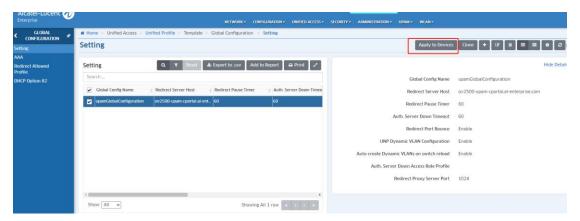
After the modification is completed, click "apply", and then click "Apply to Devices", select the AP's group, and send it to the AP.
