# Release Notes - Rev. B

## OmniAccess Stellar AP

### AWOS Release 4.0.2.2048 - MR-2 Release

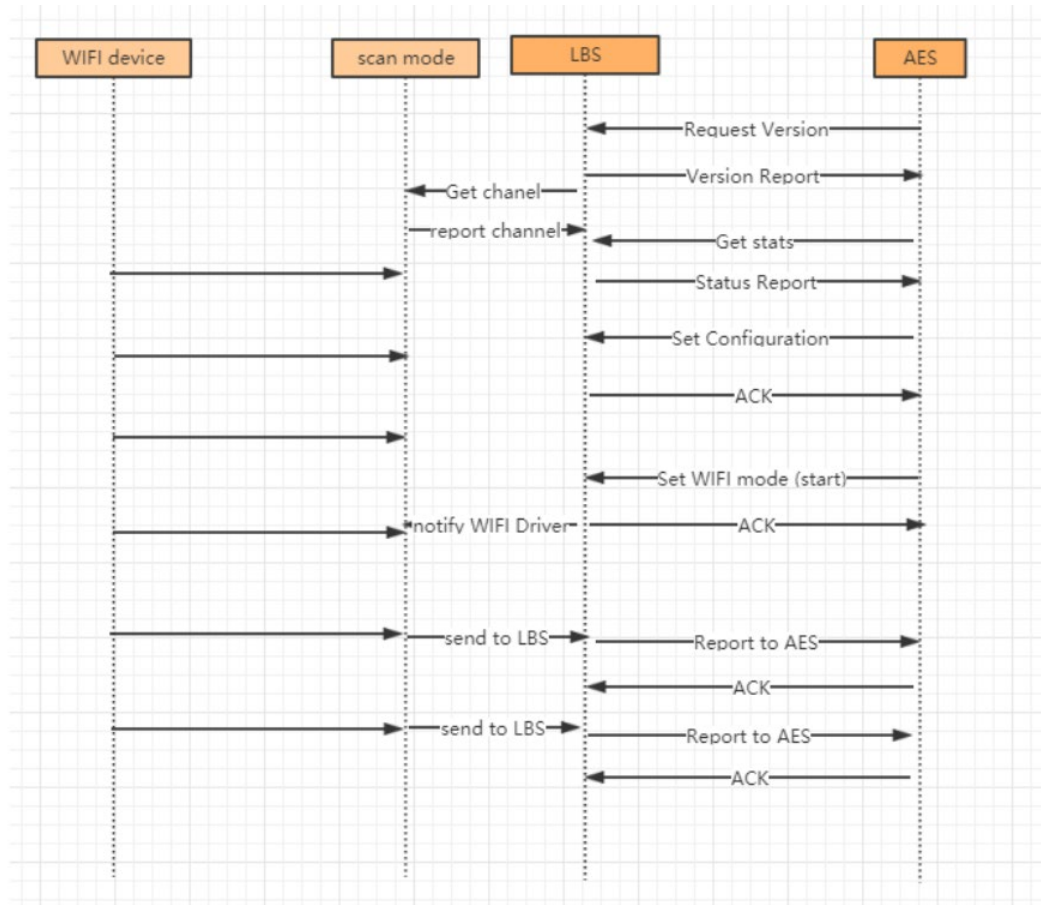
Note that AES Server must be configured in order to send the first request (get channel) and then AP will start to send data as per the following call flow:

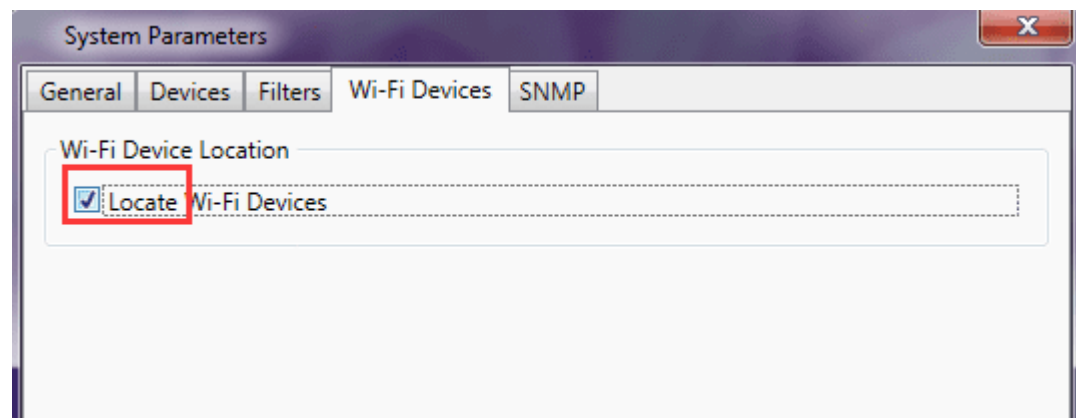
On AES Server -> System Parameters, select “Locate Wi-Fi Devices”:

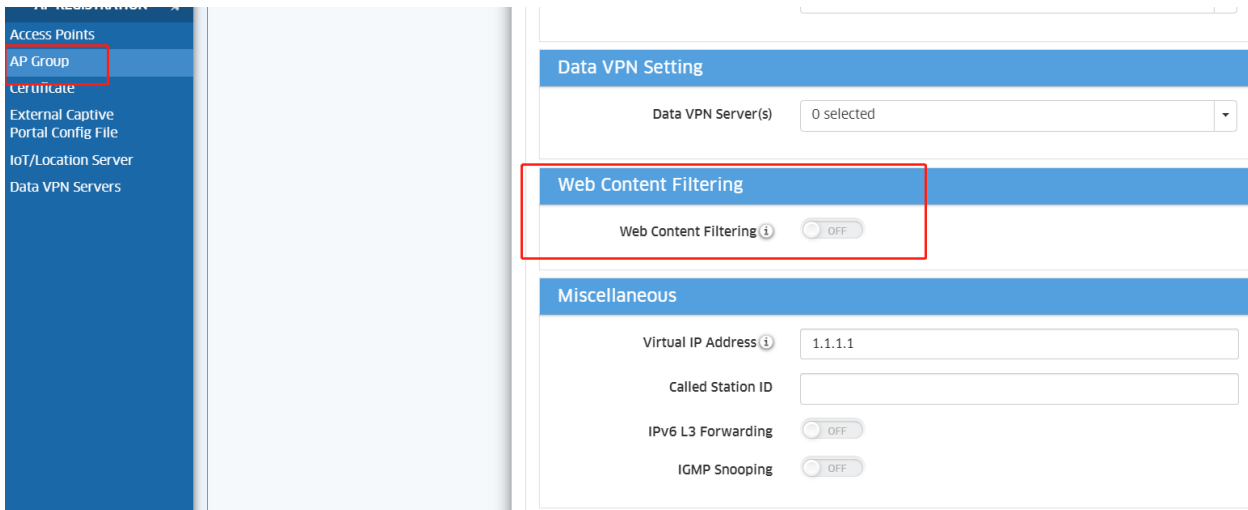
1. Group WCF configuration

The WCF function is the Web Content Filter function, which mainly filters the url to be accessed by client and adds release and deny rules so that it can only access the URL specified by the administrator.

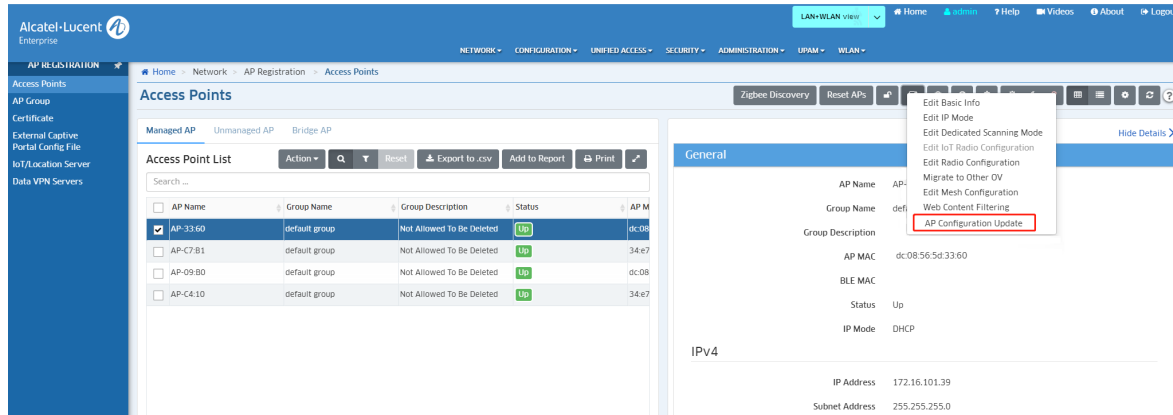
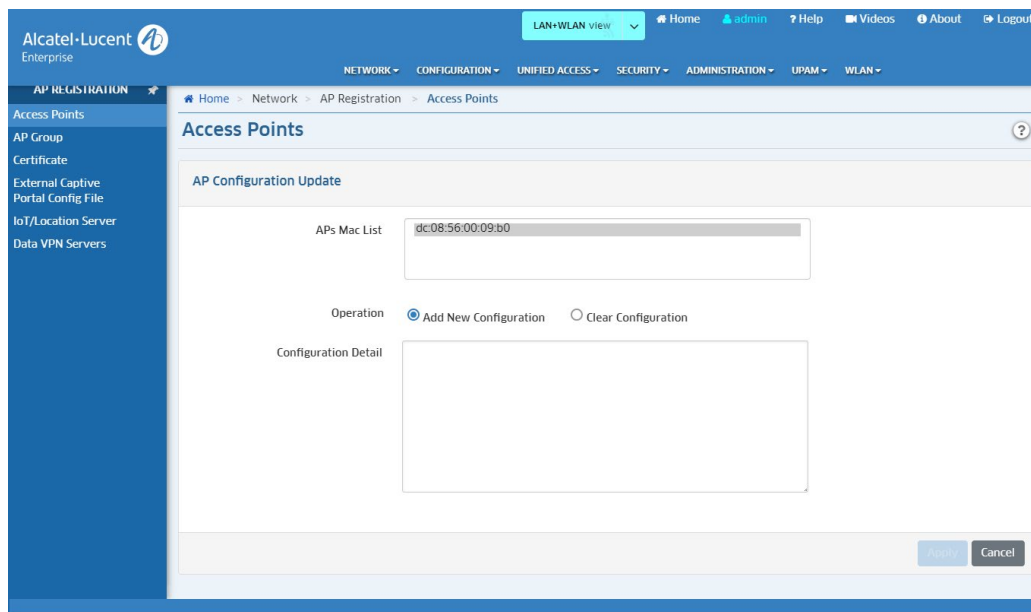
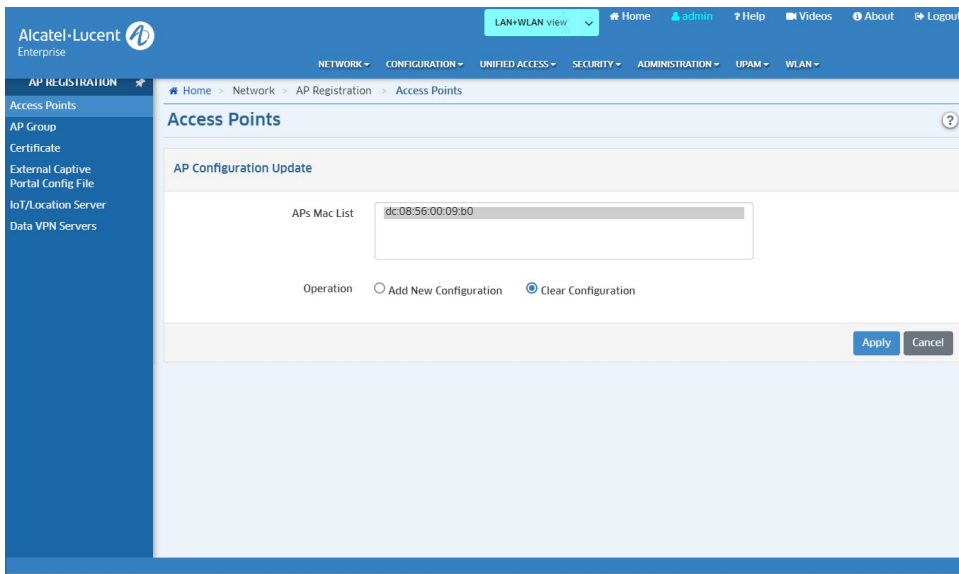
It will help the support team use the new OV version to temporarily resolve customer issues before the new AP is officially released.

Here are the configuration methods:
