Release Notes - Rev. A

OmniAccess Stellar AP

AWOS Release 4.0.4 - MR2 Release

These release notes accompany the OmniAccess Stellar Operating System (AWOS) Release 4.0.4 software for the Stellar APs. This document provides important information on individual software and hardware features. Since much of the information in the release notes is not included in the hardware and software user manuals, it is important to read all sections of this document before installing new hardware or loading new software.

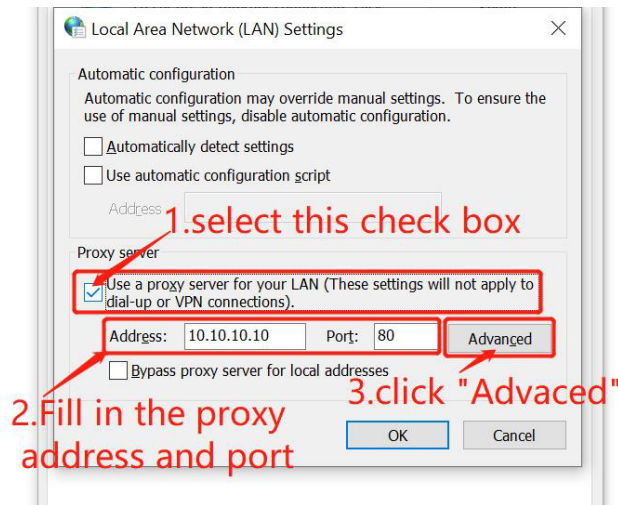
1.3 The "Local Area Network (LAN) Settings" window pops up, check "Use a proxy server for your LAN", fill in the proxy server address and port, and click the "Advanced" button
