AOS-W 6.3.1.16

The following illustration shows the patch and maintenance releases that are included in AOS-W 6.3.1.16.

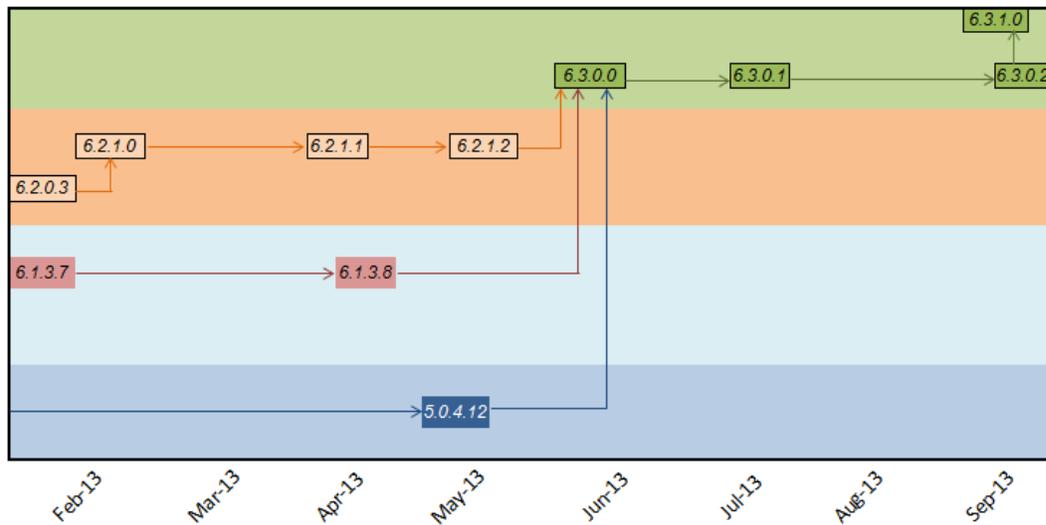
Figure 1 AOS-W Releases and Code Stream Integration

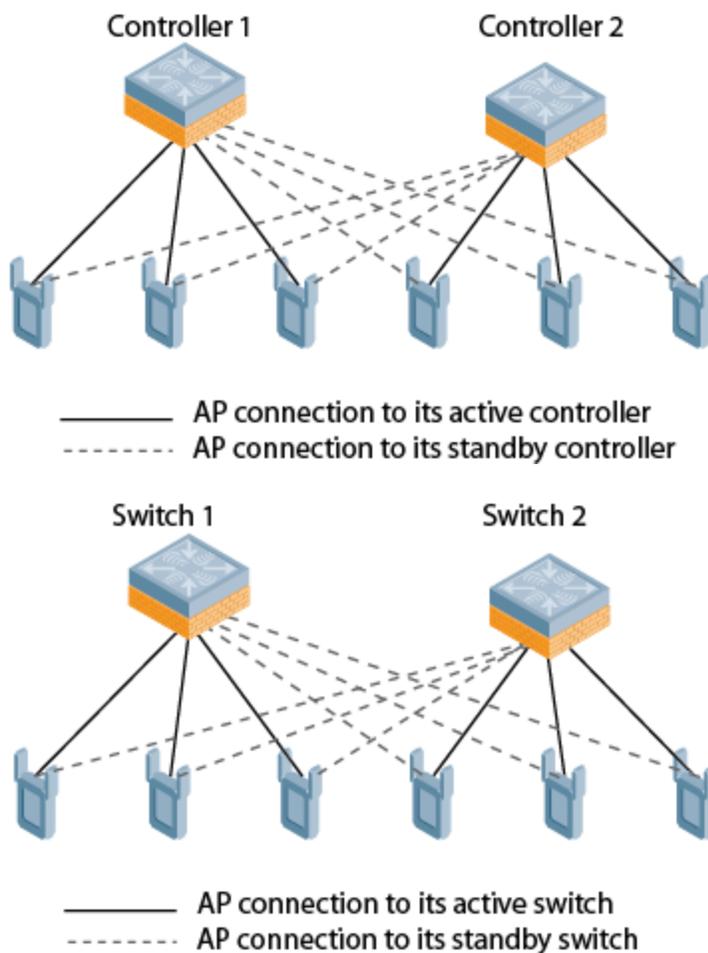
In this model, two switches are deployed in dual mode. Switch one acts as standby for the APs served by switch two, and vice-versa. Each switch in this deployment model supports approximately 50% of its total AP capacity, so if one switch fails, all the APs served by that switch would fail over to the other switch, thereby providing high availability redundancy to all APs in the cluster.

Figure 2 Active-Active HA Deployment

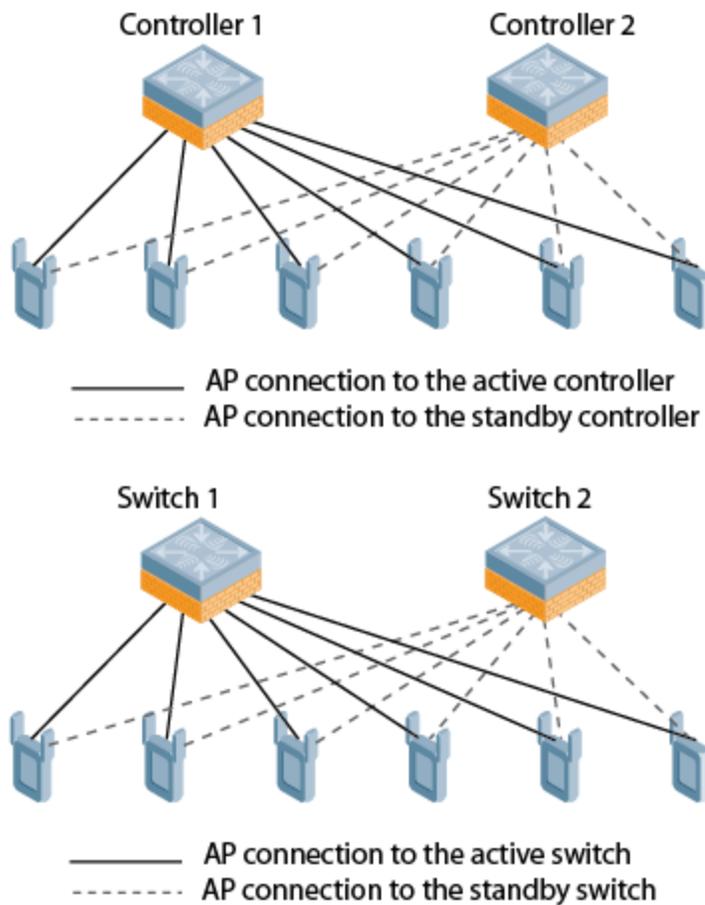
In this model, the active switch supports up to 100% of its rated AP capacity, while the other switch in standby mode is idle. If the active switch fails, all APs served by the active switch would failover to the standby switch.

Figure 3 1:1 Active/Standby Deployment

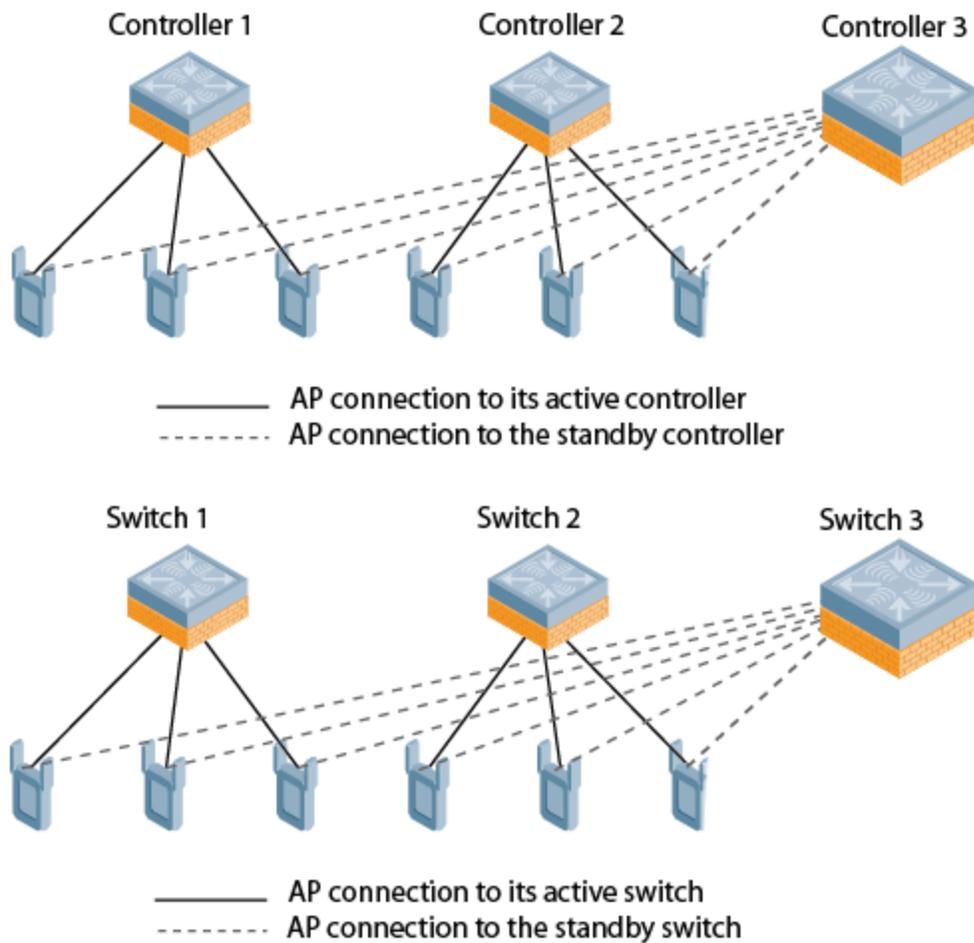
In the cluster shown in the example below, the standby switch has enough AP capacity to support the total number of APs terminating on the active switches. (Switch 1 and Switch 2)

Figure 4 1:1 Active/Standby Deployment

In this model, the active switch supports up to 100% of its rated AP capacity, while the other switch in standby mode is idle. If an active switch fails, all APs served by the active switch would failover to the standby switch.
