Intermediate Release Notes

Omni Switch 9xxx, 6850, 6855 & 6400

Release 6.4.3.930.R01

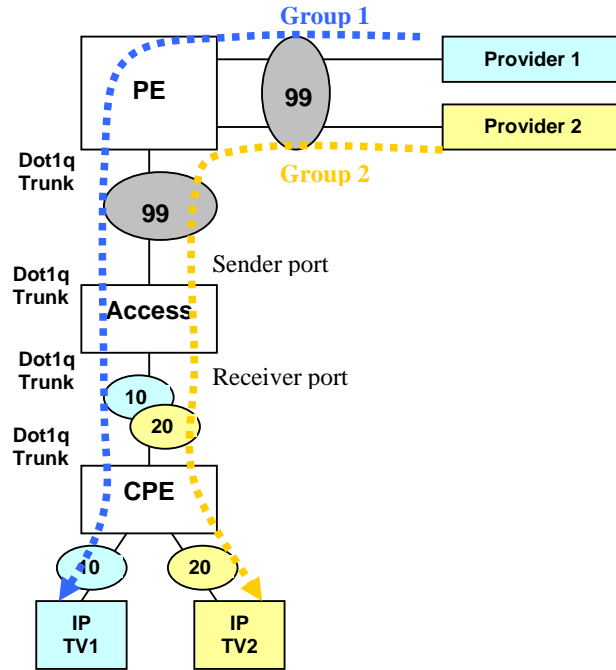
Enterprise

- Internet service is provided using dot1q.
- Multicast service is provided using dot1q.

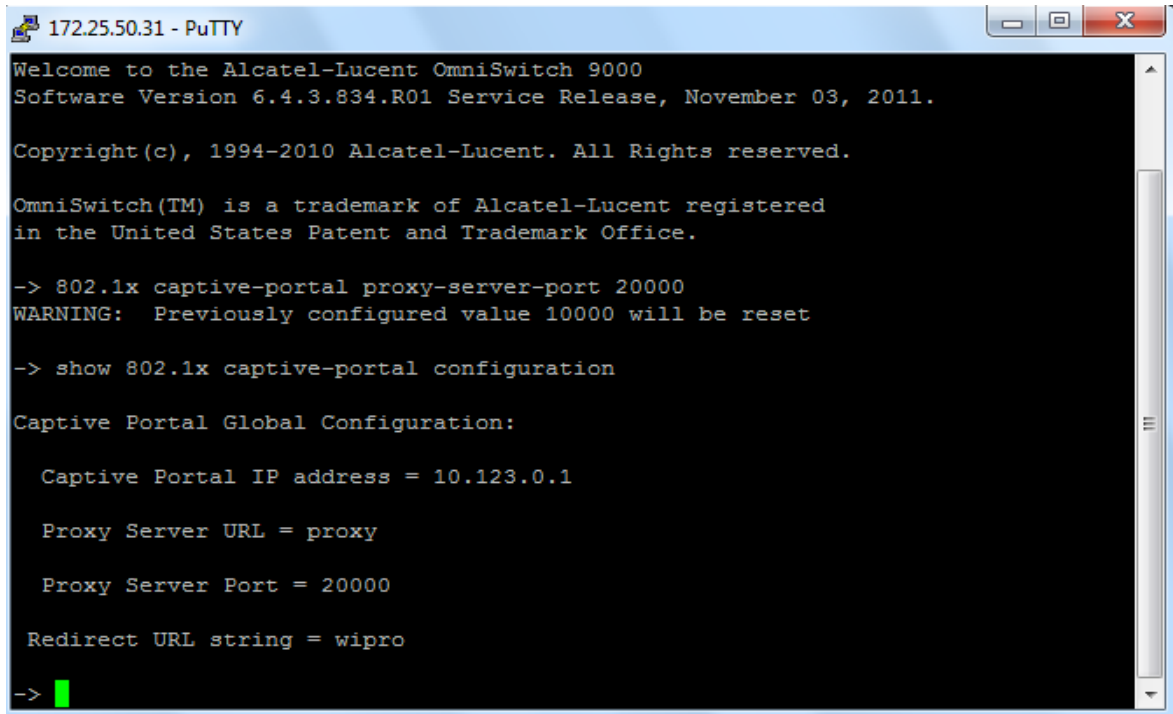
Show 802.1x captive-portal configuration

```
172.25.50.31 - PuTTY
Welcome to the Alcatel-Lucent OmniSwitch 9000
Software Version 6.4.3.834.R01 Service Release, November 03, 2011.

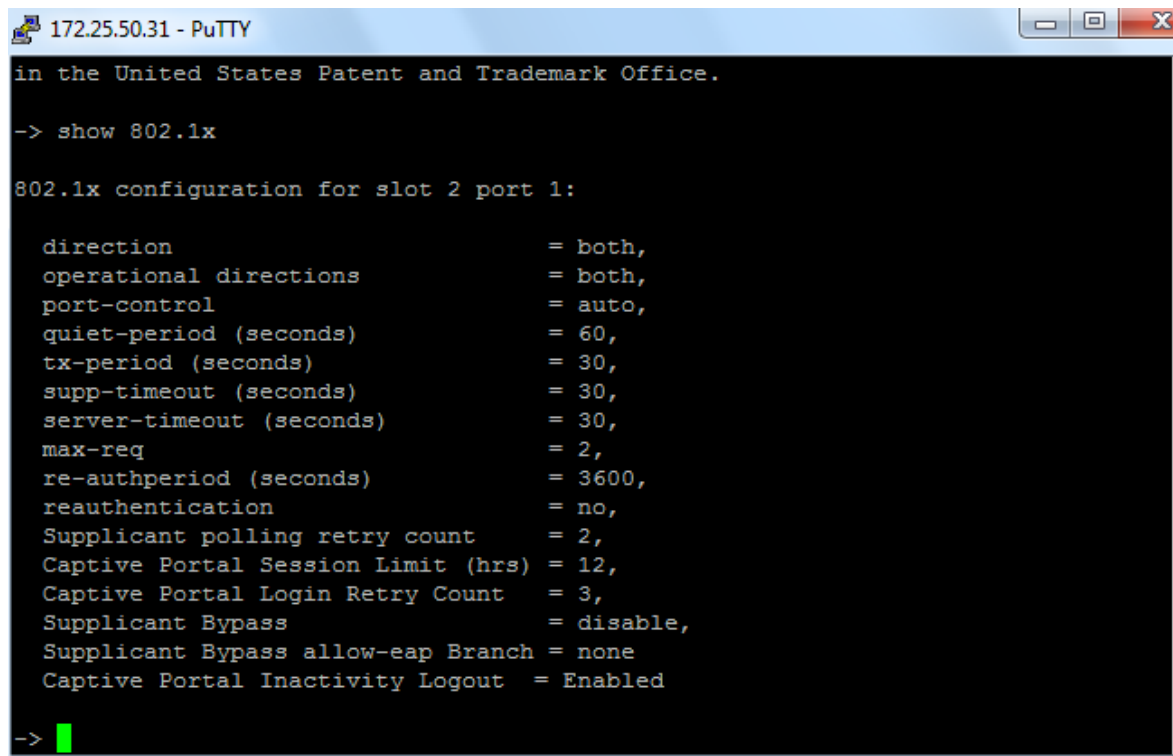
Show 802.1x slot/port

```
172.25.50.31 - PuTTY
in the United States Patent and Trademark Office.
-> show 802.1x

802.1x configuration for slot 2 port 1:
