# Upgrading OmniSwitch 6855 Series Switches to 6.4.2.R01

This instruction sheet documents how to upgrade OmniSwitch 6855 Series Switches to 6.4.2.R01 firmware and software. The upgrade can be performed using the CLI, WebView, or SNMP. Alcatel-Lucent recommends using WebView to perform the upgrade. For upgrade instructions using the CLI, see [Upgrading with the CLI on page 12](#).

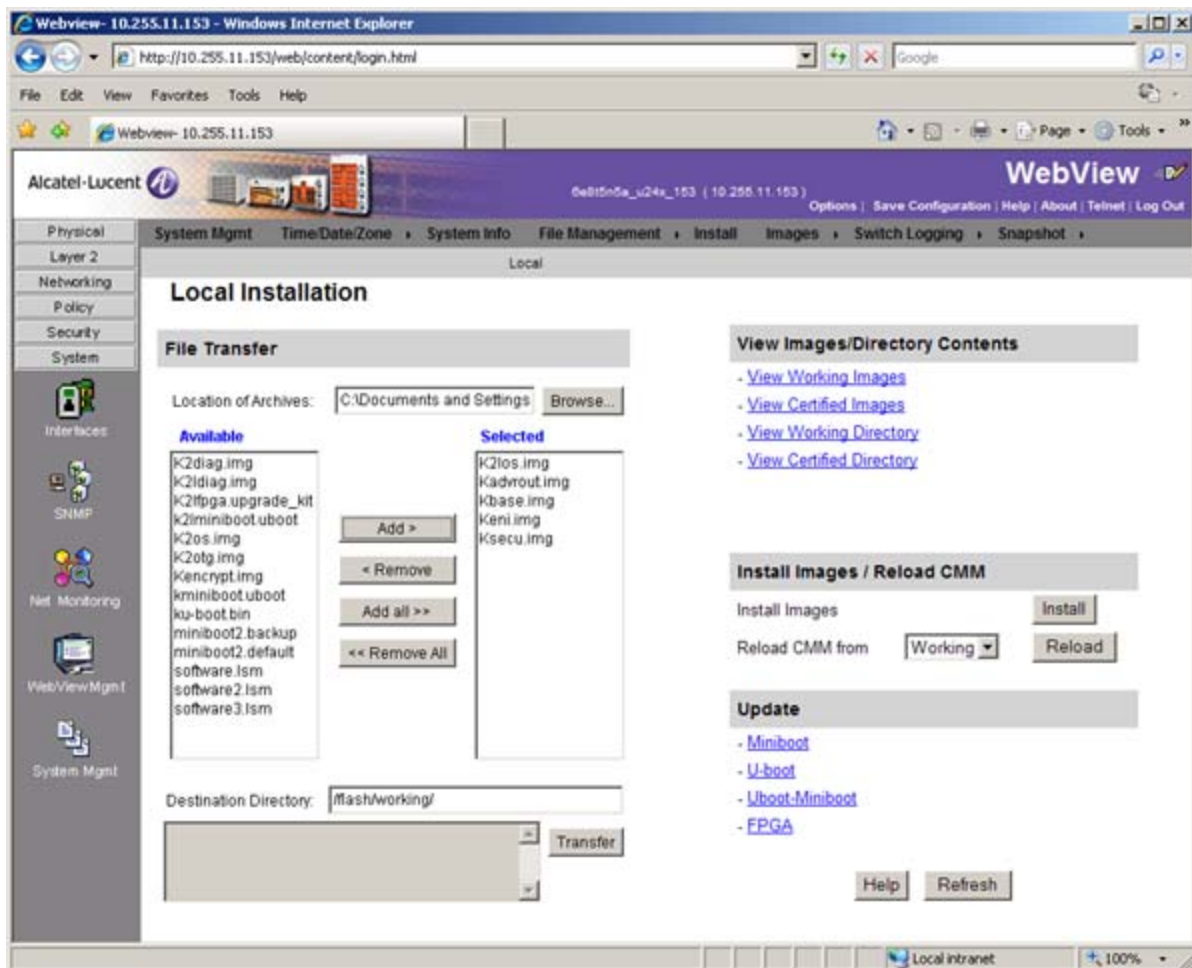
- 5 Click on the **Remove All** button to move all of the files to the “Available” area; then select the following image files and click the **Add** button to move them to the “Selected” area as shown below:  
**K2Ios.img, Kadvrout.img, Kbase.img, Keni.img, Ksecu.img.**

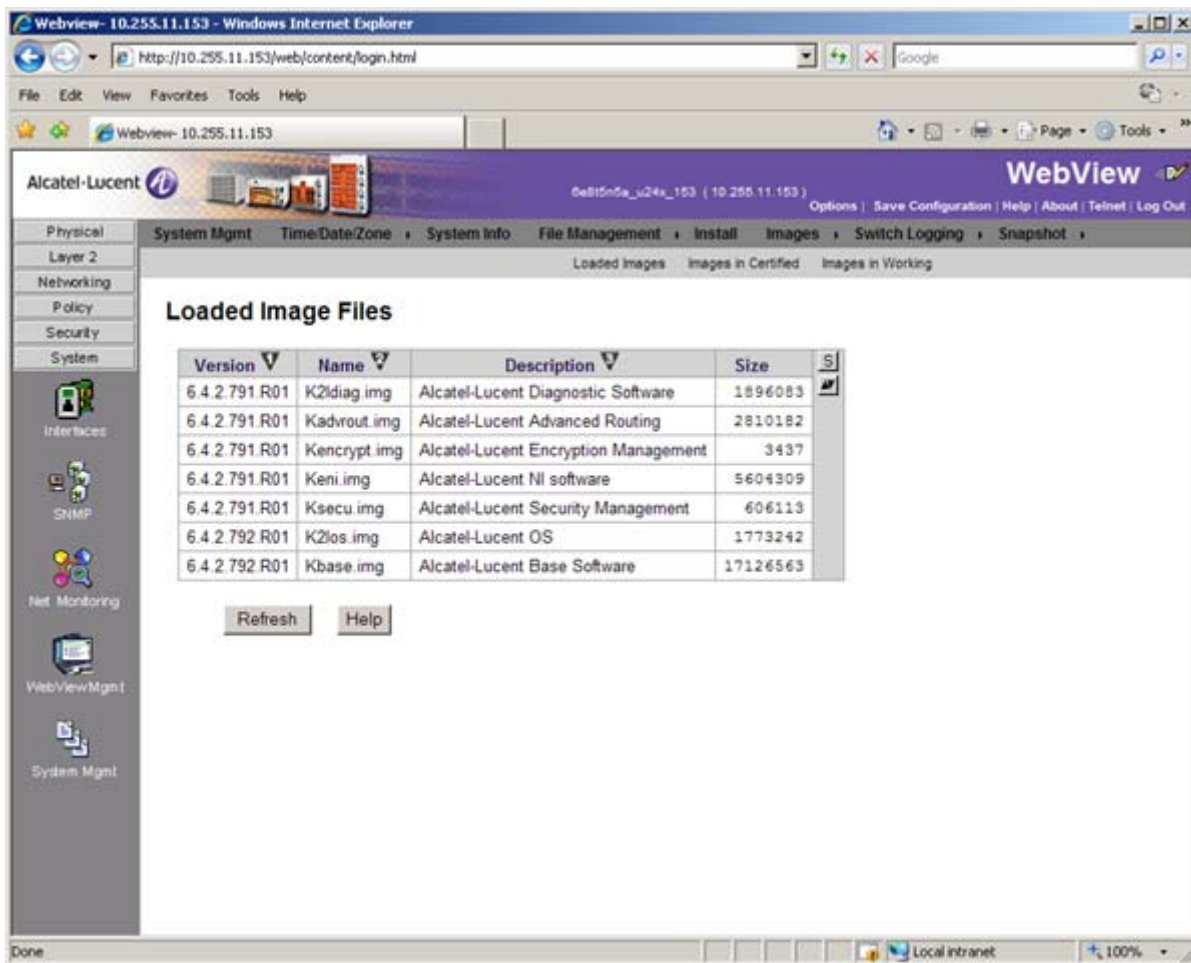
To verify that the software was successfully upgraded, go to the **Loaded Image Files** page by selecting **System > System Mgmt > Images > Loaded Images** as shown below.

The screenshot shows the Alcatel-Lucent WebView interface in a Windows Internet Explorer browser. The browser address bar shows the URL <http://10.255.11.153/web/content/login.html>. The page title is "Webview- 10.255.11.153". The main content area is titled "Loaded Image Files" and contains a table with the following data:

Version	Name	Description	Size
6.4.2.791.R01	K2ldiag.img	Alcatel-Lucent Diagnostic Software	1896083
6.4.2.791.R01	Kadvrout.img	Alcatel-Lucent Advanced Routing	2810182
6.4.2.791.R01	Kencrypt.img	Alcatel-Lucent Encryption Management	3437
6.4.2.791.R01	Keni.img	Alcatel-Lucent NI software	5604309
6.4.2.791.R01	Ksecu.img	Alcatel-Lucent Security Management	606113
6.4.2.792.R01	K2los.img	Alcatel-Lucent OS	1773242
6.4.2.792.R01	Kbase.img	Alcatel-Lucent Base Software	17126563

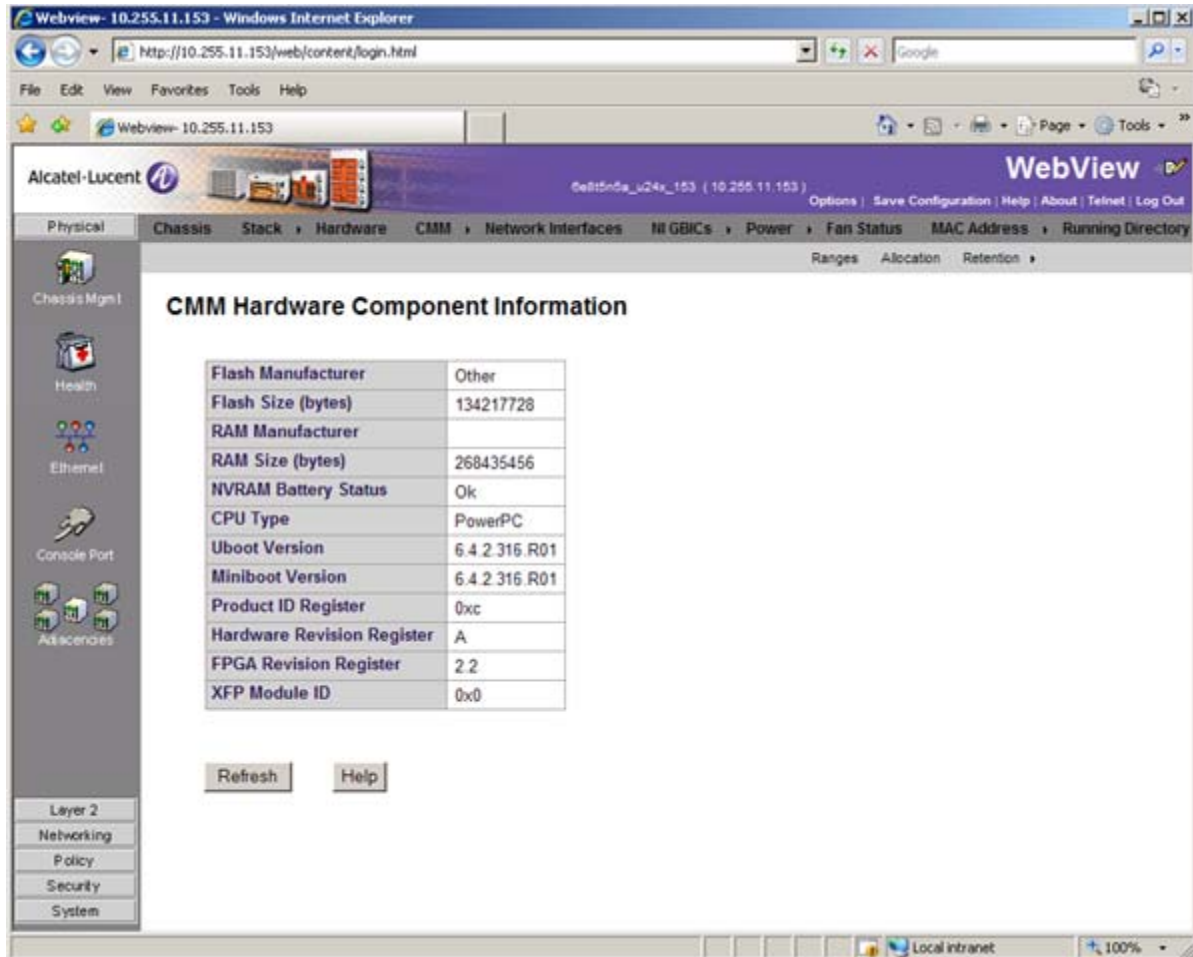
To verify that U-Boot and Miniboot files were successfully upgraded on the CMM, go to the **CMM Hardware Component Information** page by selecting **Physical > Chassis Mgmt > CMM > Hardware Component**, as shown below.

The screenshot shows the Webview interface for an Alcatel-Lucent switch. The browser address bar shows the URL `http://10.255.11.153/web/content/login.html`. The page title is "CMM Hardware Component Information". The interface includes a navigation menu on the left with options like "Physical", "Chassis Mgmt", "Health", "Ethernet", "Console Port", and "Adapters". The main content area displays a table of hardware information.

Flash Manufacturer	Other
Flash Size (bytes)	134217728
RAM Manufacturer	
RAM Size (bytes)	268435456
NVRAM Battery Status	Ok
CPU Type	PowerPC
Uboot Version	6.4.2.316.R01
Miniboot Version	6.4.2.316.R01
Product ID Register	0xc
Hardware Revision Register	A
FPGA Revision Register	2.2
XFP Module ID	0x0
