Upgrading OmniSwitch 6855 Series Switches to 6.3.4.R01

Overview

This instruction sheet documents how to upgrade OmniSwitch 6855 Series switches to 6.3.4.R01 firmware and software. The upgrade can be performed using the CLI, WebView, or SNMP. Alcatel-Lucent recommends using WebView to perform the upgrade. For upgrade instructions using the CLI, see [Upgrading with the CLI on page 13](#).

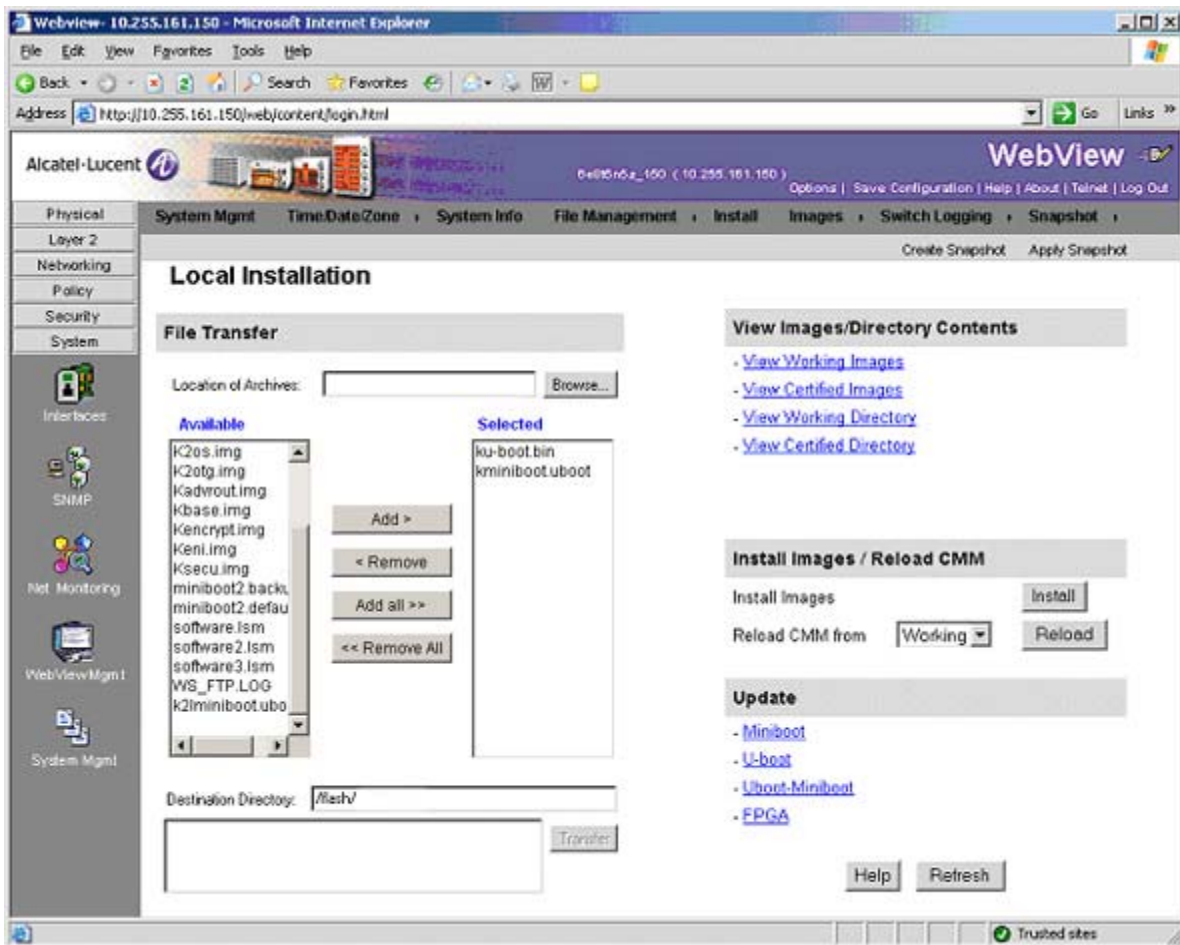
- 5 Click on the **Remove All** button to move all of the files to the “Available” area, then select the **ku-boot.bin** file and the **kminiboot.uboot** file and click the **Add** button to move them to the “Selected” area as shown below.

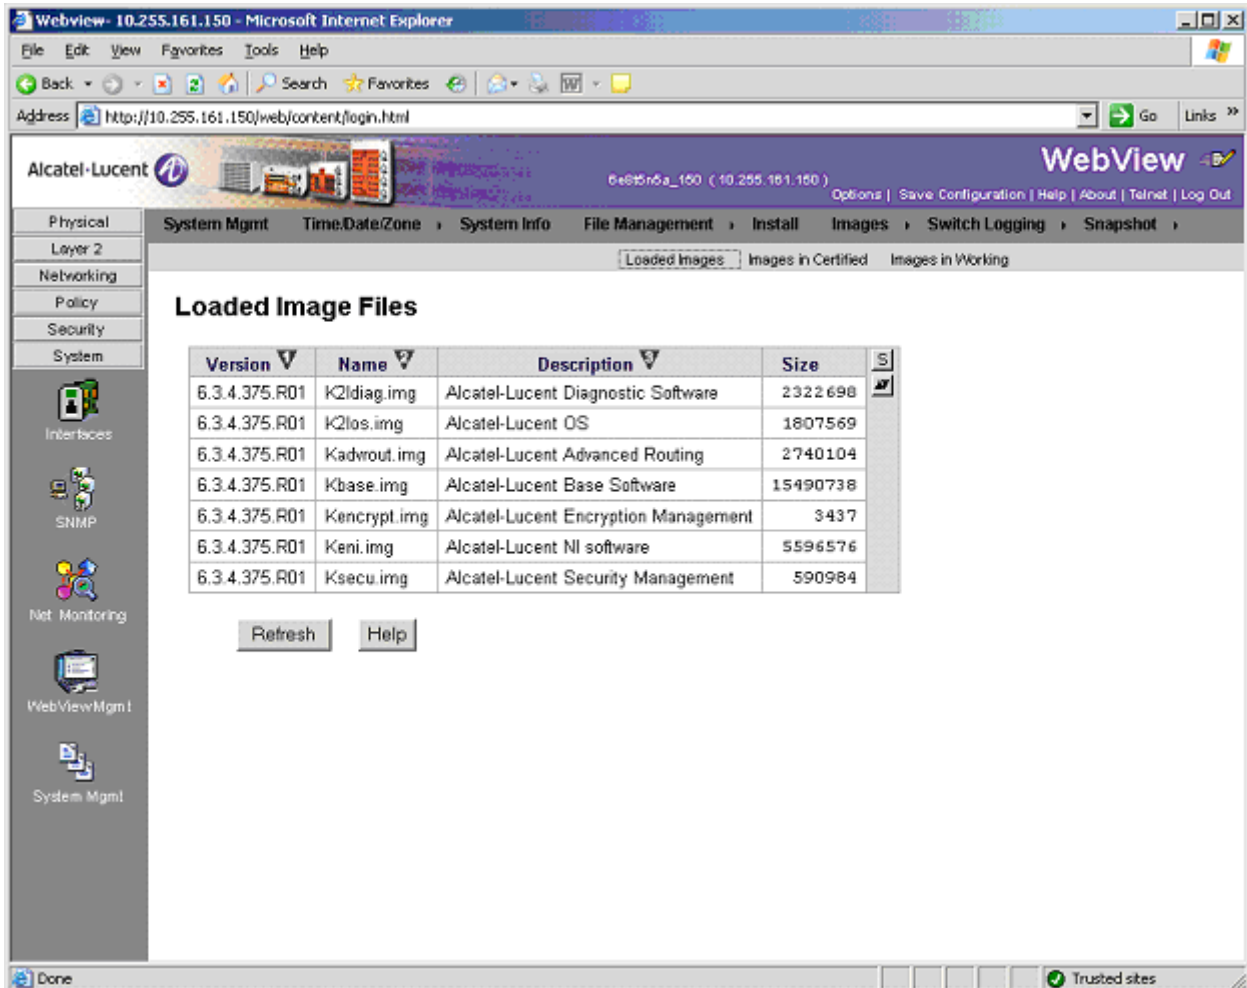
To verify that the software was successfully upgraded, go to the **Loaded Image Files** page by selecting **System > System Mgmt > Images > Loaded Images** as shown below.

The screenshot shows the Alcatel-Lucent WebView interface in Microsoft Internet Explorer. The browser address bar shows the URL: `http://10.255.161.150/web/content/login.html`. The page title is "Webview- 10.255.161.150 - Microsoft Internet Explorer". The main content area displays the "Loaded Image Files" page. The page has a navigation menu at the top with options like "System Mgmt", "Time/Date/Zone", "System Info", "File Management", "Install", "Images", "Switch Logging", and "Snapshot". The "Images" menu is expanded, showing "Loaded Images", "Images in Certified", and "Images in Working". The "Loaded Images" sub-menu is selected. The main content area shows a table of loaded image files.

Version	Name	Description	Size	
6.3.4.375.R01	K2ldiag.img	Alcatel-Lucent Diagnostic Software	2322698	
6.3.4.375.R01	K2los.img	Alcatel-Lucent OS	1807569	
6.3.4.375.R01	Kadvrout.img	Alcatel-Lucent Advanced Routing	2740104	
6.3.4.375.R01	Kbase.img	Alcatel-Lucent Base Software	15490738	
6.3.4.375.R01	Kencrypt.img	Alcatel-Lucent Encryption Management	3437	
6.3.4.375.R01	Keni.img	Alcatel-Lucent NI software	5596576	
6.3.4.375.R01	Ksecu.img	Alcatel-Lucent Security Management	590984

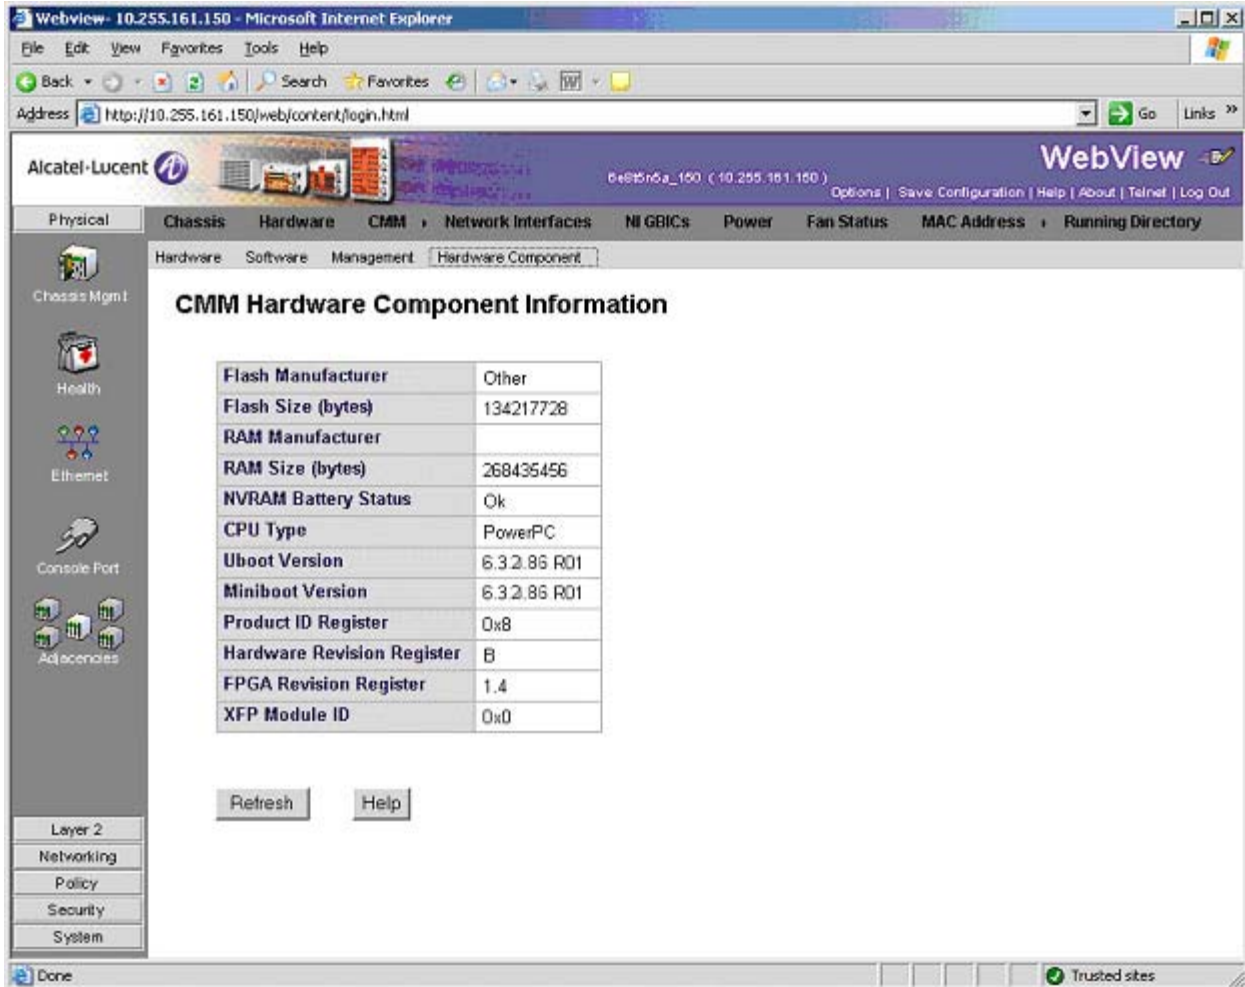
To verify that U-Boot and Miniboot files were successfully upgraded on the CMM, go to the **CMM Hardware Component Information** page by selecting **Physical > Chassis Mgmt > CMM > Hardware Component**, as shown below.

The screenshot shows the WebView interface for an Alcatel-Lucent switch. The browser address bar shows `http://10.255.161.150/web/content/login.html`. The interface includes a navigation menu on the left with options like Chassis Mgmt, Health, Ethernet, Console Port, and Adjacencies. The main content area is titled "CMM Hardware Component Information" and contains a table with the following data:

Flash Manufacturer	Other
Flash Size (bytes)	134217728
RAM Manufacturer	
RAM Size (bytes)	268435456
NVRAM Battery Status	Ok
CPU Type	PowerPC
Uboot Version	6.3.2.86 R01
Miniboot Version	6.3.2.86 R01
Product ID Register	0x8
Hardware Revision Register	B
FPGA Revision Register	1.4
XFP Module ID	0x0
