Intermediate Release Notes

Omni Switch 9xxx, 6850, 6855 & 6400

Release 6.4.3.930.R01

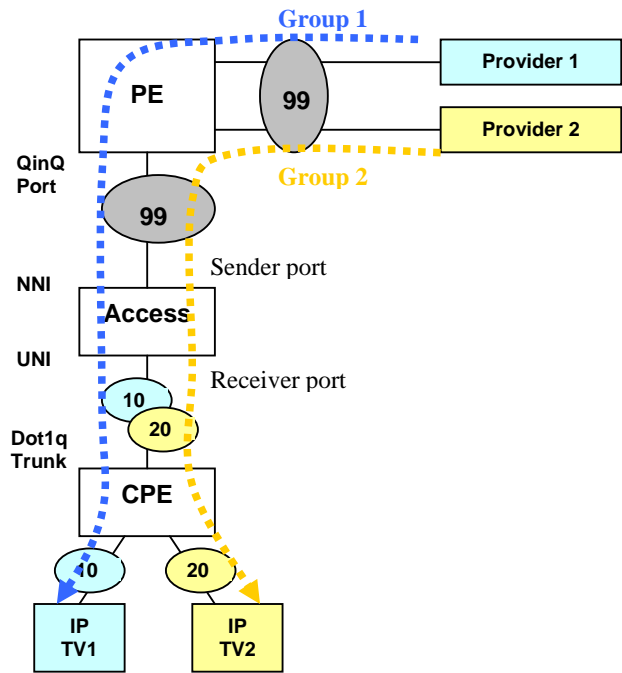
E-Service

The typical setup which the customer is going to have is as below.

Service Details

- Internet service is provided using QinQ.
- Multicast service is provided using dot1q.
