Upgrading OmniSwitch 9000 Series Switches to 6.3.1.R01

Overview

This instruction sheet documents how to upgrade OmniSwitch 9000 Series switches to 6.3.1.R01 software and firmware. The upgrade can be performed using the CLI, WebView, or SNMP. Alcatel recommends using WebView to perform the upgrade. For upgrade instructions using the CLI, see [Upgrading with the CLI on page 10](#).

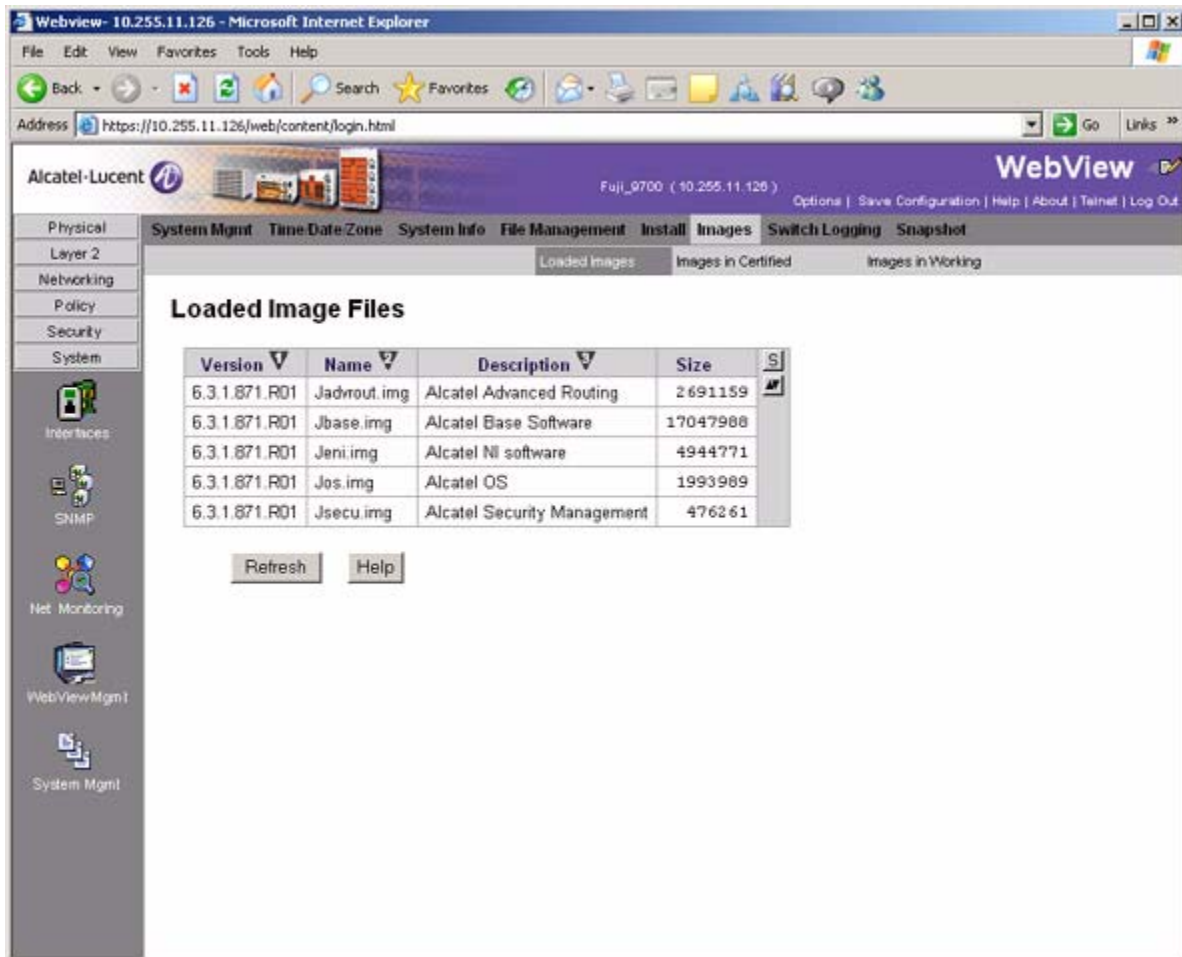
To verify that the software was successfully upgraded, go to the **Loaded Image Files** page by selecting **System > System Mgmt > Images > Loaded Images** as shown below.

Version	Name	Description	Size
6.3.1.871.R01	Jadvrout.img	Alcatel Advanced Routing	2691159
6.3.1.871.R01	Jbase.img	Alcatel Base Software	17047988
6.3.1.871.R01	Jeni.img	Alcatel NI software	4944771
6.3.1.871.R01	Jos.img	Alcatel OS	1993989
6.3.1.871.R01	Jsecu.img	Alcatel Security Management	476261

In addition, you should also select **System > System Mgmt > Images > Images in Certified** and **System > System Mgmt > Images > Images in Working** to verify that Certified and Working directories were successfully upgraded.

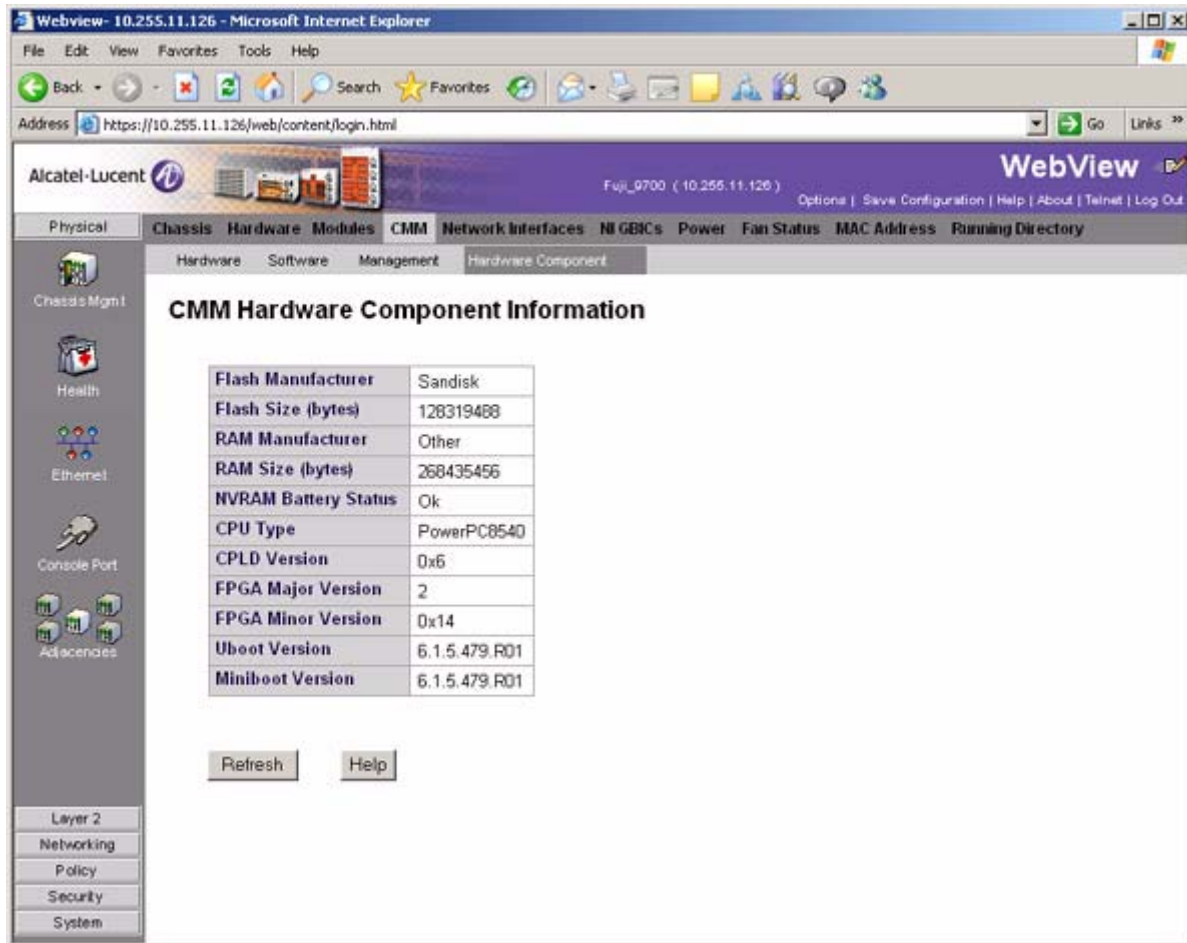
To verify that the U-Boot and Miniboot files were successfully upgraded on the CMM, go to the **CMM Hardware Component Information** page by selecting **Physical > Chassis Mgmt > CMM > Hardware Component**, as shown below.

The screenshot shows the Alcatel-Lucent WebView interface for a switch. The browser address bar shows `https://10.255.11.126/web/content/login.html`. The page title is "CMM Hardware Component Information". The table below lists the hardware details:

Flash Manufacturer	Sandisk
Flash Size (bytes)	128319488
RAM Manufacturer	Other
RAM Size (bytes)	268435456
NVRAM Battery Status	Ok
CPU Type	PowerPC8540
CPLD Version	0x6
FPGA Major Version	2
FPGA Minor Version	0x14
Uboot Version	6.1.5.479.R01
Miniboot Version	6.1.5.479.R01
