Intermediate Release Notes

Omni Switch 9xxx, 6850, 6855 & 6400

Release 6.4.3.930.R01

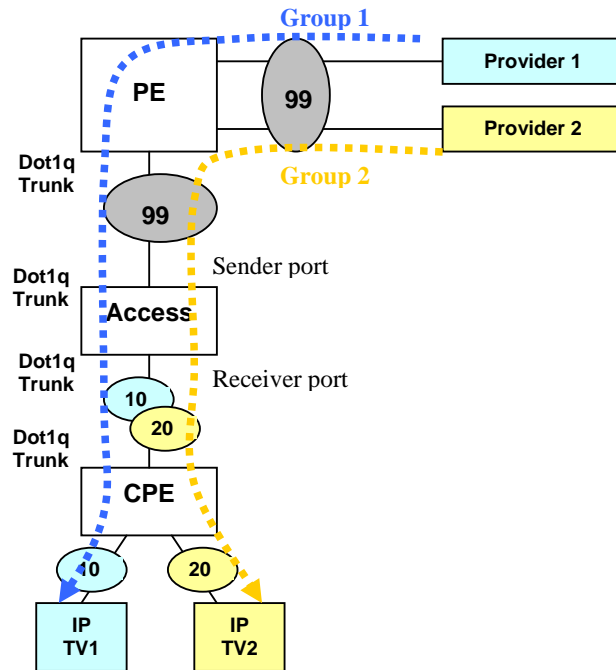
Enterprise

- Internet service is provided using dot1q.
- Multicast service is provided using dot1q.

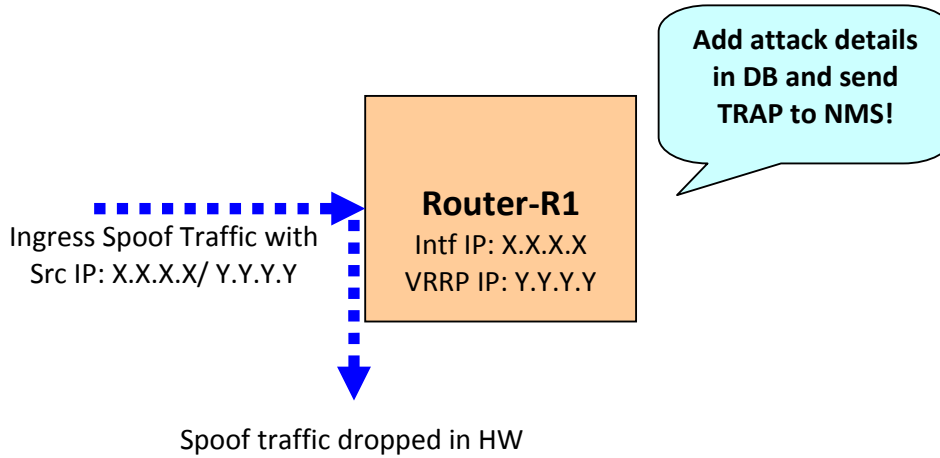
Use Case Diagram:

Sl. No.	Global Status	Per Interface IP Anti-Spoof Status	Per IP Interface Arp-Only Spoof Status	Per Virtual Router IP Anti-Spoof Status	Per Virtual Router IP Arp-Only Spoof Status
1.	Anti-Spoof Enabled	Enabled	Enabled	Enabled	Enabled
2	Anti-Spoof Disabled	Disabled	Disabled	Disabled	Disabled
3	Arp-Only Spoof Enabled	Disabled	Enabled	Disabled	Enabled
4.	Arp-only Spoof Disabled	Enabled	Enabled	Enabled	Enabled

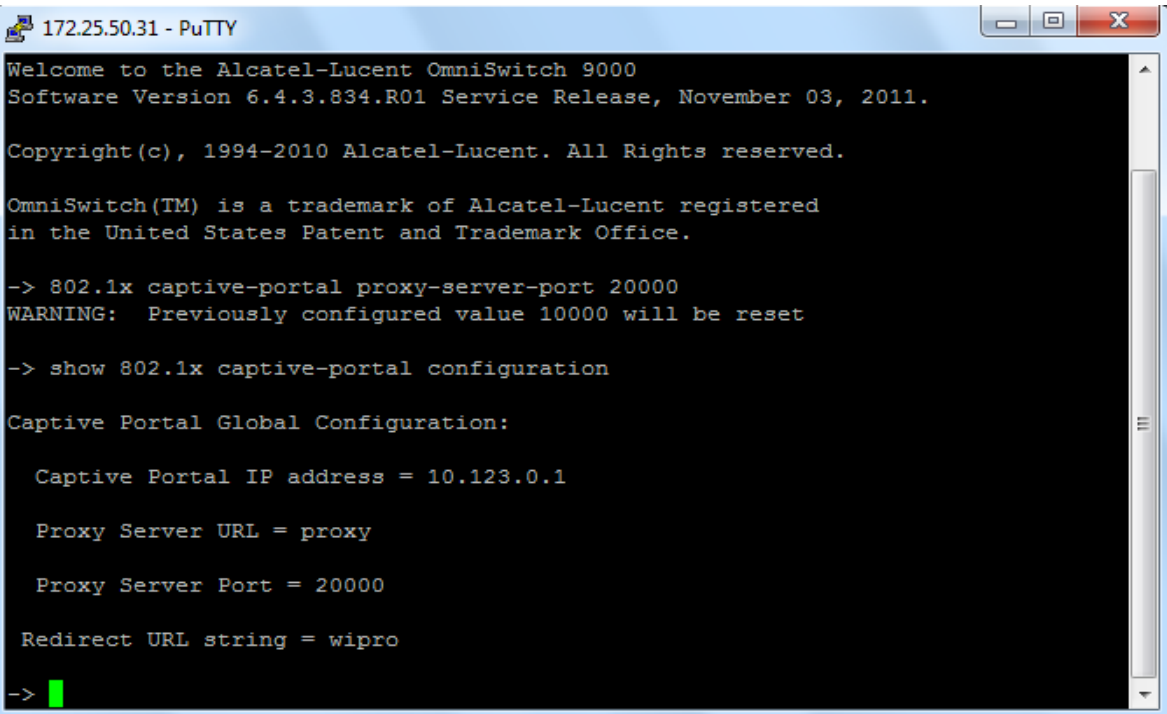
Show 802.1x captive-portal configuration

```
172.25.50.31 - PuTTY
Welcome to the Alcatel-Lucent OmniSwitch 9000
Software Version 6.4.3.834.R01 Service Release, November 03, 2011.
