Upgrading OmniSwitch 9000E Series Switches to 6.4.3.R01

Overview

This instruction sheet documents how to upgrade OmniSwitch 9000E Series Switches to 6.4.3.R01 software and firmware. The upgrade can be performed using the CLI or WebView. Alcatel-Lucent recommends using WebView to perform the upgrade. For upgrade instructions using the CLI, see [Upgrading with the CLI on page 12](#).

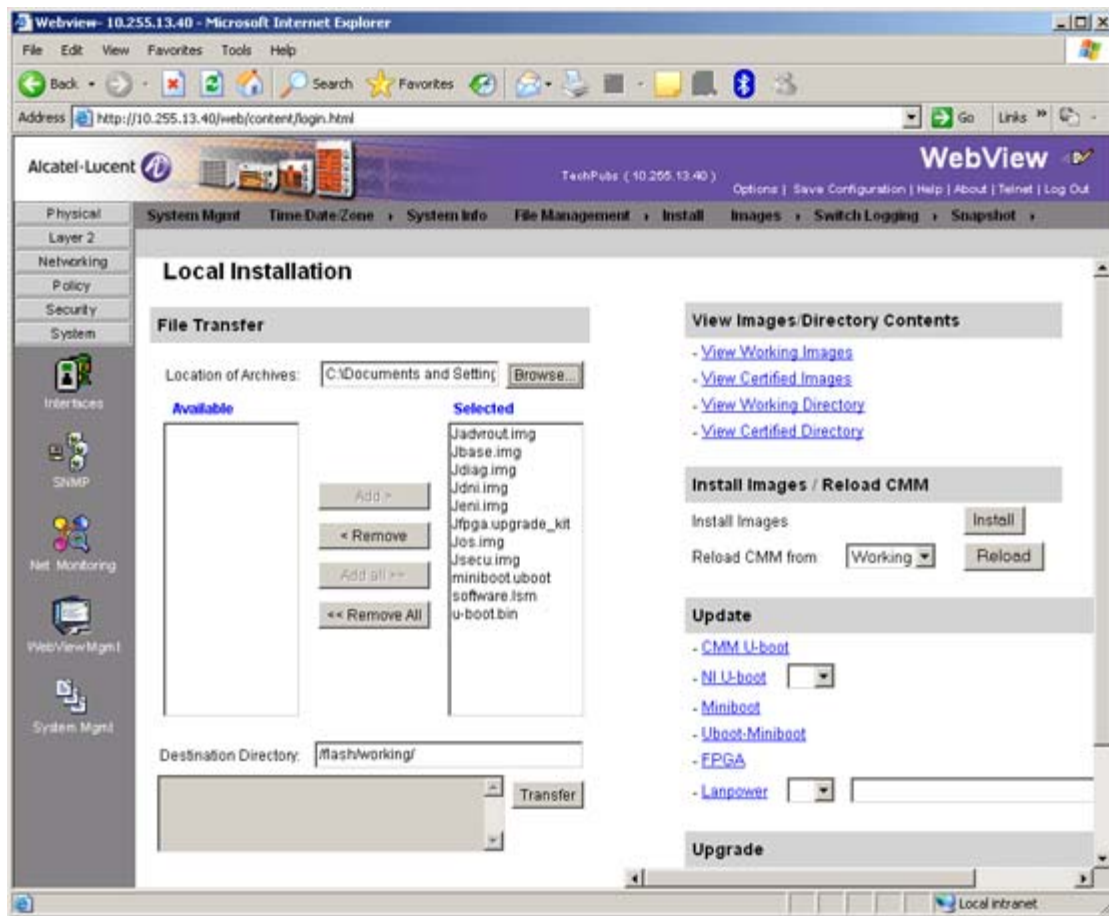
- 3 Select **System > System Mgmt > Install** to locate and FTP the 6.4.3.R01 image files that you downloaded in Step 1. Click on the **Browse** button to locate the files.
- 4 Select one of the files and click **Open**. All of the files will appear in the "Selected" area as shown below.

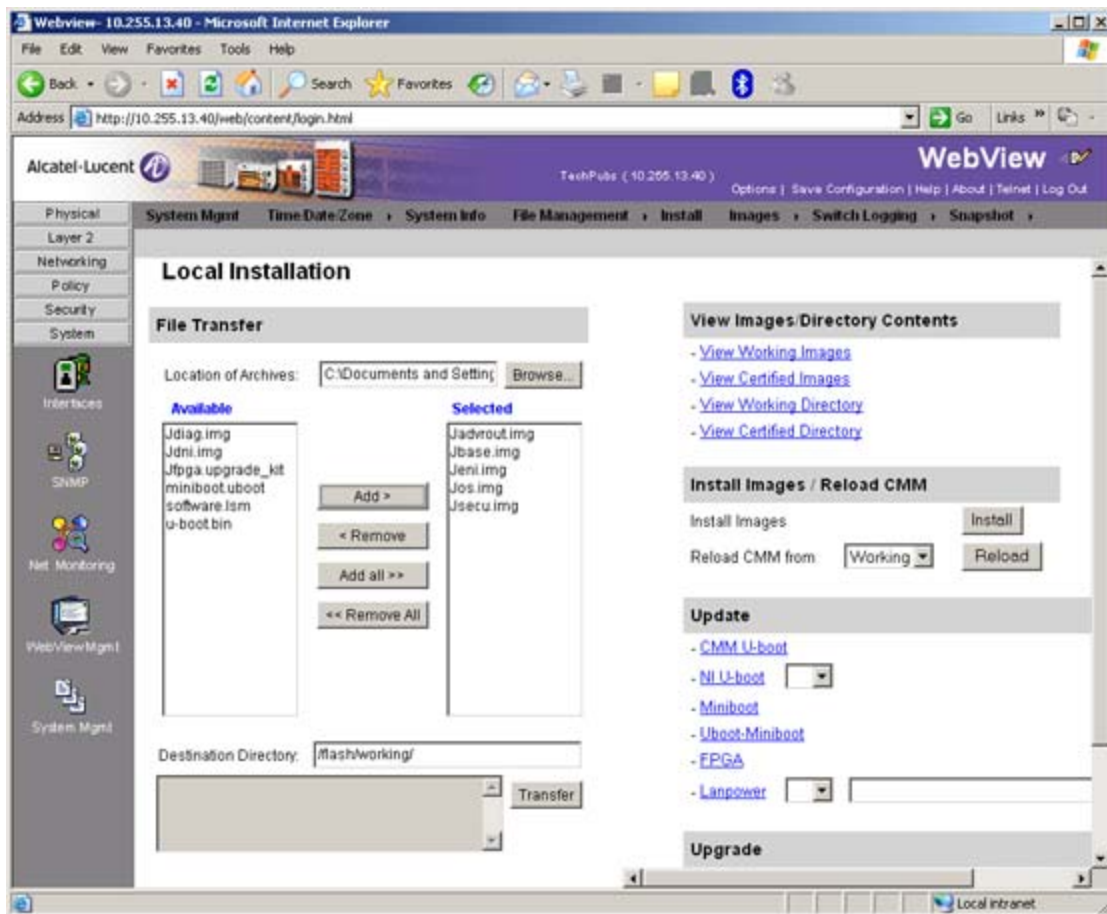
- 5 Click on the **Remove All** button to move all of the files to the “Available” area; then select the following image files and click the **Add** button to move them back to the “Selected” area as shown below: **Jadvrout.img**, **Jbase.img**, **Jeni.img**, **Jos.img**, **Jsecu.img**.

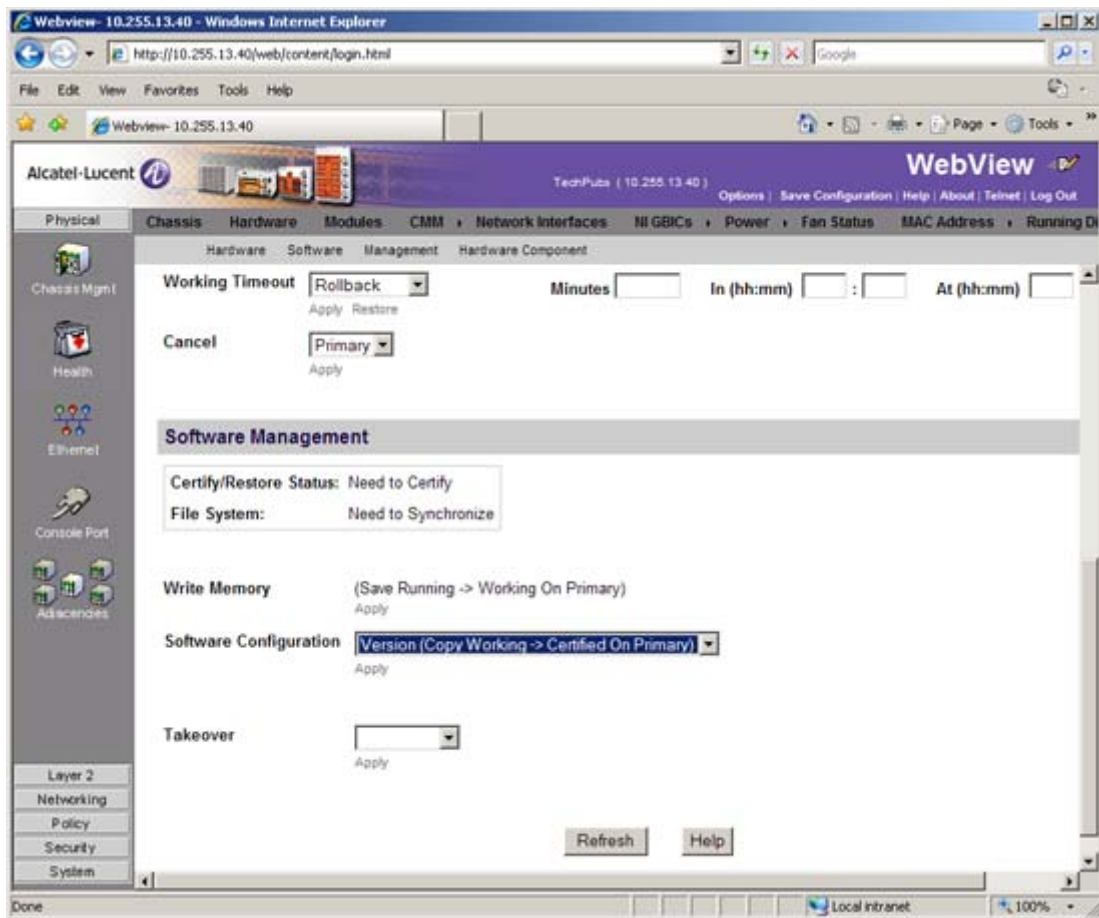
- 6 Transfer the files to the **flash/working** directory. Make sure the **Destination Directory** is **flash/working**, then click the **Transfer** button. Wait until the process is complete (indicated in the area next to the **Transfer** button - “All files have been transferred successfully”).
- 7 Reload the switch from the Working Directory. In the “Install Images/Reload CMM” area, select **Working** in the **Reload CMM From** field, then click the **Reload** button. Click **OK** at the warning prompt. Wait until the process is complete.
- 8 After the CMM finishes rebooting, log into WebView.
- 9 Copy the files to the Certified Directory and sync the Primary and Secondary CMMs (if applicable). Select **Physical > Chassis Mgmt > CMM > Management** as shown below.

- 10** In the **Software Configuration** field, select **Copy Working -> Certified on Primary** for switches with a single CMM, or **Copy Working -> Certified & Synchronize with Secondary** for switches with a secondary CMM, then click **Apply**.

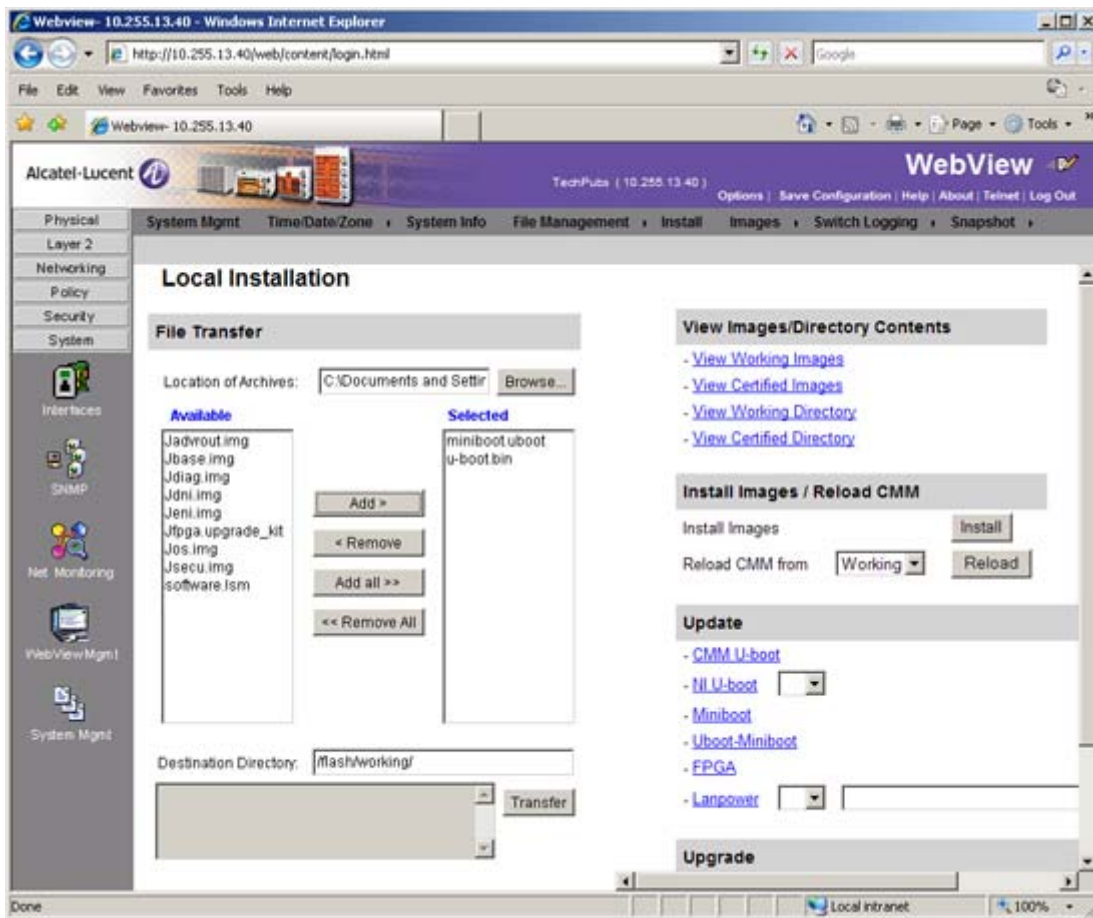
- 6 Transfer the files to the **/flash** Directory. Make sure the **Destination Directory** is **/flash**, then click the **Transfer** button. Wait until the process is complete (indicated in the area next to the **Transfer** button - "All files have been transferred successfully").

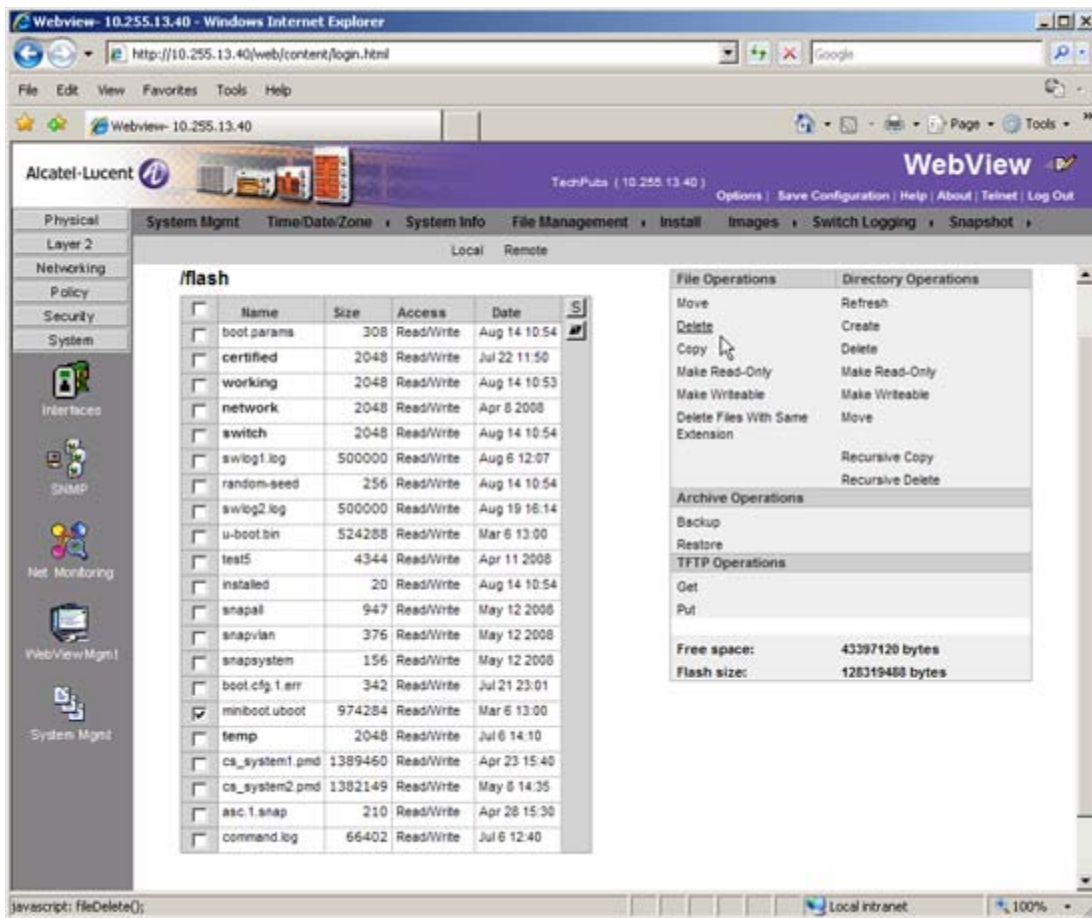
- 9 After verifying that the upgrade was successful (see [Verifying the Upgrade with WebView on page 8](#)), delete the **miniboot.uboot** and **uboot.bin** files from the Flash Directory by selecting **System > System Mgmt > File Management > Local**, as shown below.

- 10 Check the box next to the **miniboot.uboot** file, select **Delete** in the **File Operations** box, then click **OK** at the confirmation prompt. Repeat to delete the **u-boot.bin** file.

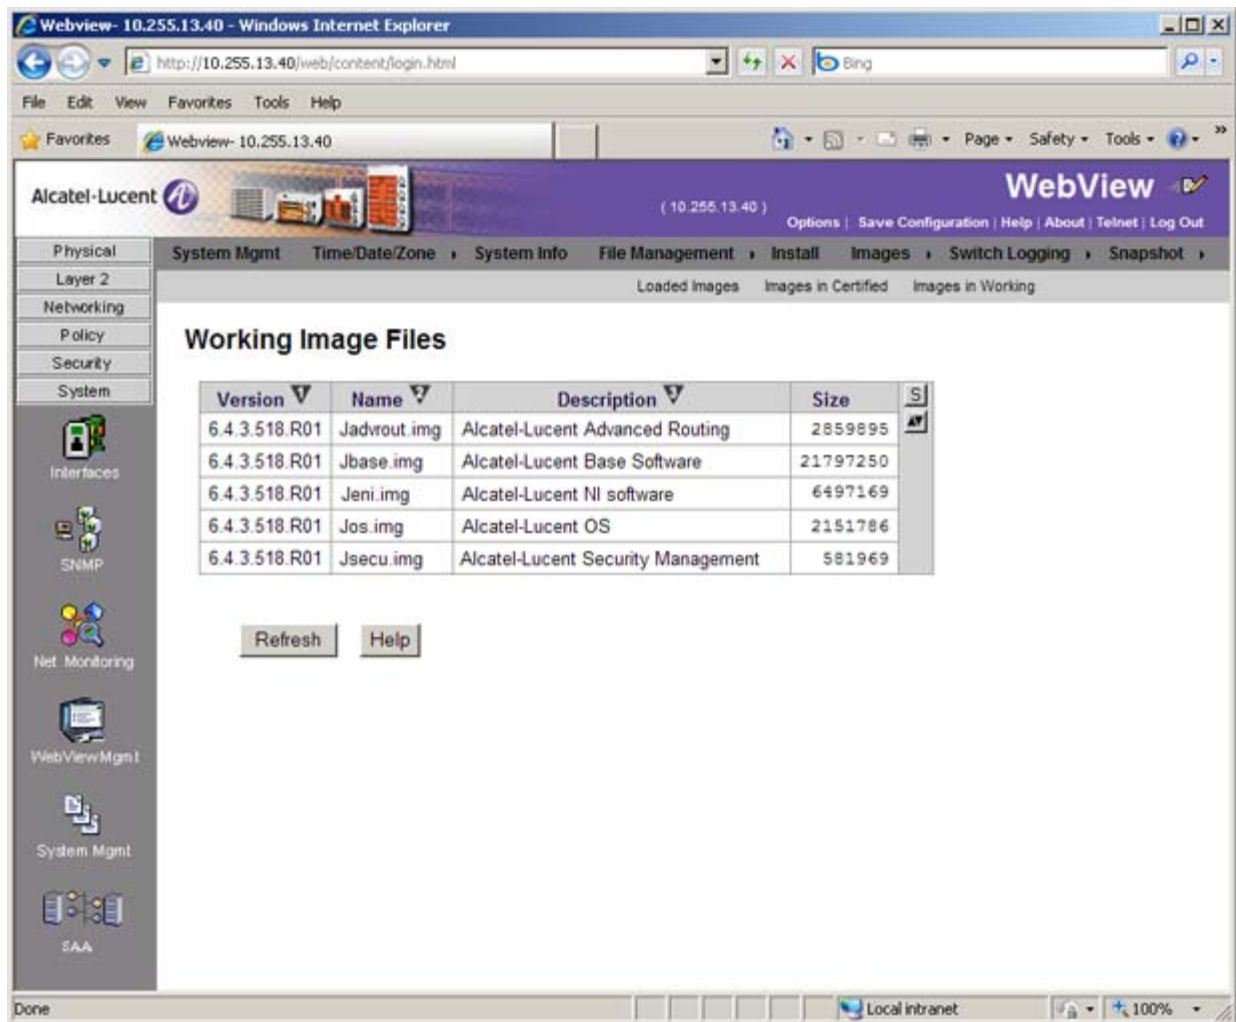
To verify that the software was successfully upgraded, go to the **Loaded Image Files** page by selecting **System > System Mgmt > Images > Loaded Images** as shown below.

In addition, you should also select **System > System Mgmt > Images > Images in Certified** and **System > System Mgmt > Images > Images in Working** to verify that Certified and Working directories were successfully upgraded.

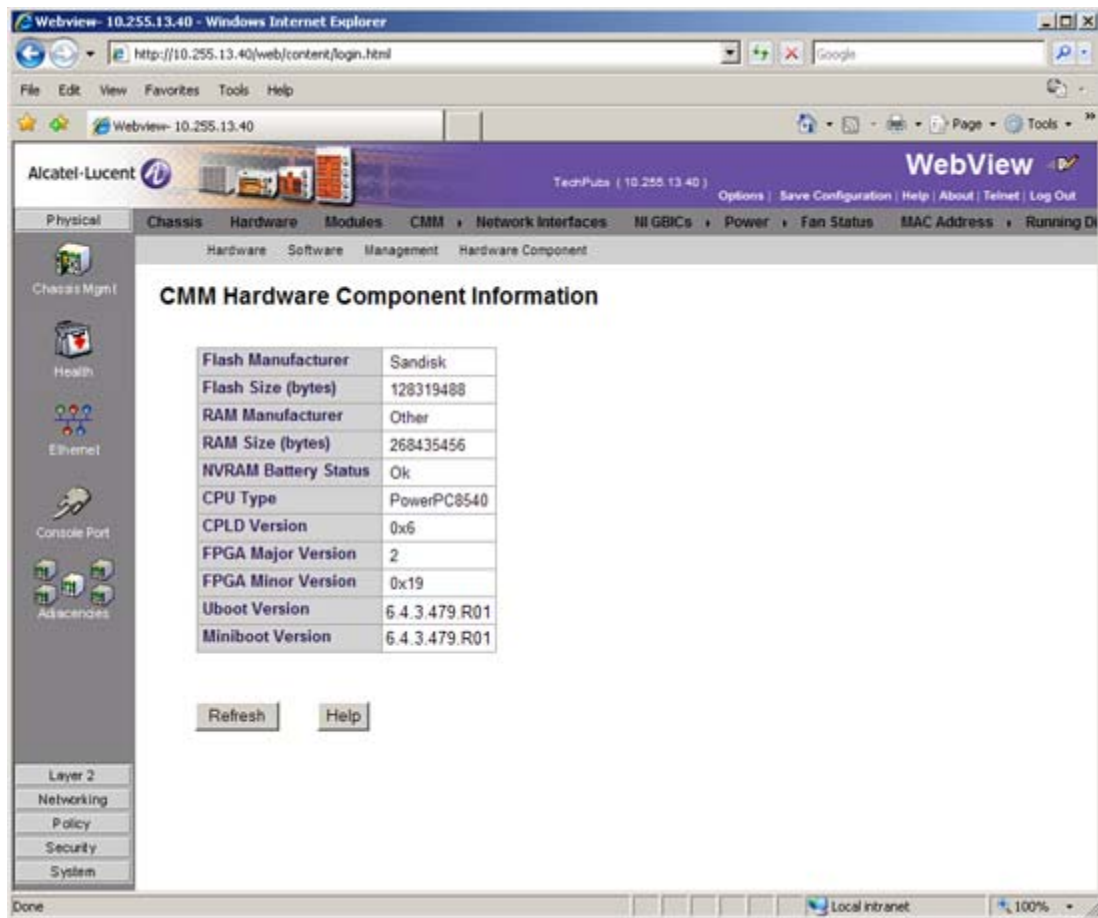
To verify that the U-Boot and Miniboot files were successfully upgraded on the CMM, go to the **CMM Hardware Component Information** page by selecting **Physical > Chassis Mgmt > CMM > Hardware Component**, as shown below.

The screenshot displays the Alcatel-Lucent WebView management interface for a switch. The browser window title is "WebView- 10.255.13.40 - Windows Internet Explorer" and the address bar shows "http://10.255.13.40/web/content/login.html". The interface includes a navigation menu on the left with options like "Physical", "Chassis Mgmt", "Health", "Ethernet", "Console Port", and "Adjacencies". The main content area is titled "CMM Hardware Component Information" and contains a table with the following data:

Flash Manufacturer	Sandisk
Flash Size (bytes)	128319488
RAM Manufacturer	Other
RAM Size (bytes)	268435456
NVRAM Battery Status	Ok
CPU Type	PowerPC8540
CPLD Version	0x6
FPGA Major Version	2
FPGA Minor Version	0x19
Uboot Version	6.4.3.479.R01
Miniboot Version	6.4.3.479.R01

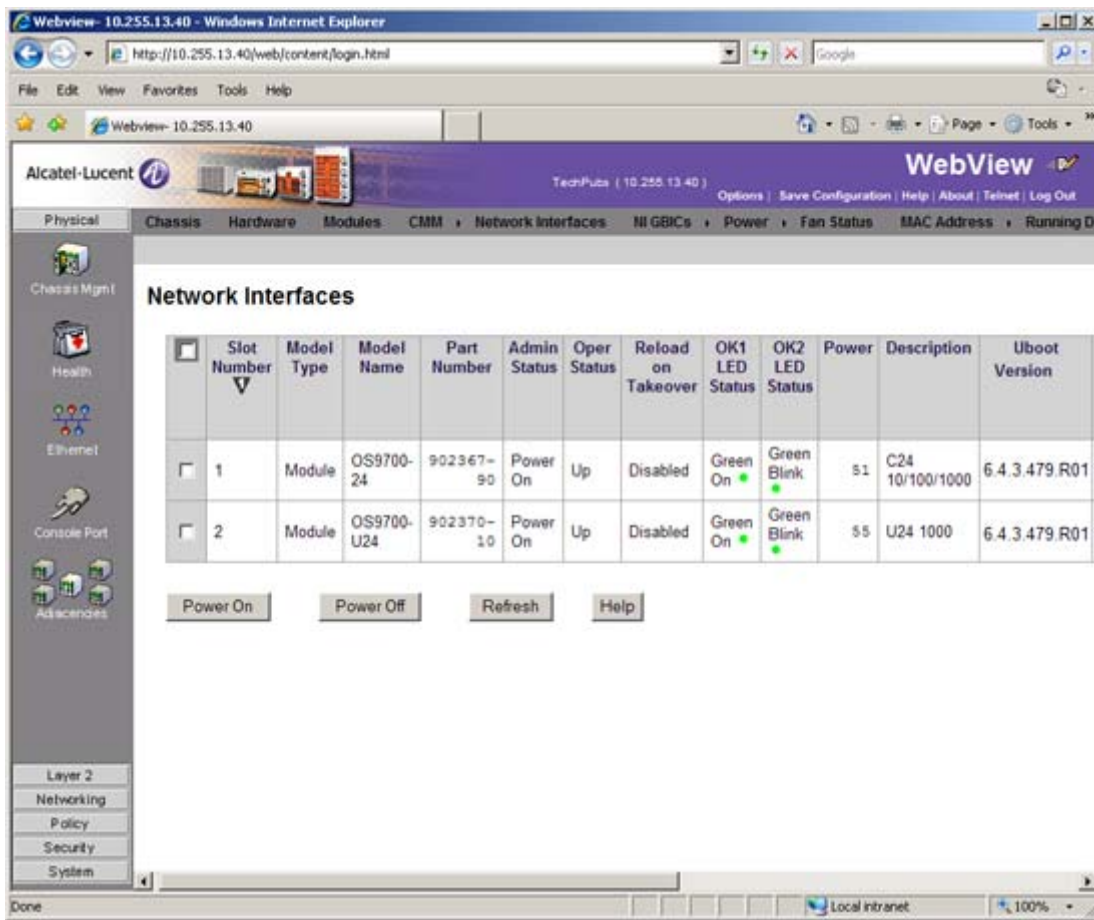
To verify that the U-Boot file was successfully upgraded on the switch's NIs, go to the **Network Interfaces** page by selecting **Physical > Chassis Mgmt > Network Interfaces**, as shown below.
