Ruckus FastIron Software Upgrade Guide, 08.0.80

Supporting FastIron Software Release 08.0.80

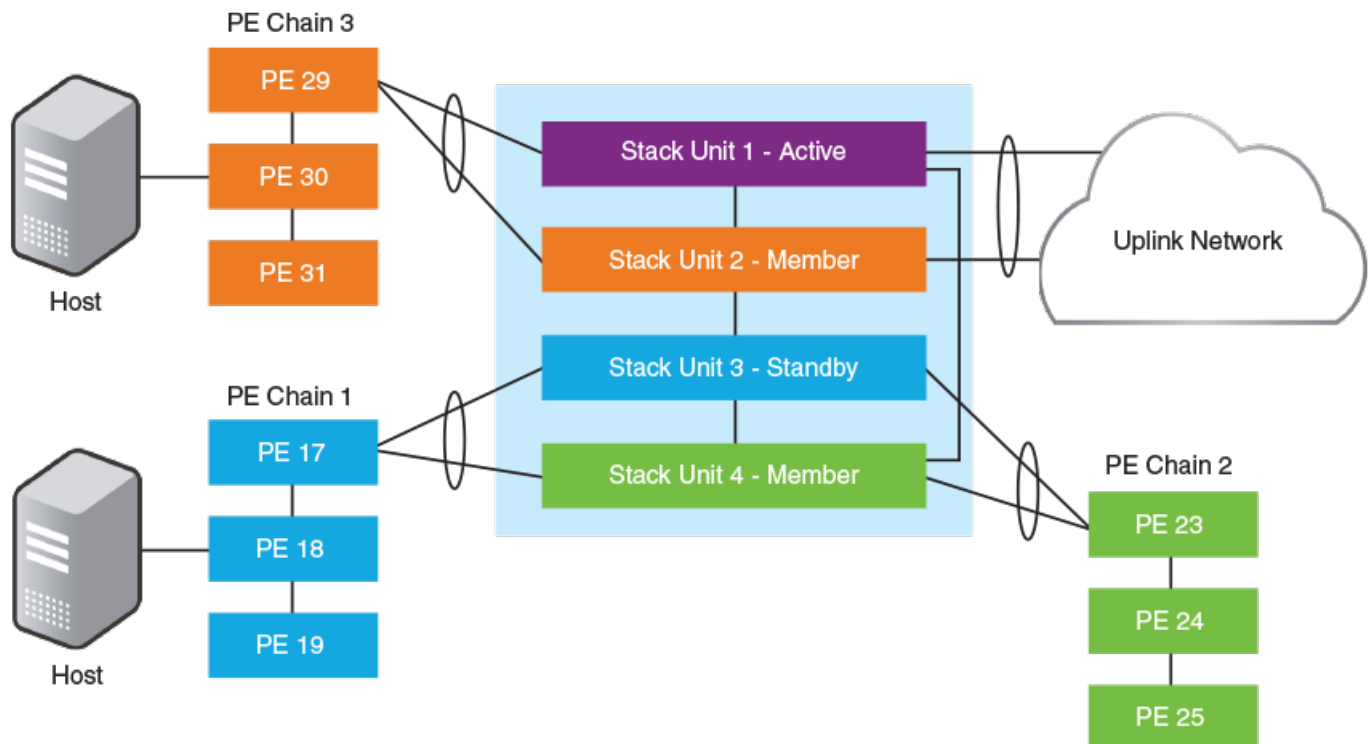
FIGURE 2 Recommended topology for SPX ISSU

In the figure, redundant links connect different CB units in the SPX system to the uplink network. As each node is upgraded, it undergoes a hardware reset, which resets the packet processor and disrupts traffic flowing through the node. The redundant links allow traffic to flow through other units, minimizing the impact of each unit upgrade.

The following figure illustrates a typical topology where ISSU can be used effectively to upgrade an SPX system.
