# Ruckus FastIron Software Upgrade Guide, 08.0.92

Supporting FastIron Software Release 08.0.92

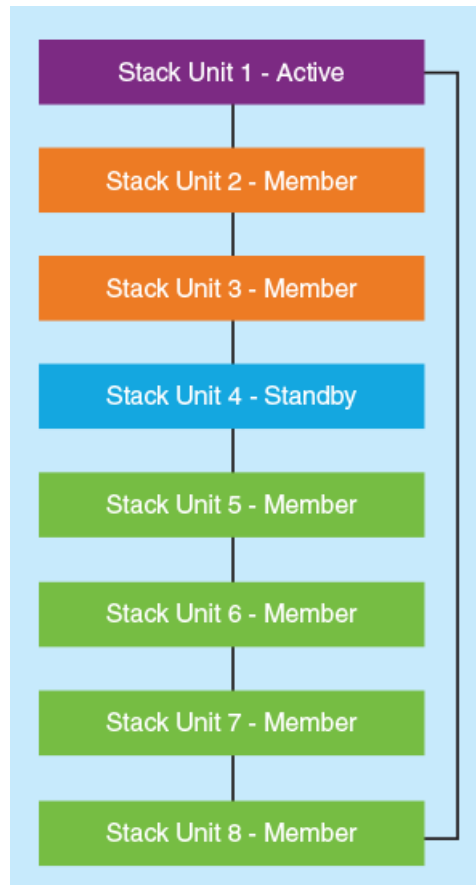
**FIGURE 3** Stack Units To Be Upgraded

The following section describes the checks and the upgrade sequence for the typical 8-unit stack shown in the [Figure 3](#). For a step-by-step procedure on performing an ISSU, refer to [Upgrading a Stack with ISSU](#) on page 43.

After you have downloaded release software as described in [Initial Steps](#) on page 11 and [The Upgrade Process](#) on page 13, you can check the sequence in which stack units will be upgraded using the **show issu sequence** command. The following example displays the ISSU upgrade sequence for the stack shown in [Figure 3](#).

```
device# show issu sequence
Stack units will be upgraded in the following order
ID Type Role
4 ICX7450-32ZP standby
3 ICX7450-32ZP member
2 ICX7450-32ZP member
5 ICX7450-32ZP member
6 ICX7450-32ZP member
7 ICX7450-32ZP member
8 ICX7450-32ZP member
1 ICX7450-32ZP active
```

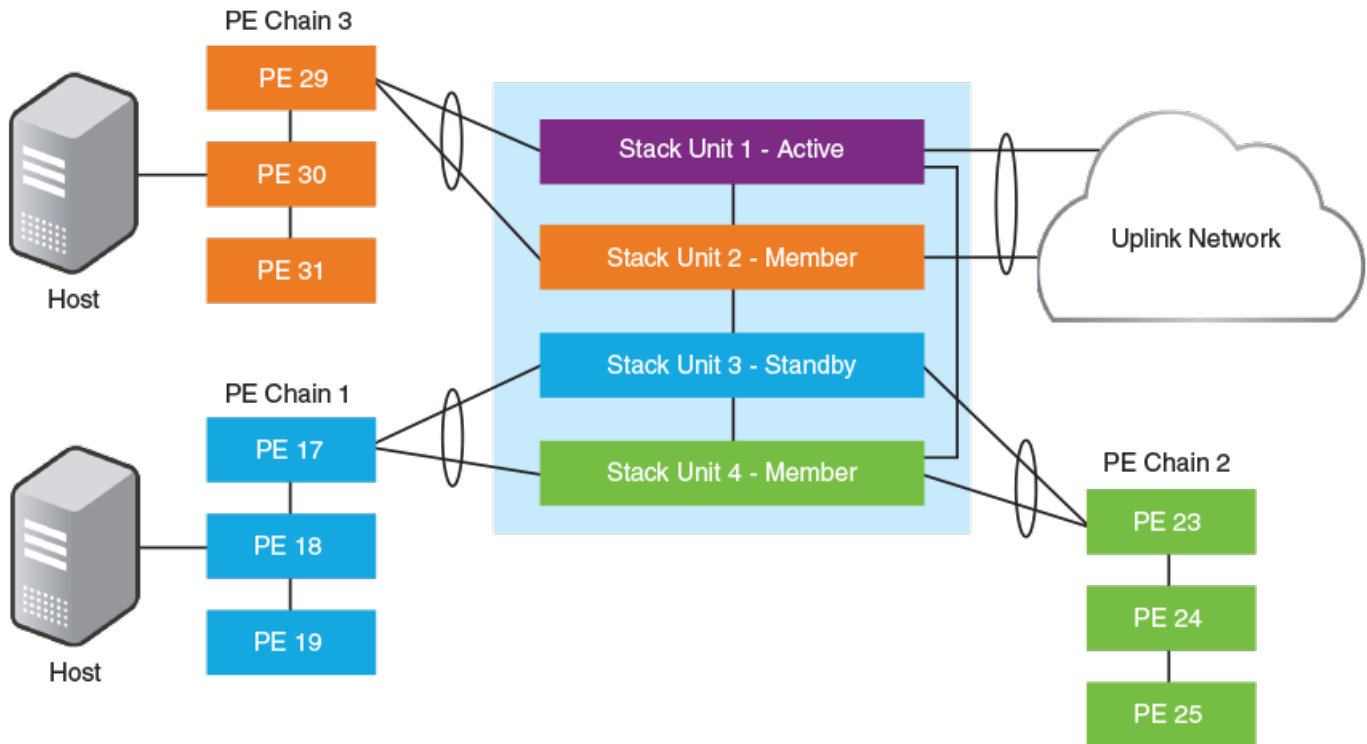
**FIGURE 4** Recommended Topology for SPX ISSU

The following figure illustrates a typical topology where ISSU can be used effectively to upgrade an SPX system.

In the figure, redundant links connect different CB units in the SPX system to the uplink network. As each node is upgraded, it undergoes a hardware reset, which resets the packet processor and disrupts traffic flowing through the node. The redundant links allow traffic to flow through other units, minimizing the impact of each unit upgrade.

Because traditional LAGs are not supported on Port Extender (PE) units in an SPX system, dual connectivity (through two different PE units) is recommended for every PE chain or ring.

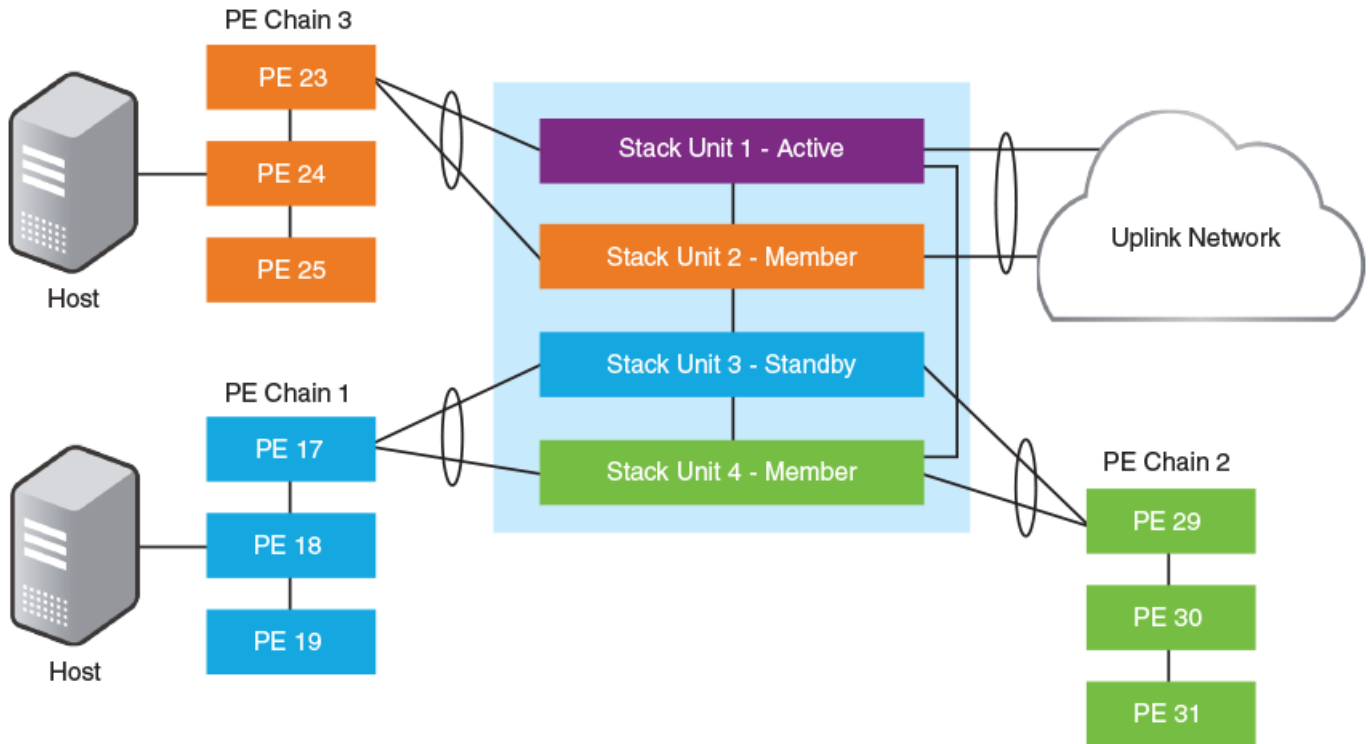
FIGURE 5 Typical SPX Topology

The following section describes the checks and the upgrade sequence for an SPX system in the typical topology shown below. For a step-by-step procedure on performing an ISSU, refer to [Upgrading a Campus Fabric \(SPX\) System with ISSU](#) on page 51.

The following example displays **show issu sequence** command output for the Campus Fabric (SPX) topology shown above and indicates the sequence in which CB units and their associated PE units will be upgraded. PE units are upgraded along with their associated CB units. This association of PE units to CB units is computed automatically.
