# RUCKUS FastIron Software Upgrade Guide, 09.0.00

**Supporting FastIron Software Release 09.0.00**

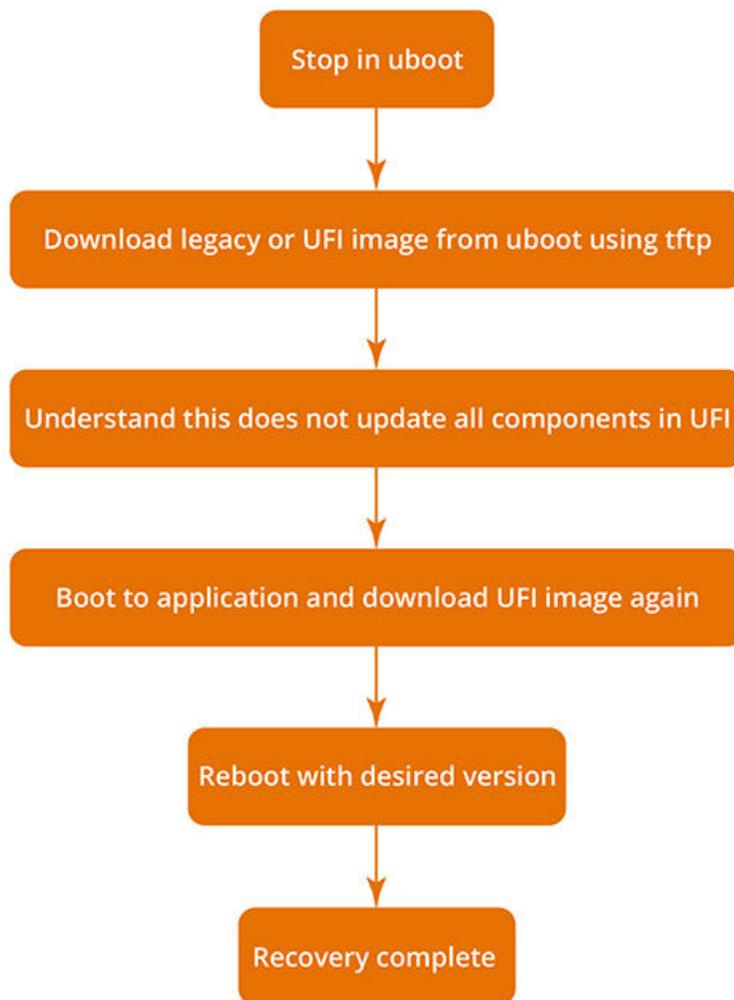
Follow the below steps, when the application fails to boot from both the primary/secondary partitions.

1. Stop at uboot prompt using the console.
2. From uboot prompt, update the UFI for ICX 7850, or legacy image for all other ICX 7K platforms.
  - This step updates the uboot and application only.
  - Other UFI components cannot be updated from the uboot.
3. Boot to FastIron application image and download UFI again.
4. Reboot with the desired version.

**FIGURE 1** Recovery procedure

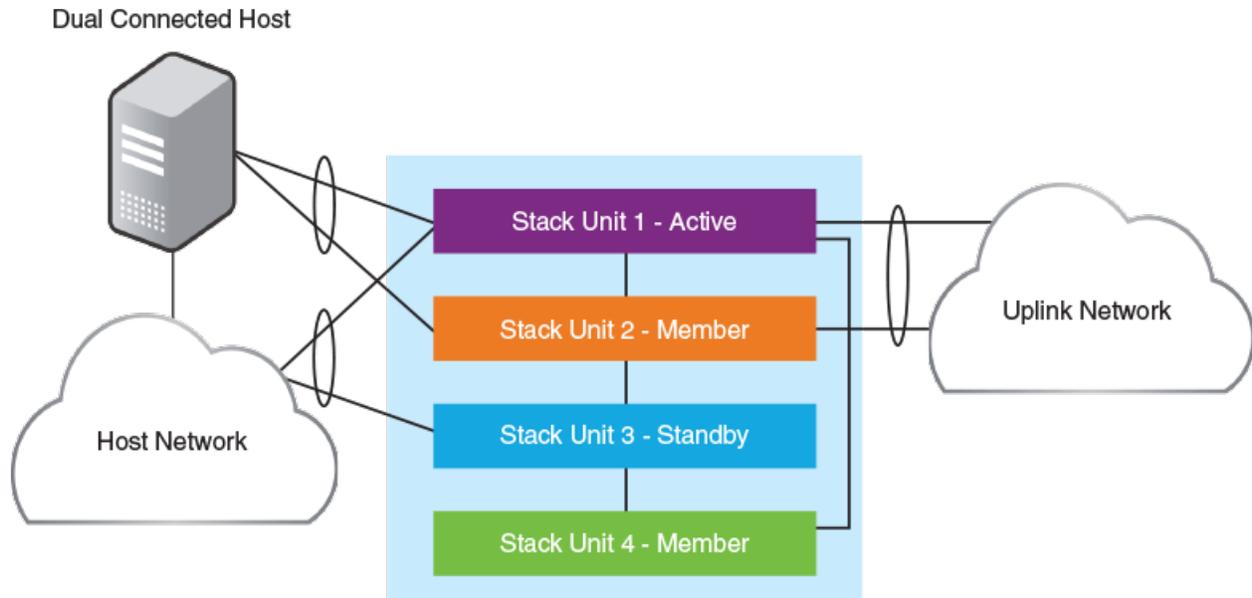
**FIGURE 2** Recommended Stack Topology for ISSU

In the figure, redundant links are going to both the uplink network and the downlink network from different units of the stack. At any point during the upgrade, the uplink and downlink connectivity is maintained. The following software features are used to provide link redundancy:

- Link aggregation (or dual connectivity to two different PEs in a chain or ring to provide PE redundancy)
- VRRP and VRRP-E
- Graceful restart for IP routing features

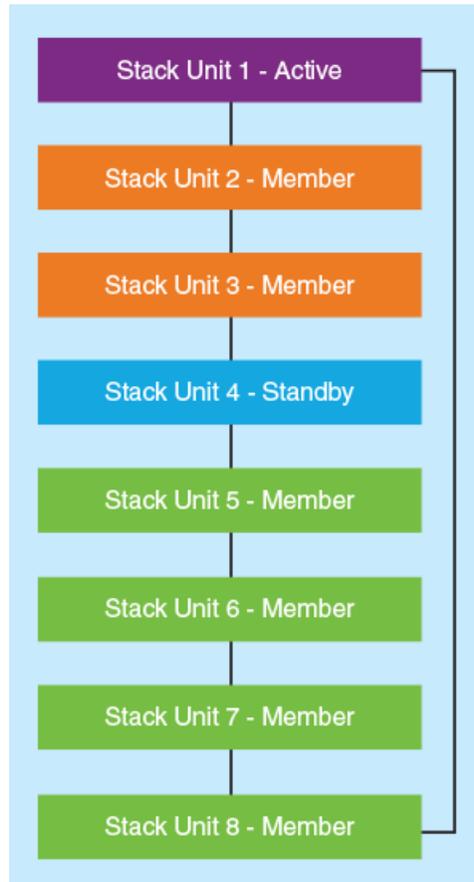
The following section describes the checks and the upgrade sequence for the typical 8-unit stack shown in the [Figure 3](#). For a step-by-step procedure on performing an ISSU, refer to [Upgrading a Stack with ISSU](#) on page 52.

FIGURE 3 Stack Units To Be Upgraded

After you have downloaded release software as described in [Initial Steps](#) on page 12 and [Upgrade Process](#) on page 24, you can check the sequence in which stack units will be upgraded using the `show issu sequence` command. The following example displays the ISSU upgrade sequence for the stack shown in [Figure 3](#).

```
device# show issu sequence
Stack units will be upgraded in the following order
ID Type Role
4 ICX7450-32ZP standby
3 ICX7450-32ZP member
2 ICX7450-32ZP member
5 ICX7450-32ZP member
6 ICX7450-32ZP member
7 ICX7450-32ZP member
8 ICX7450-32ZP member
1 ICX7450-32ZP active
```
