# RUCKUS FastIron Software Upgrade Guide, 09.0.10

**Supporting FastIron Software Release 09.0.10**

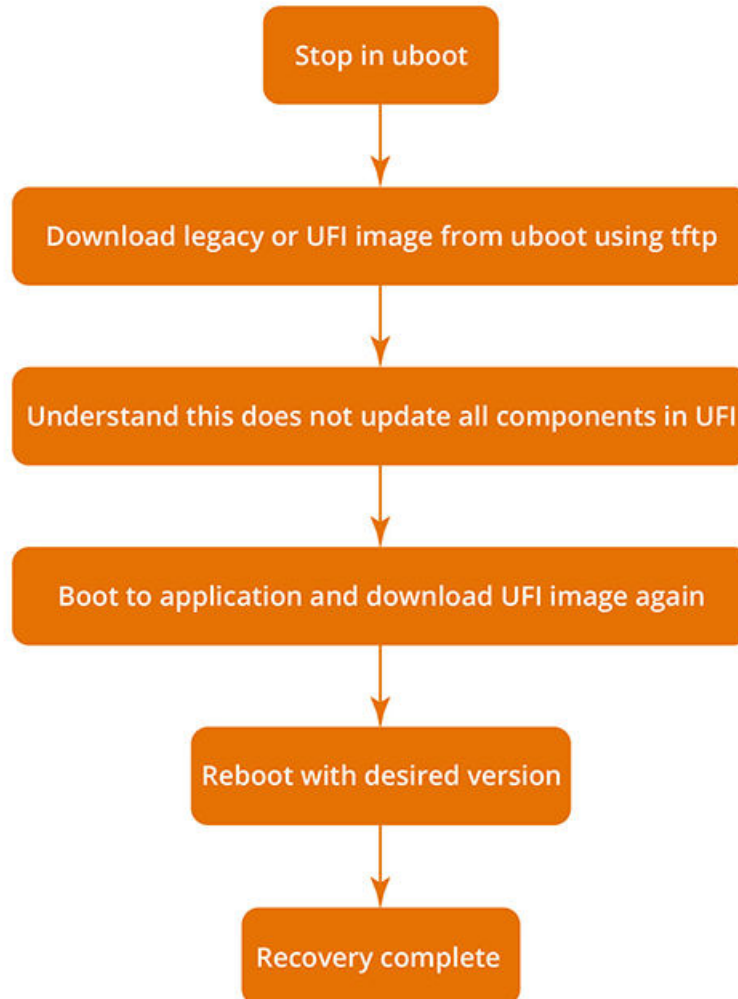
FIGURE 1 Recovery procedure

This section explains how to recover devices from image installation failure or deleted or corrupted flash images.

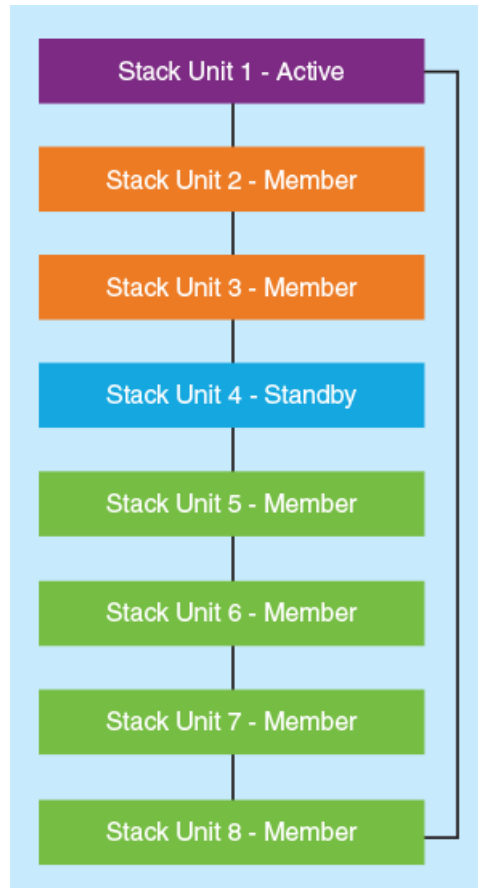
FIGURE 3 Stack Units To Be Upgraded

The following section describes the checks and the upgrade sequence for the typical 8-unit stack shown in the [Figure 3](#). For a step-by-step procedure on performing an ISSU, refer to [Upgrading a Stack with ISSU](#) on page 48.

After you have downloaded release software as described in [Initial Steps](#) on page 13 and [Upgrade Process](#) on page 27, you can check the sequence in which stack units will be upgraded using the `show issu sequence` command. The following example displays the ISSU upgrade sequence for the stack shown in [Figure 3](#).

```
device# show issu sequence
Stack units will be upgraded in the following order
ID Type Role
4 ICX7450-32ZP standby
3 ICX7450-32ZP member
2 ICX7450-32ZP member
5 ICX7450-32ZP member
6 ICX7450-32ZP member
7 ICX7450-32ZP member
8 ICX7450-32ZP member
1 ICX7450-32ZP active
```
