SmartZone 3.4.2

Release Notes

Part Number: 800-71479-001 Rev A
Published: 28 March 2017

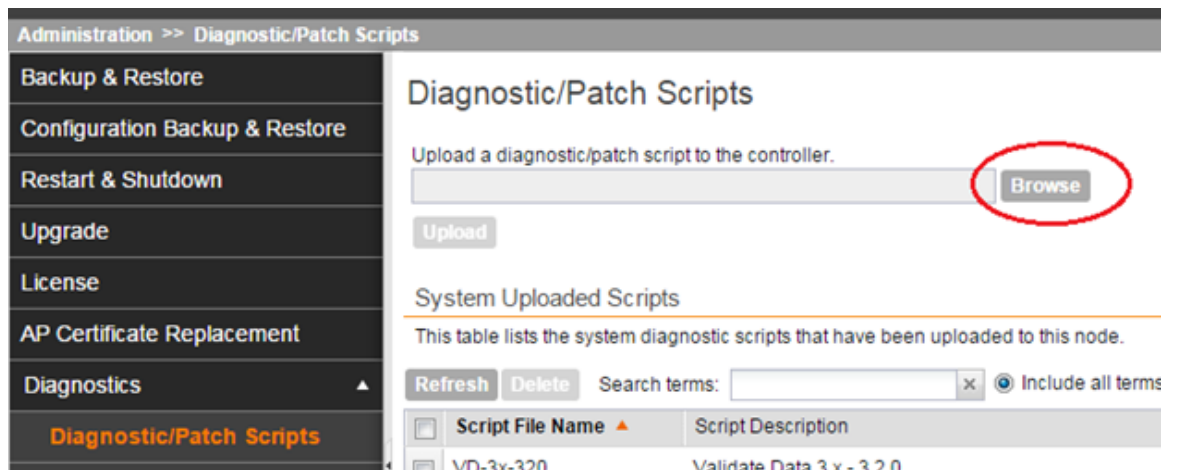
1. Download the KSP file from the Support website to your computer. The file name is `extendPrecheckTimeout_0.ksp`.
2. Log on to the controller, and then go to **Administration > Diagnostics > Diagnostic/Patch Scripts**.
3. Click **Browse**, and select the KSP file that you downloaded.

The screenshot shows the 'Administration >> Diagnostic/Patch Scripts' page. On the left is a navigation menu with 'Diagnostic/Patch Scripts' selected. The main area is titled 'Diagnostic/Patch Scripts' and contains an upload form with a 'Browse' button circled in red. Below the form is a table of 'System Uploaded Scripts' with one entry: 'VD-3x-320' with description 'Validate Data 3 x - 3 2 0'.

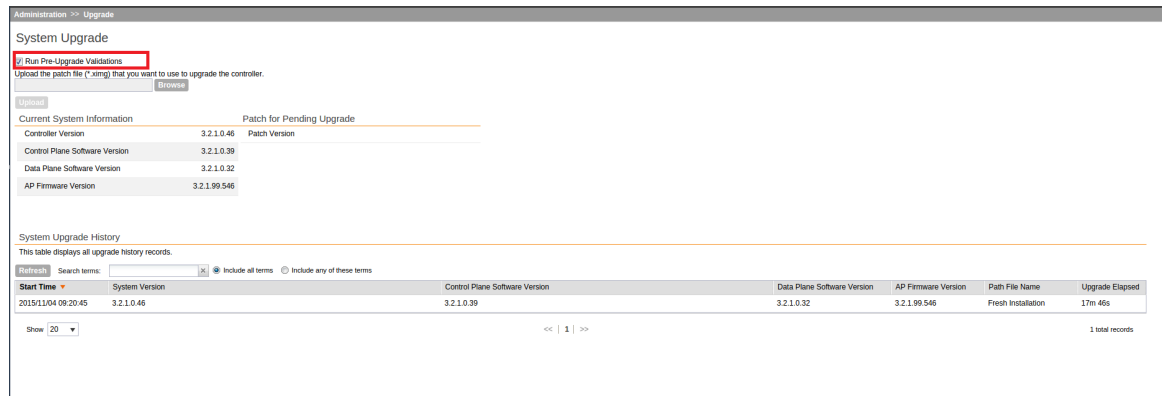
The screenshot shows the 'System Upgrade' section of a web interface. At the top, there is a 'Run Pre-Upgrade Validations' button highlighted with a red box. Below it, there is a 'Upload' button and a 'Patch for Pending Upgrade' section. The 'Current System Information' table shows the following details:

Control Plane Software Version	Patch Version
3.2.1.0.39	
3.2.1.0.32	
3.2.1.99.546
