Ruckus SmartZone Release Notes

Supporting SmartZone 5.0

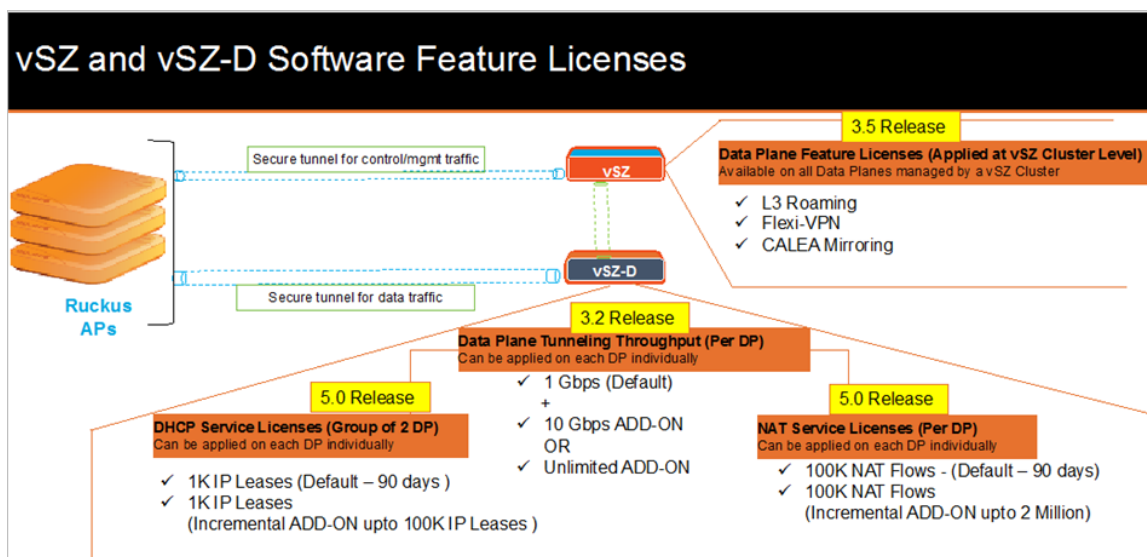
The illustration below provides details about the license tiers. Do also refer to the vSZ-D datasheet for the associated SKUs.

FIGURE 1 vSZ and vSZ-D software license tiers
