Ruckus SmartZone 5.1.1 Release Notes

Supporting SmartZone 5.1.1

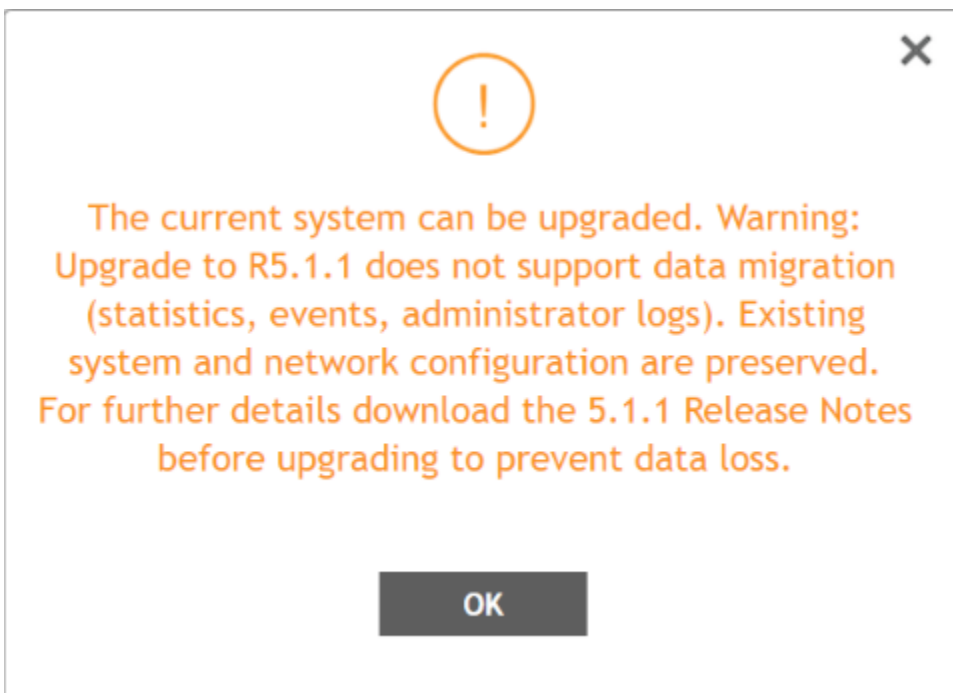
- The upgrade path is changed and is now limited to N-2 support. Only 3.6.0 or 3.6.1 or 3.6.2 or 5.0 or 5.1 releases can be upgraded to 5.1.1 release.
- When upgrading to the release 5.1.1 image from release 3.6.0 or 3.6.1 or 3.6.2, the system displays the following warning message about not supporting data migration (statistics, events, administrator logs) during the upgrade process.

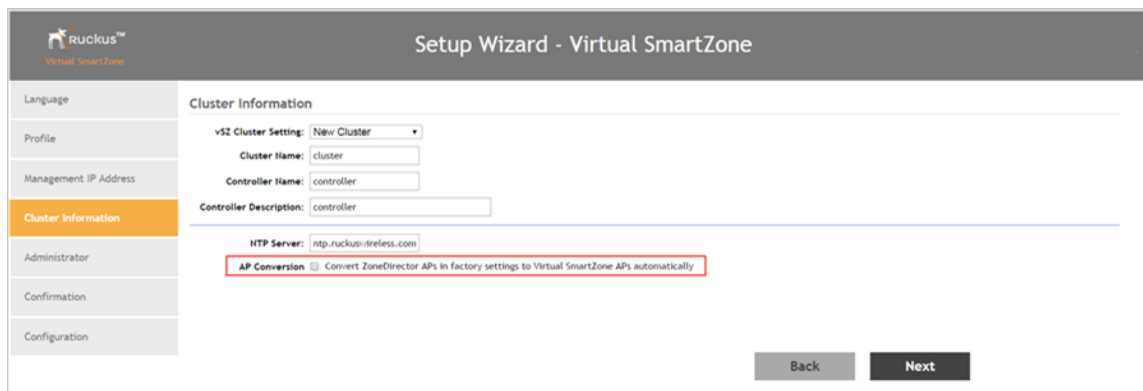
FIGURE 1 Select the AP Conversion check box to convert standalone ZoneFlex APs to controller APs

The figure below shows the AP Conversion check box for the vSZ Setup Wizard. If you are setting up SZ300, or SZ100 the check box description may be slightly different.

The screenshot shows the 'Setup Wizard - Virtual SmartZone' interface. On the left is a navigation menu with 'Cluster Information' selected. The main area is titled 'Cluster Information' and contains the following fields:

- vSZ Cluster Setting: New Cluster (dropdown)
- Cluster Name: cluster (text input)
- Controller Name: controller (text input)
- Controller Description: controller (text input)
- HTP Server: ntp.ruckuswireless.com (text input)
