Ruckus SmartZone 5.1.2 Release Notes

Supporting SmartZone 5.1.2

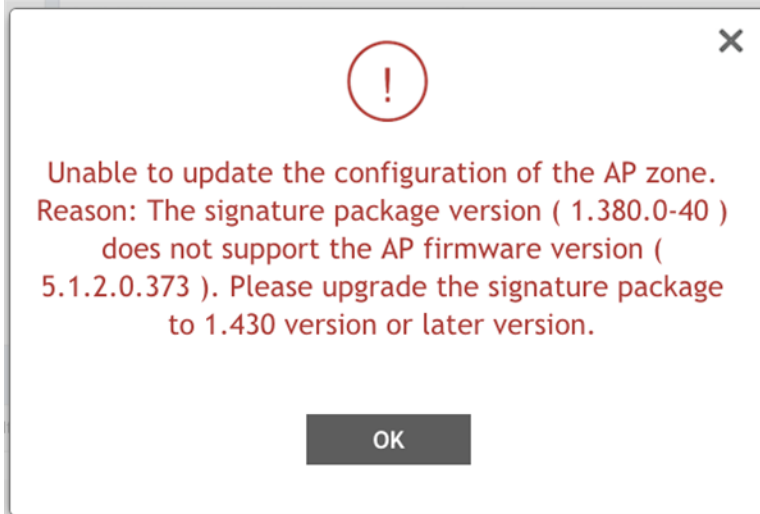
AP DPI feature uses an Application Signature Package that in general it can be optionally updated when a new version is available. But in this case, previous packages are not compatible with 5.1.2 AP firmware, and upgrading zone firmware is blocked until the corresponding signature package (**RuckusSigPack-v2-1.430.1.tar.gz**) is installed.
