RUCKUS IoT 2.1.0.0 GA Release Notes

Supporting IoT Controller Release 2.1.0.0

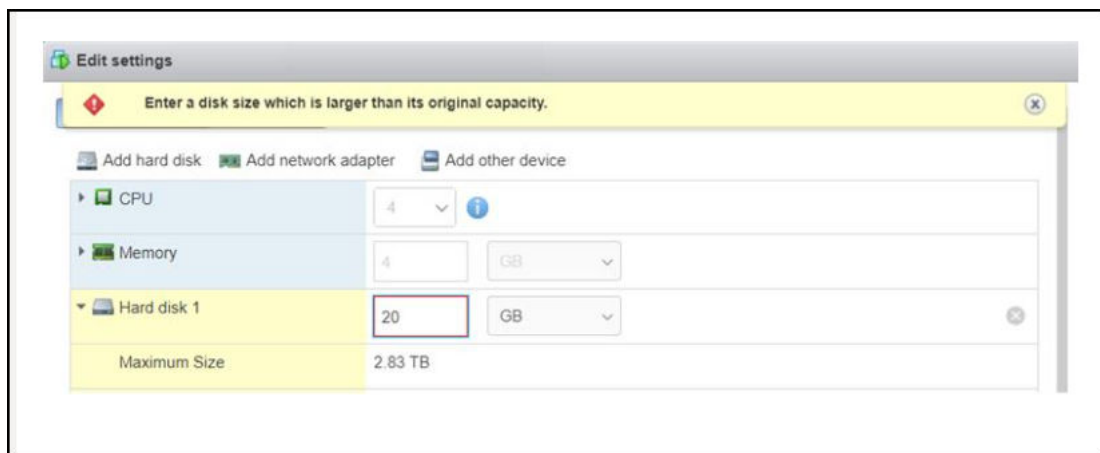
You receive the following error while decreasing the HDD size on the VMware.

FIGURE 1 Error Message when HDD size is Reduced

The HDD shrinking for a VM requires expertise an editing *.vmdk. To shrink the disk size, you can refer to https://www.vmware.com/support/ws5/doc/ws_disk_shrink.html or <https://kb.vmware.com/s/article/1002019>. An alternative mechanism is to take config backup of existing vRIOT instance, install a fresh instance of vRIOT of the same version as the config backup, and allocate the recommended HDD/CPU/memory resources. After the new instance is up, you can shutdown the existing instance to avoid any conflicts. You can then upload the configuration backup to it and upgrade the vRIOT to the desired version firmware.
