# SmartZone 3.4.1

## Release Notes

Part Number: 800-71382-001  
Published: 17 October 2016

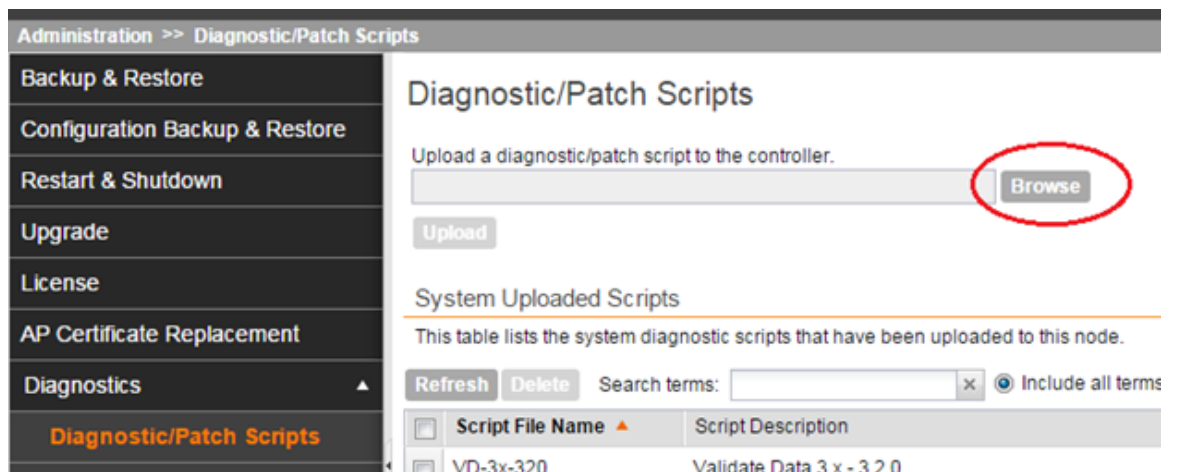
1. Download the KSP file from the Support website to your computer. The file name is `extendPrecheckTimeout_0.ksp`.
2. Log on to the controller, and then go to **Administration > Diagnostics > Diagnostic/Patch Scripts**.
3. Click **Browse**, and select the KSP file that you downloaded.

The screenshot shows the 'Administration >> Diagnostic/Patch Scripts' page. On the left is a navigation menu with 'Diagnostic/Patch Scripts' selected. The main content area is titled 'Diagnostic/Patch Scripts' and contains an upload form. The form has a text input field with the placeholder 'Upload a diagnostic/patch script to the controller.' and a 'Browse' button circled in red. Below the input field is an 'Upload' button. Underneath is a section titled 'System Uploaded Scripts' with a table listing uploaded scripts. The table has columns for 'Script File Name' and 'Script Description'. One script is listed: 'VD-3x-320' with description 'Validate Data 3 x - 3 2 0'. Above the table are buttons for 'Refresh' and 'Delete', a search field, and a checkbox for 'Include all terms'.
