Ruckus SmartZone Release Notes

Supporting SmartZone Release 3.6.1

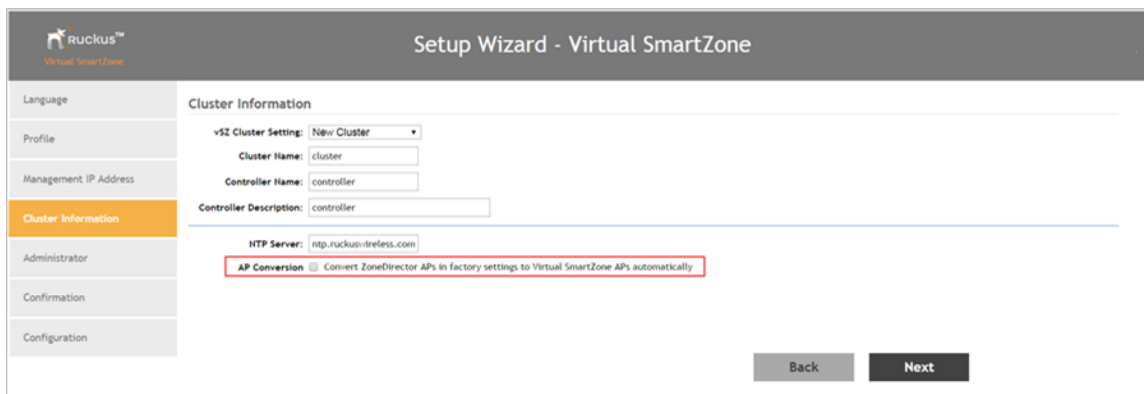
FIGURE 1 Select the AP Conversion check box to convert standalone ZoneFlex APs to controller APs

The figure below shows the AP Conversion check box for the vSZ Setup Wizard. If you are setting up SZ300, or SZ100 the check box description may be slightly different.

The screenshot shows the 'Setup Wizard - Virtual SmartZone' interface. On the left is a navigation menu with options: Language, Profile, Management IP Address, Cluster Information (highlighted), Administrator, Confirmation, and Configuration. The main area is titled 'Cluster Information' and contains the following fields:

- vSZ Cluster Setting: New Cluster (dropdown)
- Cluster Name: cluster
- Controller Name: controller
- Controller Description: controller
- NTP Server: ntp.ruckus-ireless.com
- AP Conversion: Convert ZoneDirector APs in factory settings to Virtual SmartZone APs automatically
