# Ruckus SmartZone 3.6.2 (MR2) Release Notes

Supporting AP R730

Part Number: 800-72028-001 Rev A Publication Date: October 2018

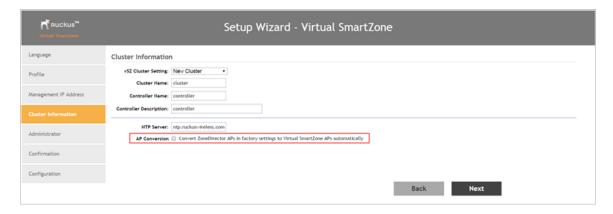
The figure below shows the AP Conversion check box for the vSZ Setup Wizard. If you are setting up SZ300, or SZ100 the check box description may be slightly different.

FIGURE 1 Select the AP Conversion check box to convert standalone ZoneFlex APs to controller APs
